Verdigris River Post Flood Channel and Riparian Assessment Report

See-Kan RC&D
2008

Prepared for

Kansas Water Office
901 South Kansas
Topeka, KS 66612

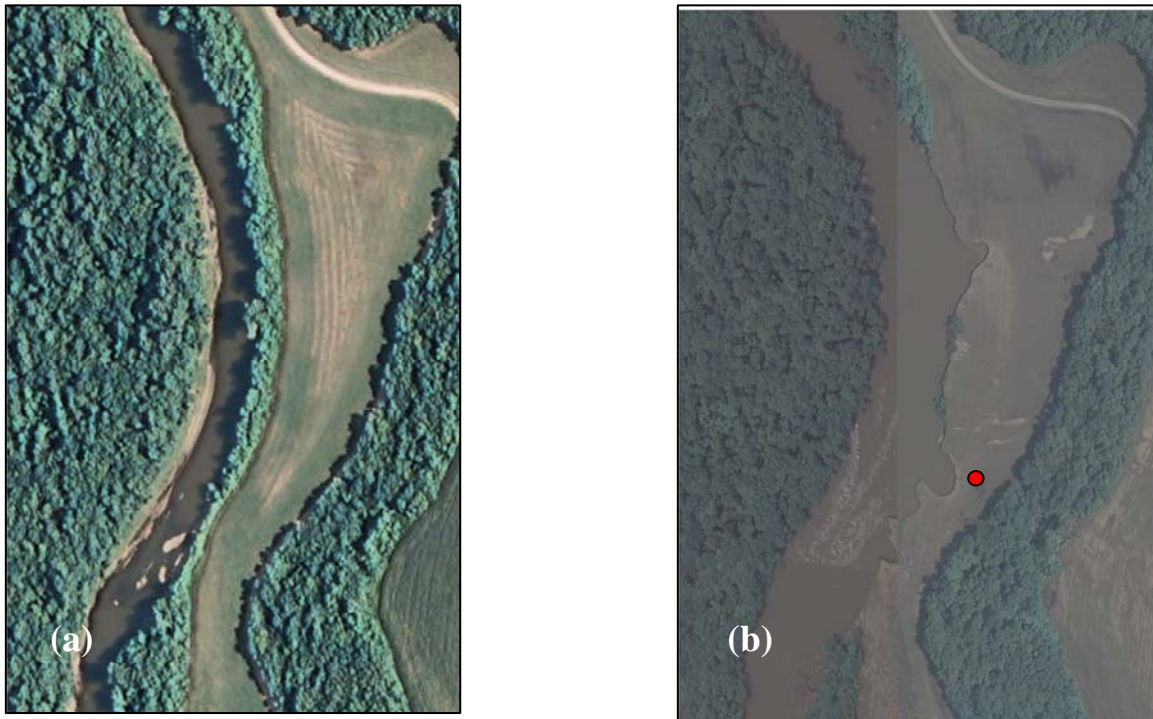
The eroded streambank was thought to be formed from the movement of the channel resulting in a less cohesive substrate than adjacent areas. The lack of cohesiveness would explain why this area received such a great amount of damage as opposed to the surrounding area. It should be noted that Area 11, is not characteristic of the whole stream.

Figure 6. Eroded area (Area 11) south of Liberty, KS representing damage from flood.(a) 2006. (b) 2007.

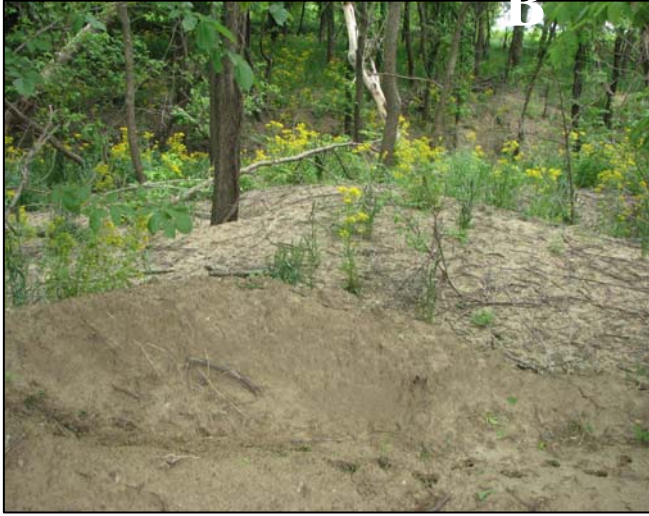
Figure 9. Sediment accumulation in riparian area of adjacent stream.

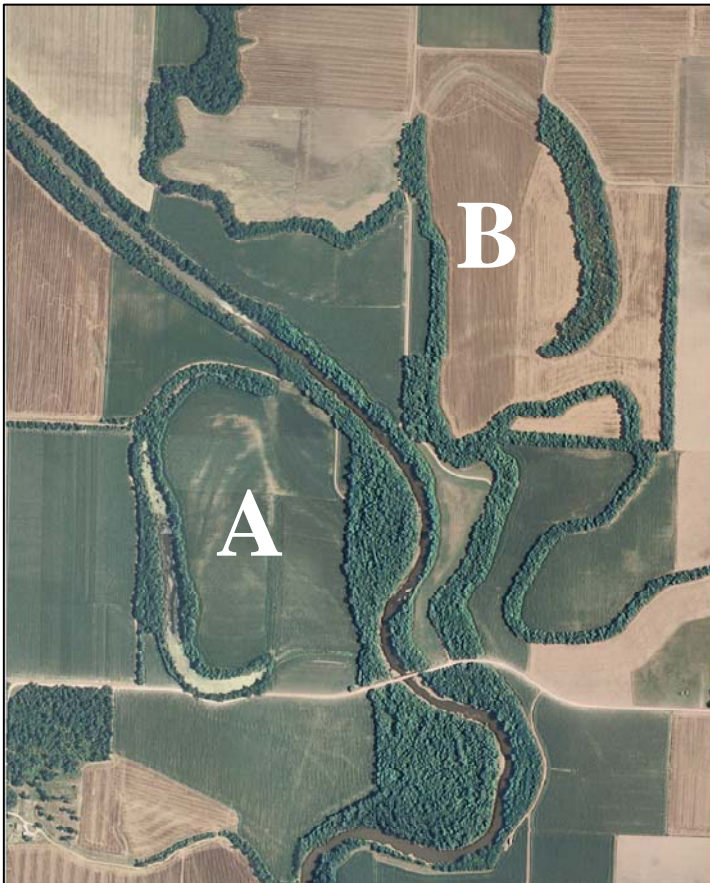
Figure 10. Representative oxbow lake (A), and meander scar (B).
