Kansas River Basin Regional Sediment Management Section 204 Stream and River Channel Assessment

March 2010

Final Report

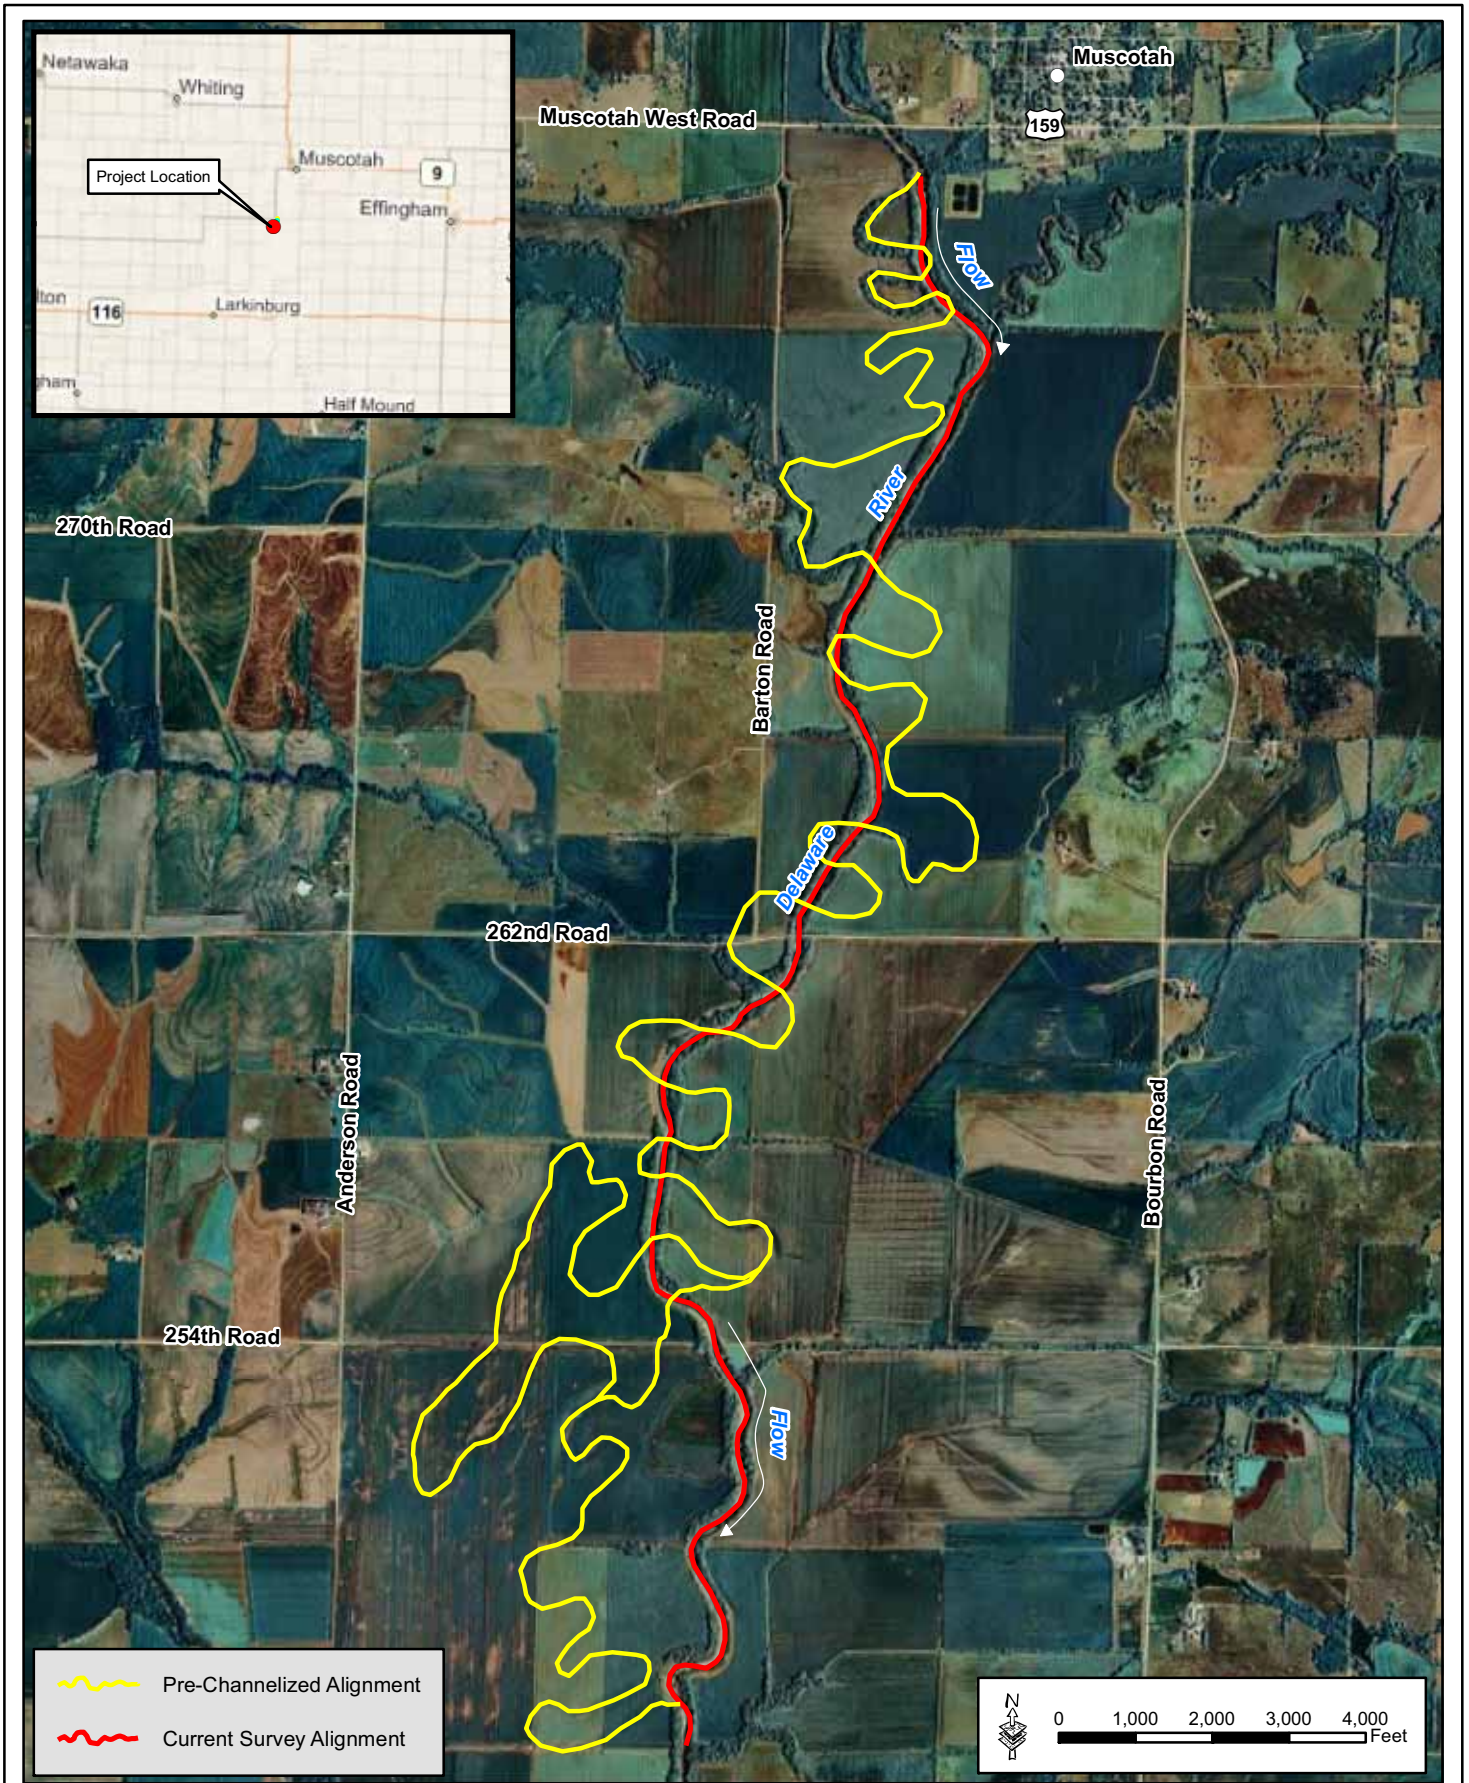
Figure ES-1: Channelization of Delaware River at USGS Muscotah Gauge

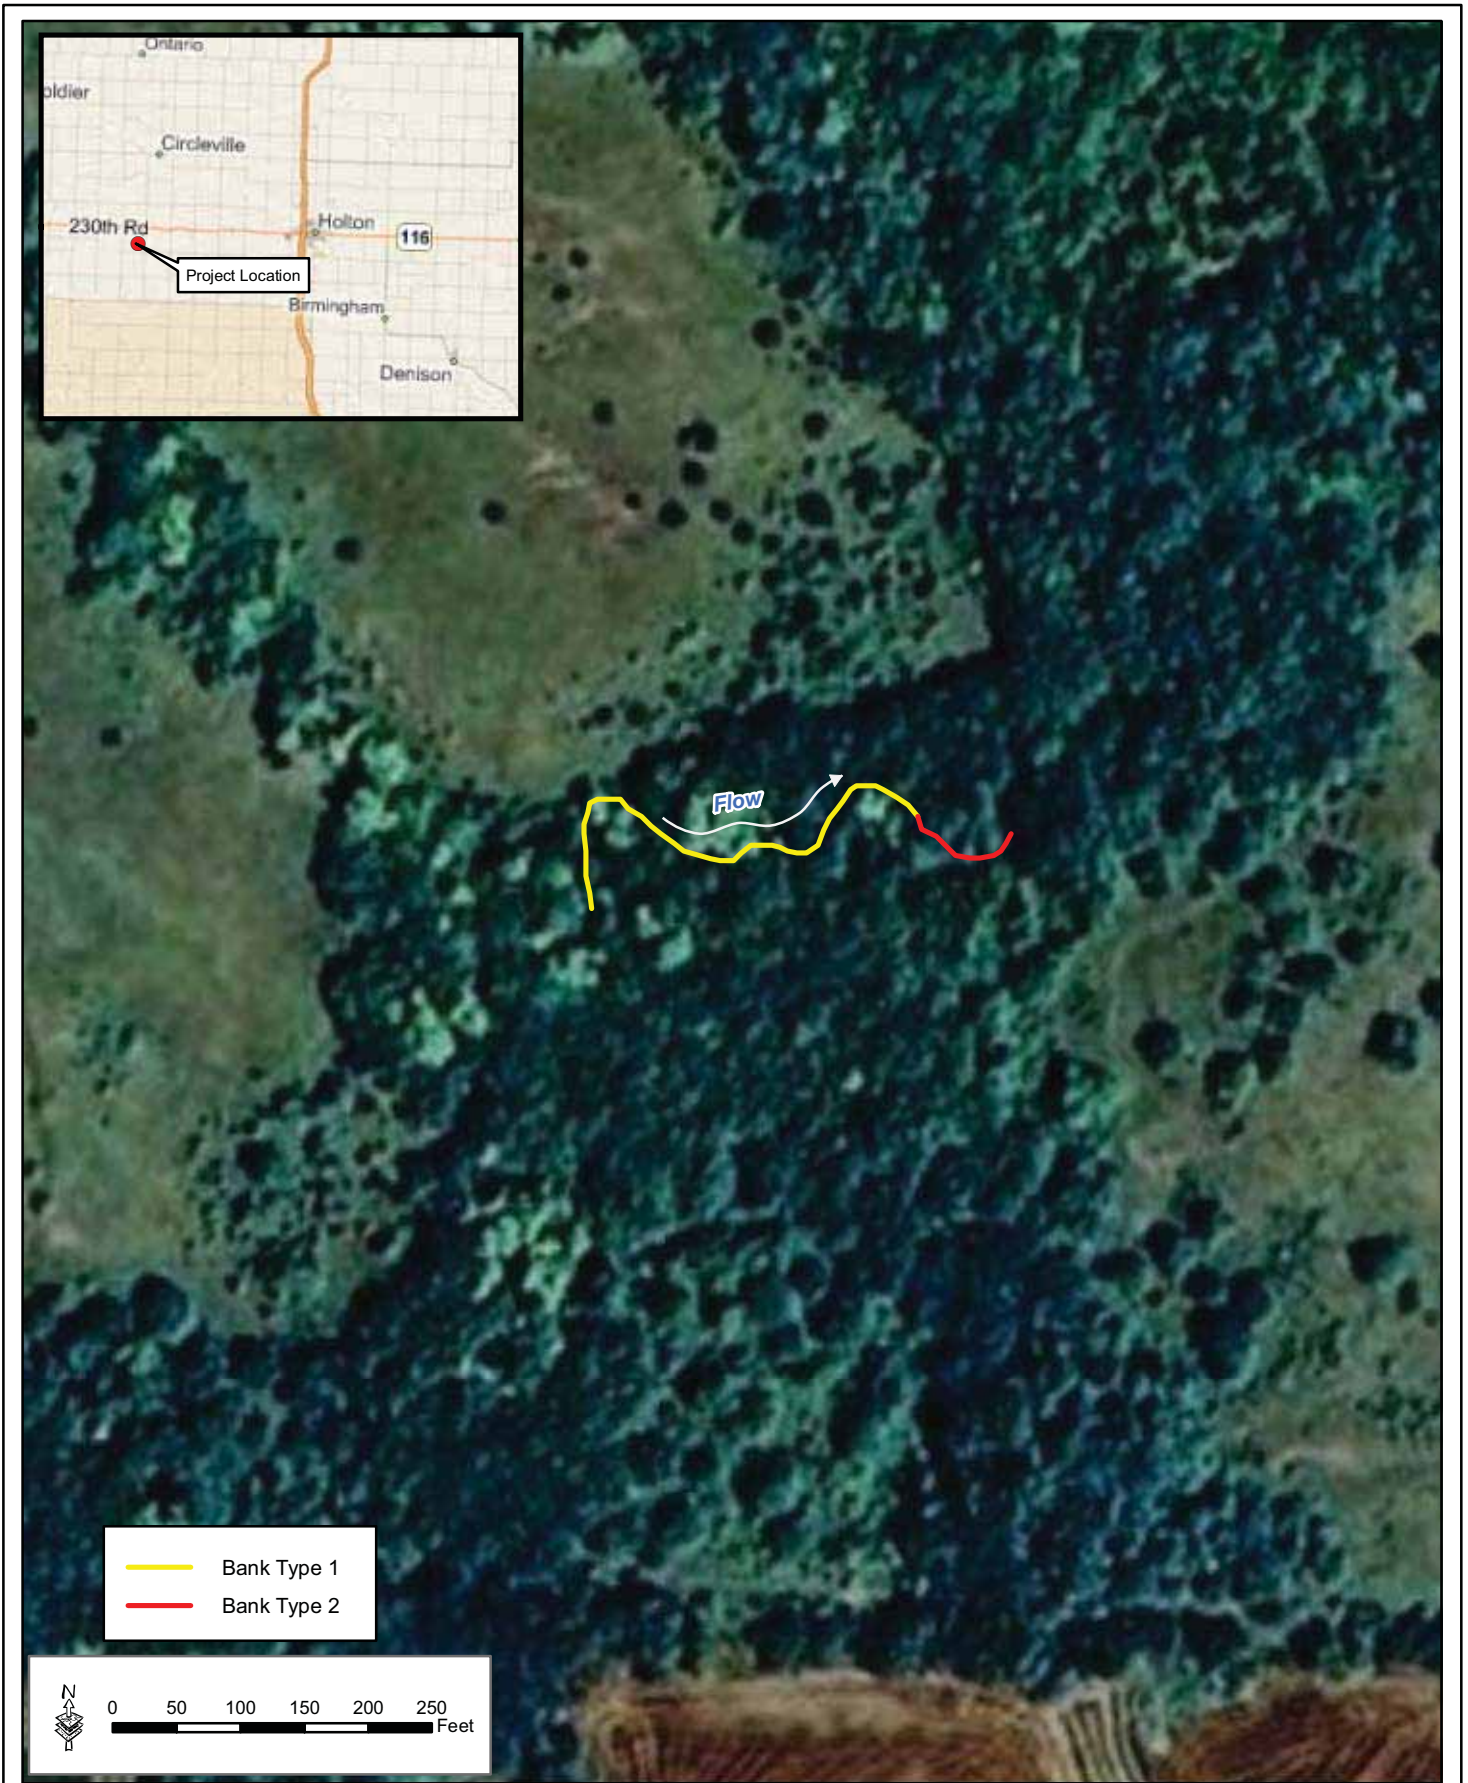
Figure 4-2: Bank Types at Banner Creek Survey Site 1

The creek was fairly sinuous with high, moderately unstable banks. The survey identified two bank types along the 528 foot survey reach. Most of the survey reach (415 feet or 79% of survey reach) was representative of bank type 1 (Photograph 1, Appendix F). This bank was composed of two layers; the top was a dark silt loam and the lower was a dense yellow-brown silty-clay loam. The lower layer appeared to be fairly resistive to erosion, because very few active signs of erosion were observed. Plant roots extended down through the entire bank profile with a moderate density of approximately 50%.

Bank type 2 was identified along the last 113 feet of the reach (21% of survey reach). In this area, the stream was cutting into a high terrace, thus increasing the bank height (Photograph 2, Appendix F). The bank materials were similar to bank type 1; however, the roots were less dense and not as deep as bank type 1 and, therefore, bank type 2 exhibited a greater potential to erode. Throughout the Banner Creek reach, the most common sign of active erosion was fallen trees. Several small woody debris jams, leaning trees, and exposed roots were consistently observed (Photograph 3, Appendix F). Table 4-4 summarizes the erosion potential of the two bank types at Survey Site 1. Figure 4-2 illustrates the proportional extent of each bank type.

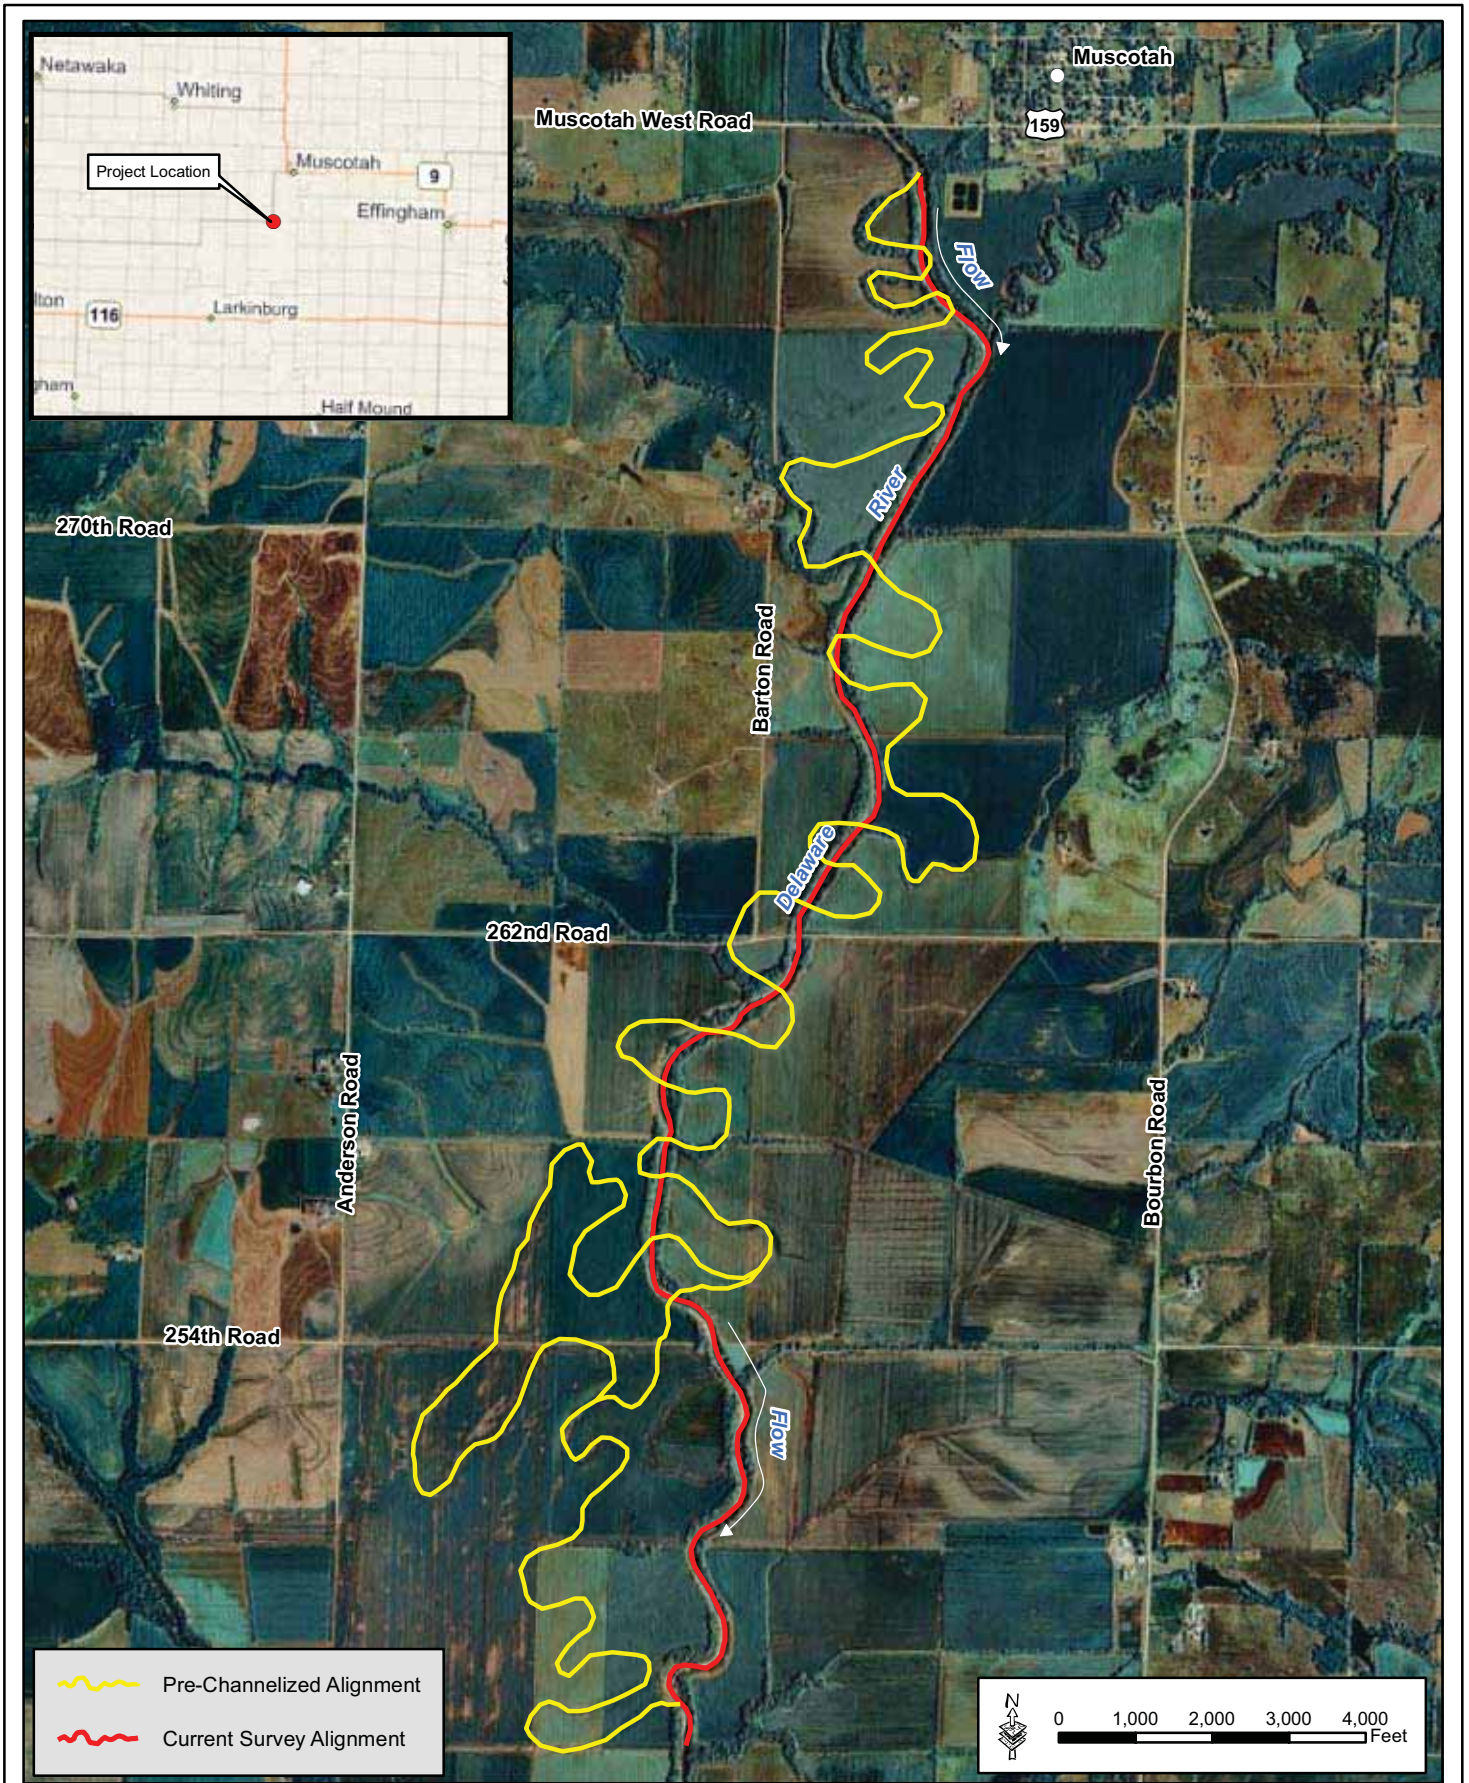
Figure 4-6: Channelization of Delaware River at USGS Muscotah Gauge

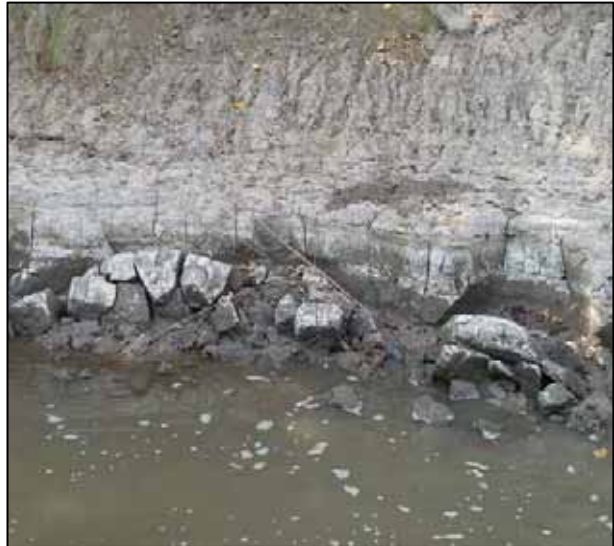
Photograph 5-1. Highly erodible bank on Delaware River with steep slope and no vegetation.

Bank shaping, such as constructing a bankfull bench, is recommended to increase stream stability by dissipating energy during high flow events. Bank shaping is employed at river bends where the slope of the bank is so great that it is difficult for vegetation to grow. Photograph 5-1 presents a highly erodible river bend bank that was unable to support vegetation. This bank would require excavation to reduce the angle and create a gentle slope (3 horizontal to 1 vertical) that would support indigenous trees and grasses. The vegetation's root matter stabilizes the soils and significantly reduces the potential for soils to erode during high water flows.

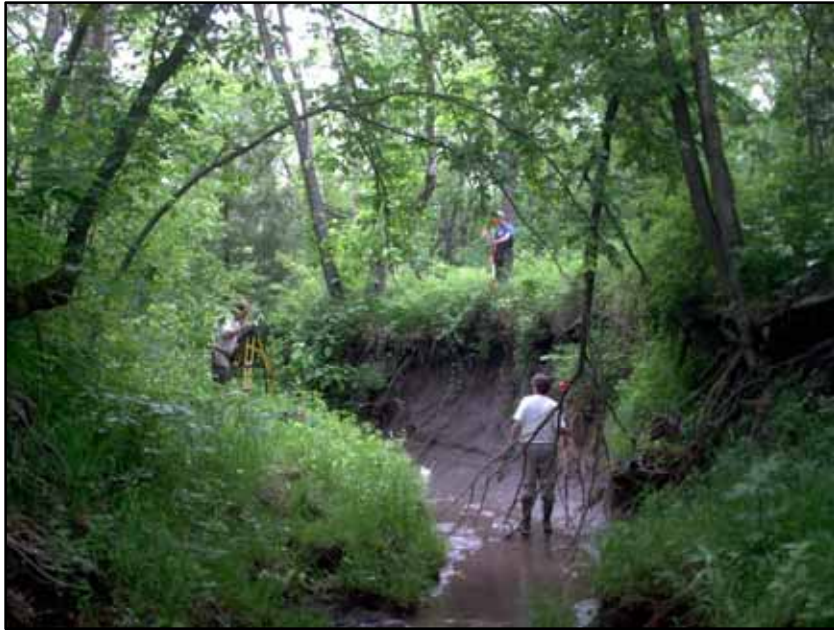
Kansas River Basin Stream and River Channel Assessment Direction: East	DESCRIPTION	Bank type 1 conditions	1
	LOCATION	Banner Creek	Date
	PHOTOGRAPHER	Brock Emmert	May 28, 2009

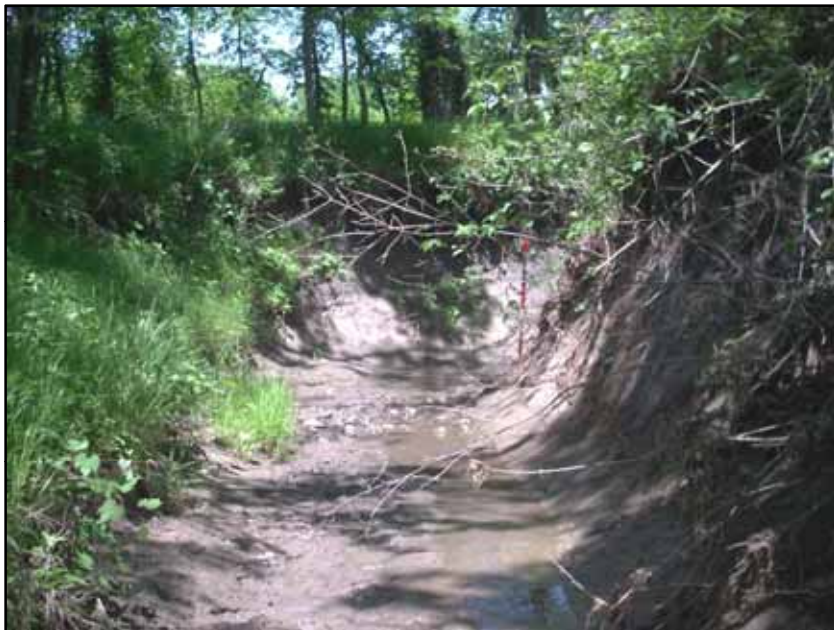
Kansas River Basin Stream and River Channel Assessment Direction: Northeast	DESCRIPTION	Bank type 2 conditions	2
	LOCATION	Banner Creek	Date
	PHOTOGRAPHER	Brock Emmert	May 28, 2009

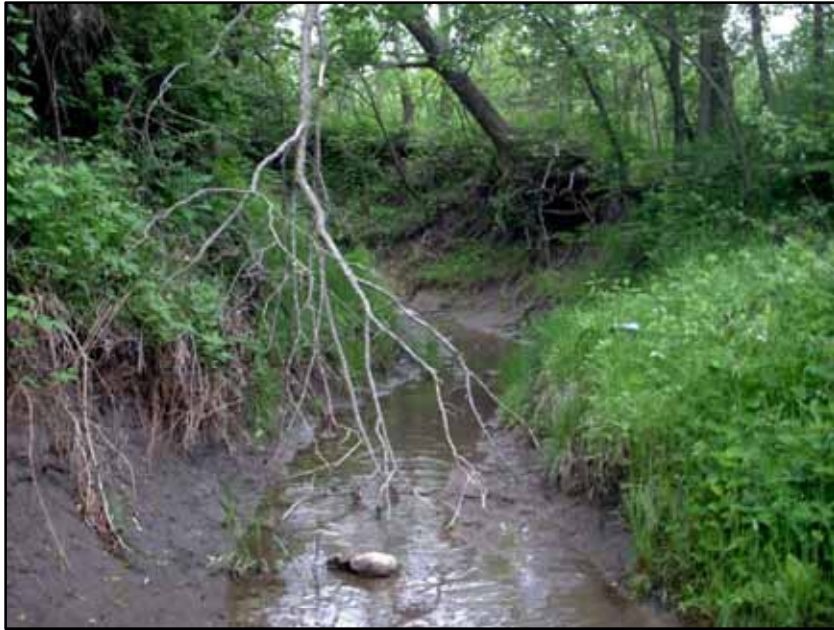
Kansas River Basin Stream and River Channel Assessment Direction: West	DESCRIPTION	Root exposure and tree leaning	3
	LOCATION	Banner Creek	Date
	PHOTOGRAPHER	Brock Emmert	May 28, 2009

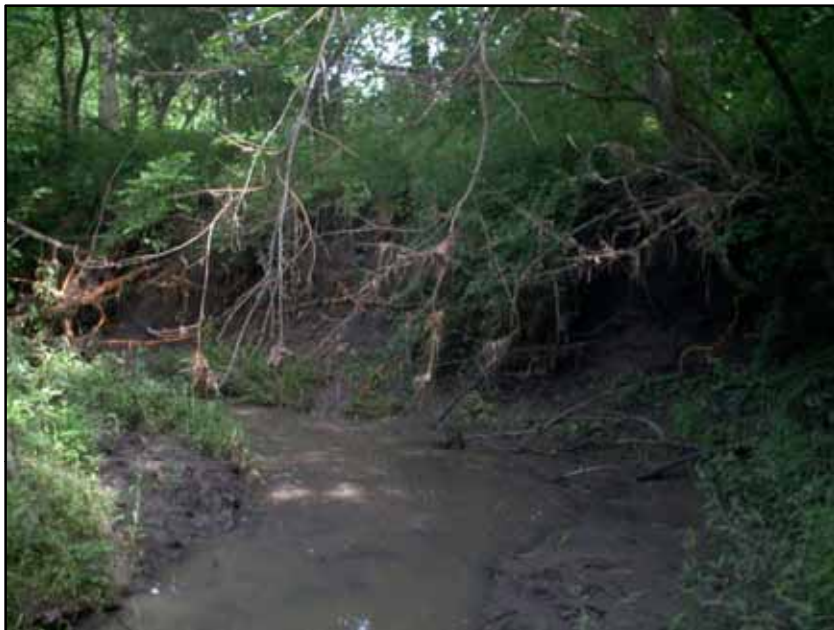
Only one consistent bank type was observed at Survey Site 2. The bank condition consisted of clay loam materials, and the slope of the streambank was moderately steep (Photograph 4, Appendix F). The riparian vegetation provided moderate rooting density and depth that extended down through the entire bank profile. The streambank height was typically two times the bankfull height increasing the bank erodibility. Exposed roots and trees beginning to lean into the stream channel were observed. The NBS rating was high due to a high d_{nb}/d_{bkf} ratio. The predicted erosion loss was derived from monitoring data from the Black Vermillion River watershed. Table 4-6 summarizes the erosion potential for the bank type. Figure 4-3 presents the stream reach at Survey Site 2, which consists of one bank type.

Kansas River Basin Stream and River Channel Assessment Direction: South	DESCRIPTION	Typical bank conditions	4
	LOCATION	Clear Creek Tributary	Date
	PHOTOGRAPHER	Brock Emmert	June 19, 2009

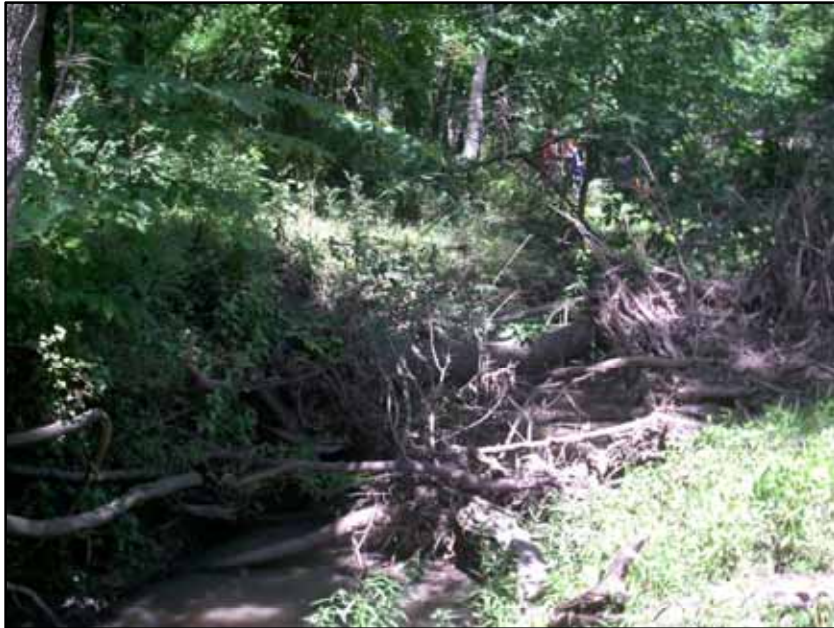
Kansas River Basin Stream and River Channel Assessment Direction: Southwest	DESCRIPTION	Large woody debris	5
	LOCATION	Clear Creek Tributary	Date
	PHOTOGRAPHER	Brock Emmert	June 19, 2009

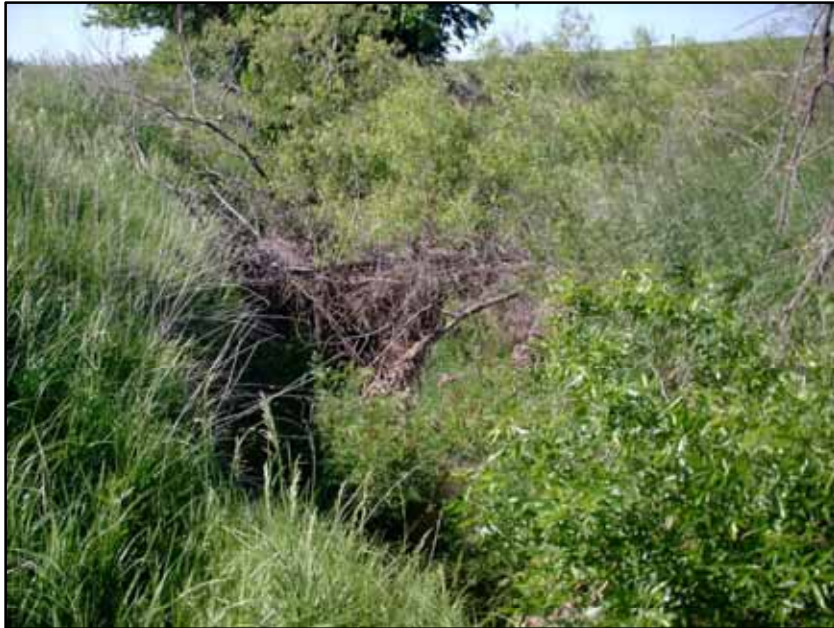
Kansas River Basin Stream and River Channel Assessment Direction: South	DESCRIPTION	Bank type 1 conditions	7
	LOCATION	Centralia Lake Tributary	Date
	PHOTOGRAPHER	Brock Emmert	May 29, 2009

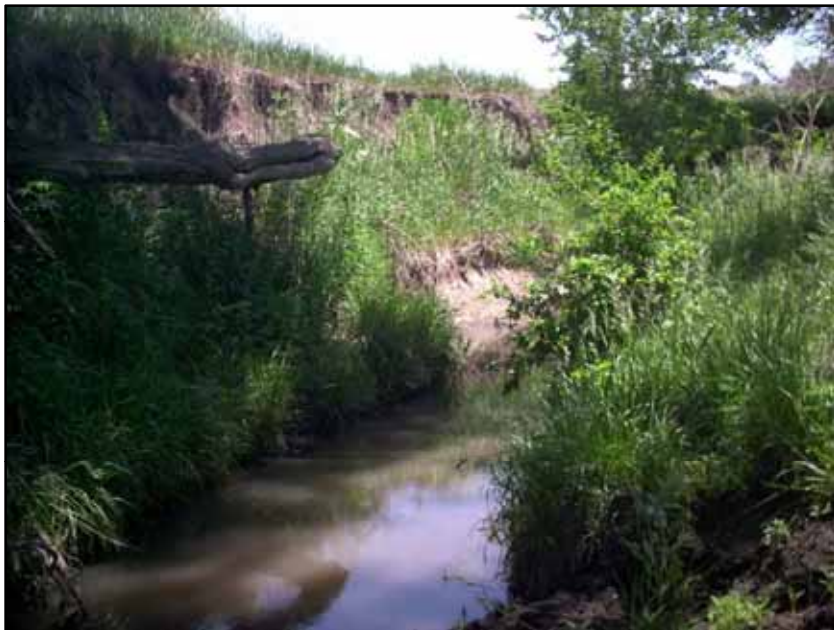
Kansas River Basin Stream and River Channel Assessment Direction: Northwest	DESCRIPTION	Bank type 2 conditions	8
	LOCATION	Centralia Lake Tributary	Date
	PHOTOGRAPHER	Brock Emmert	May 29, 2009

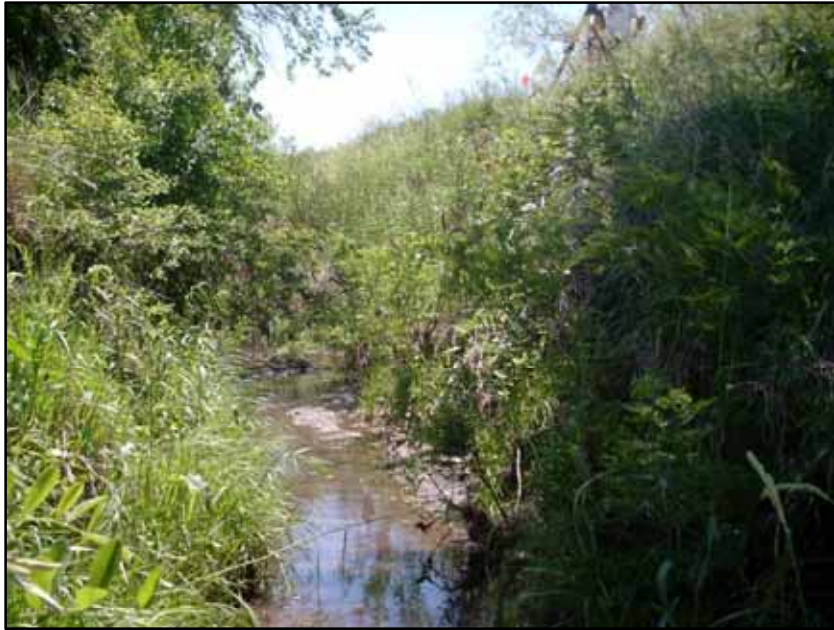
Kansas River Basin Stream and River Channel Assessment Direction: Northeast	DESCRIPTION	Bank type 3 conditions	9
	LOCATION	Centralia Lake Tributary	Date
	PHOTOGRAPHER	Brock Emmert	May 29, 2009

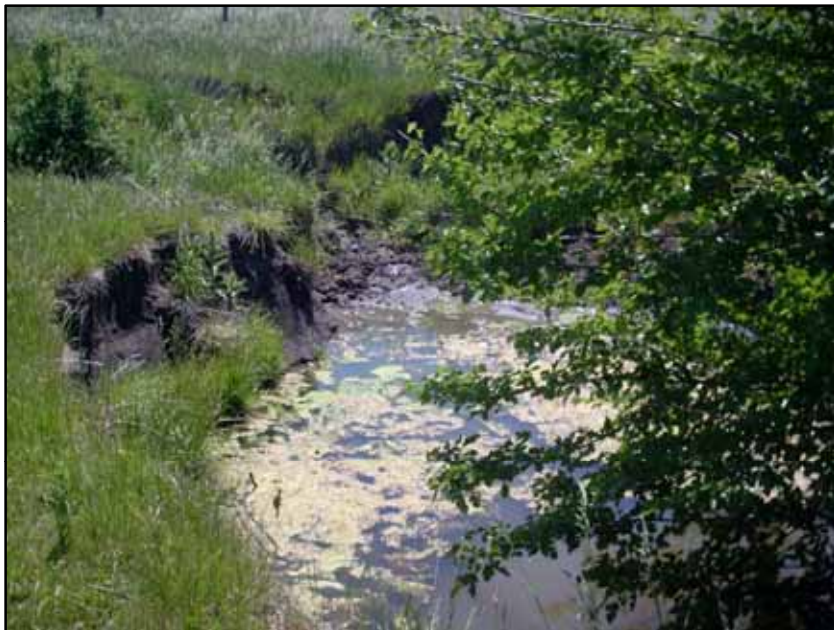
Kansas River Basin Stream and River Channel Assessment Direction: West	DESCRIPTION	Tributary knickpoint	8
	LOCATION	Centralia Lake Tributary	Date
	PHOTOGRAPHER	Brock Emmert	May 29, 2009

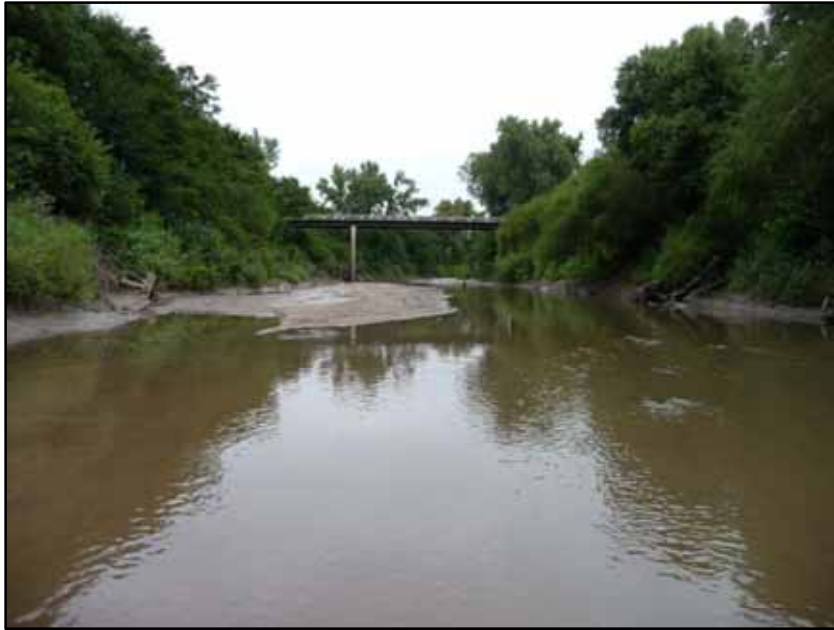
Kansas River Basin Stream and River Channel Assessment Direction: North	DESCRIPTION	Bank type 1 conditions	11
	LOCATION	Delaware River near Muscotah USGS gage	Date
	PHOTOGRAPHER	Brock Emmert	August 31, 2009

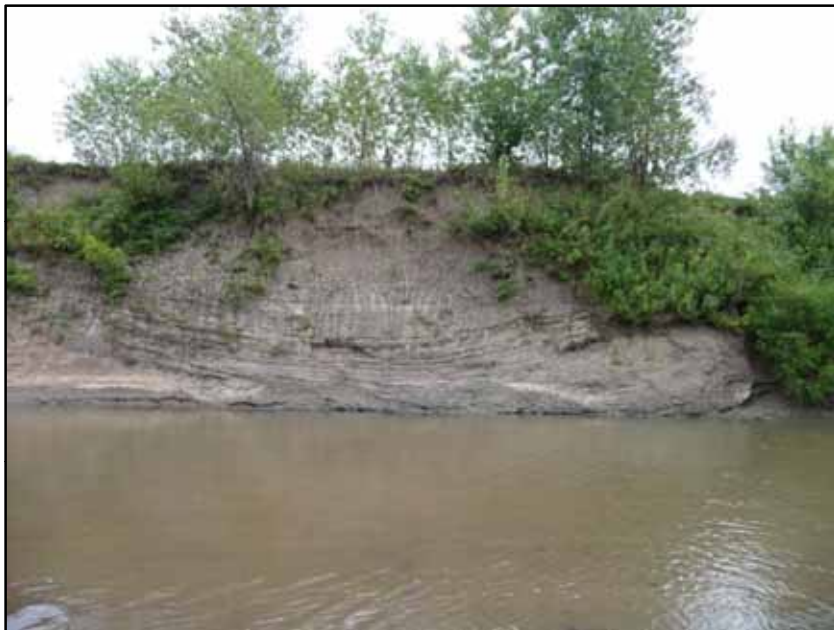
Kansas River Basin Stream and River Channel Assessment Direction: Southeast	DESCRIPTION	Bank type 2 conditions	12
	LOCATION	Delaware River near Muscotah USGS gage	Date
	PHOTOGRAPHER	Brock Emmert	August 31, 2009

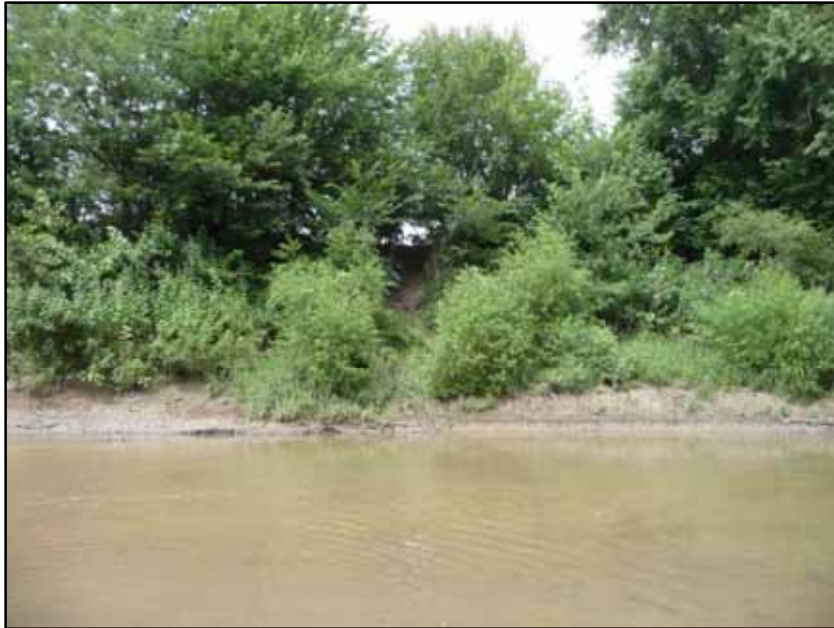
Kansas River Basin Stream and River Channel Assessment Direction: North	DESCRIPTION	Bank type 3 conditions	13
	LOCATION	Delaware River near Muscotah USGS gage	Date
	PHOTOGRAPHER	Brock Emmert	August 31, 2009

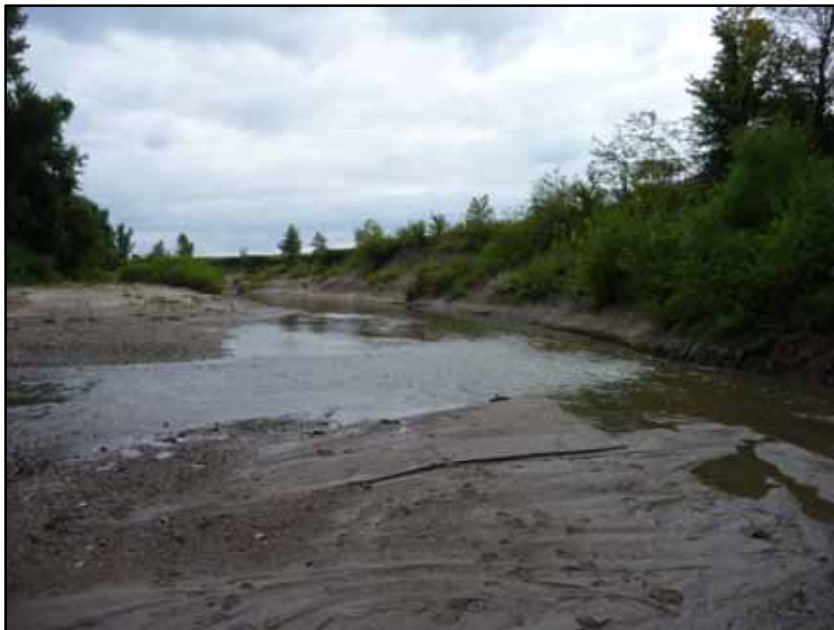
Kansas River Basin Stream and River Channel Assessment Direction: Southwest	DESCRIPTION	Mid and point bar	14
	LOCATION	Delaware River near Muscotah USGS gage	Date
	PHOTOGRAPHER	Brock Emmert	August 31, 2009
