STREAMBANK ASSESSMENT

PROCESS AND DEFINITIONS

Purpose of KWO Streambank Erosion Assessment

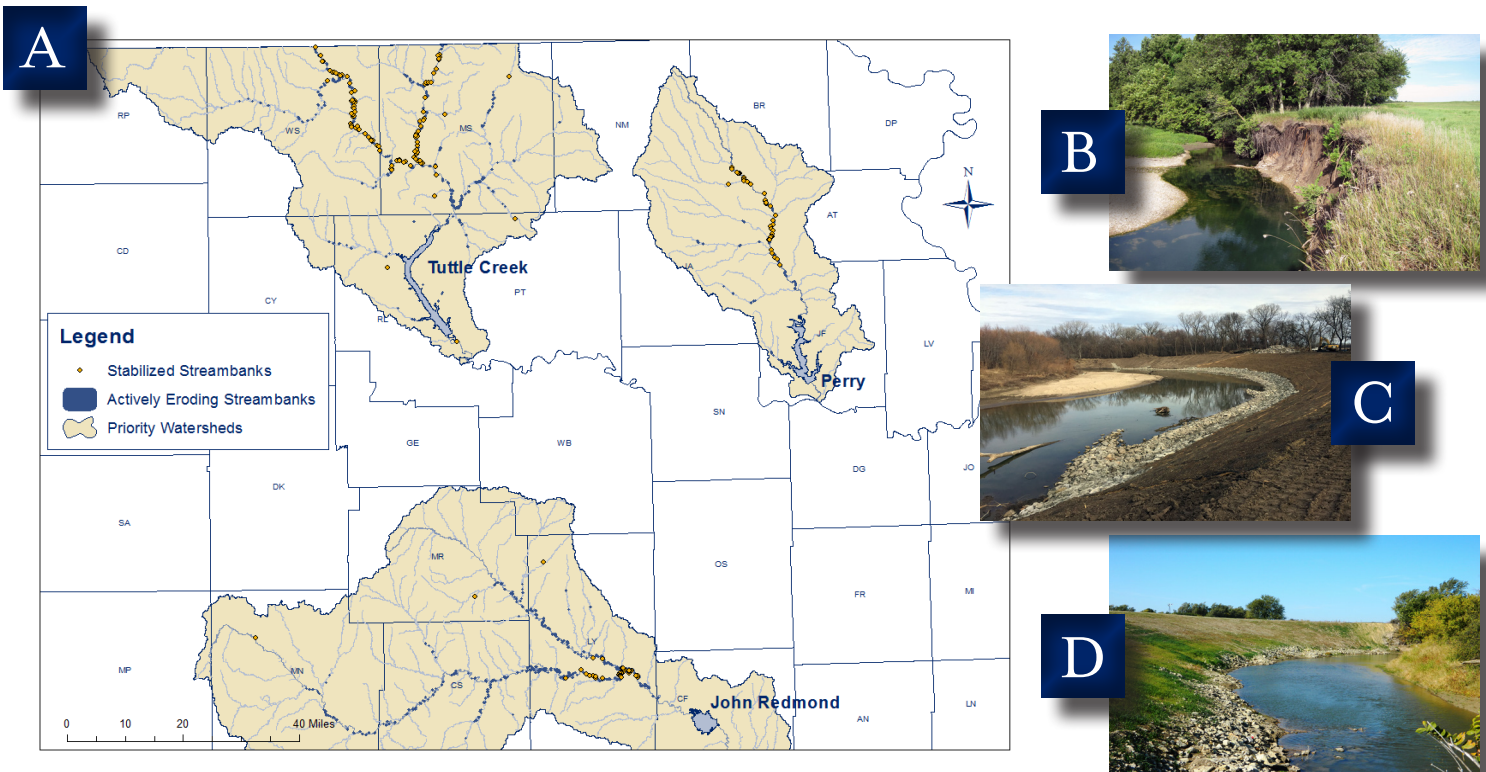
A Actively eroding streambanks in the three priority watersheds
 C Recently completed stabilized streambank site
B Eroding streambank along Fall River
 D Completed stabilized streambank site
