# Urban Green Infrastructure and Water Conservation: Monitoring irrigation and soil moisture on two large-scale prairie green roofs in the Flint Hills Eco-region with the aim of conserving potable water

Presented by Lee R. Skabelund, 2016-2018 Mary K. Jarvis Research Chair, Kansas State University  
Dept. of Landscape Architecture and Regional & Community Planning

## **KSU Memorial Stadium Green Roofs - Design & Implementation, Monitoring & Management**

## Monitoring green roof soil moisture dynamics on two large-scale prairie green roofs in the Flint Hills Eco-region with the aim of conserving potable water and promoting native plant coverage

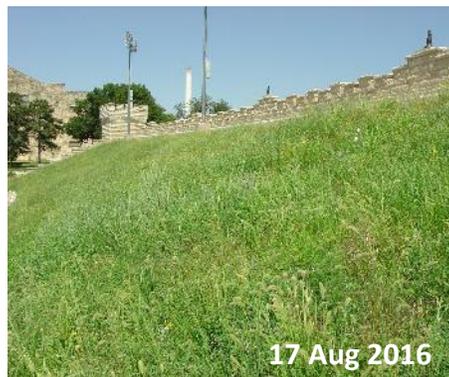
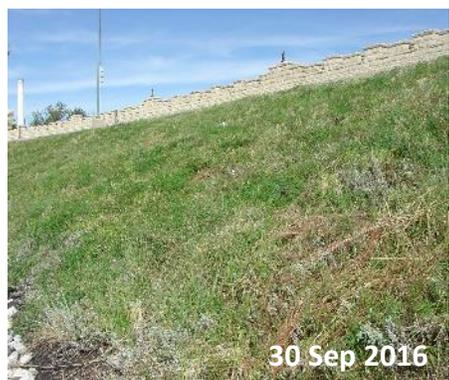
28-Jun	Variables		EMS-GR		WMS-GR	
Rain Event	Sky Cover	28-Jun	partly sunny		mostly sunny	
	Solar Radiation	max	1027	28-Jun	965	27-Jun
	Temperature (°C)	low	39.5	28-Jun	33.4	28-Jun
		high	22.5	28-Jun	22.9	28-Jun
	Soil Moisture (VWC)	before	0.15-0.17	5:45 AM	0.15-0.19	5:45 AM
		peak	0.30-0.34	6:45 AM	0.25-0.29	6:15 AM
		level	0.16-0.20	9:00 PM	0.18	4:00 PM
19-Aug	Variables		EMS-GR		WMS-GR	
Rain Event	Sky Cover	19-Aug	mostly cloudy		mostly sunny	
	Solar Radiation	max	844	19-Aug	932	19-Aug
	Temperature (°C)	low	21.1	20-Aug	35.1	19-Aug
		high	29.4	19-Aug	21.1	20-Aug
	Soil Moisture (VWC)	before	0.15-0.22	5:45 PM	0.16-0.18	5:30 PM
		peak	0.26-0.28	6:00 PM	0.23-0.25	6:00 PM
		level	0.19-0.24	1:00 AM	0.19	2:00 AM
13-Sep	Variables		EMS-GR		WMS-GR	
Rain Event	Sky Cover	13-Sep	mostly sunny		mostly cloudy	
	Solar Radiation	max	923	13-Sep	857	10-Sep
	Temperature (°C)	low	16.8	13-Sep	30.4	13-Sep
		high	23.8	13-Sep	21.3	13-Sep

Soil Moisture (VWC)	before	0.10-0.15	1:45 AM	0.12-0.14	2:00 AM
		peak	0.27	4:15 AM	0.24-0.29	4:15 AM
		level	0.17-0.21	4:45 PM	0.19	3:00 PM

The chart on the right shows the summary (average, minimum, and maximum) values for the soil moisture and temperature for the six high sensors on the EMS and WMS green roofs. The chart below illustrates the variation between solar radiation, and sub-surface temperatures and soil moisture values, on each of the green roofs for three different rain events (June 28, August 19, and September 13, 2016).

Fig. 9. June 21-Nov. 5, 2016 EMS-GR Soil Moisture and Temperature Summaries (top right), Selected Rain Event Data (bottom left) and Associated High Sensor Locations (synthesized by Decker, Shrestha, Skabelund – November, 2016)

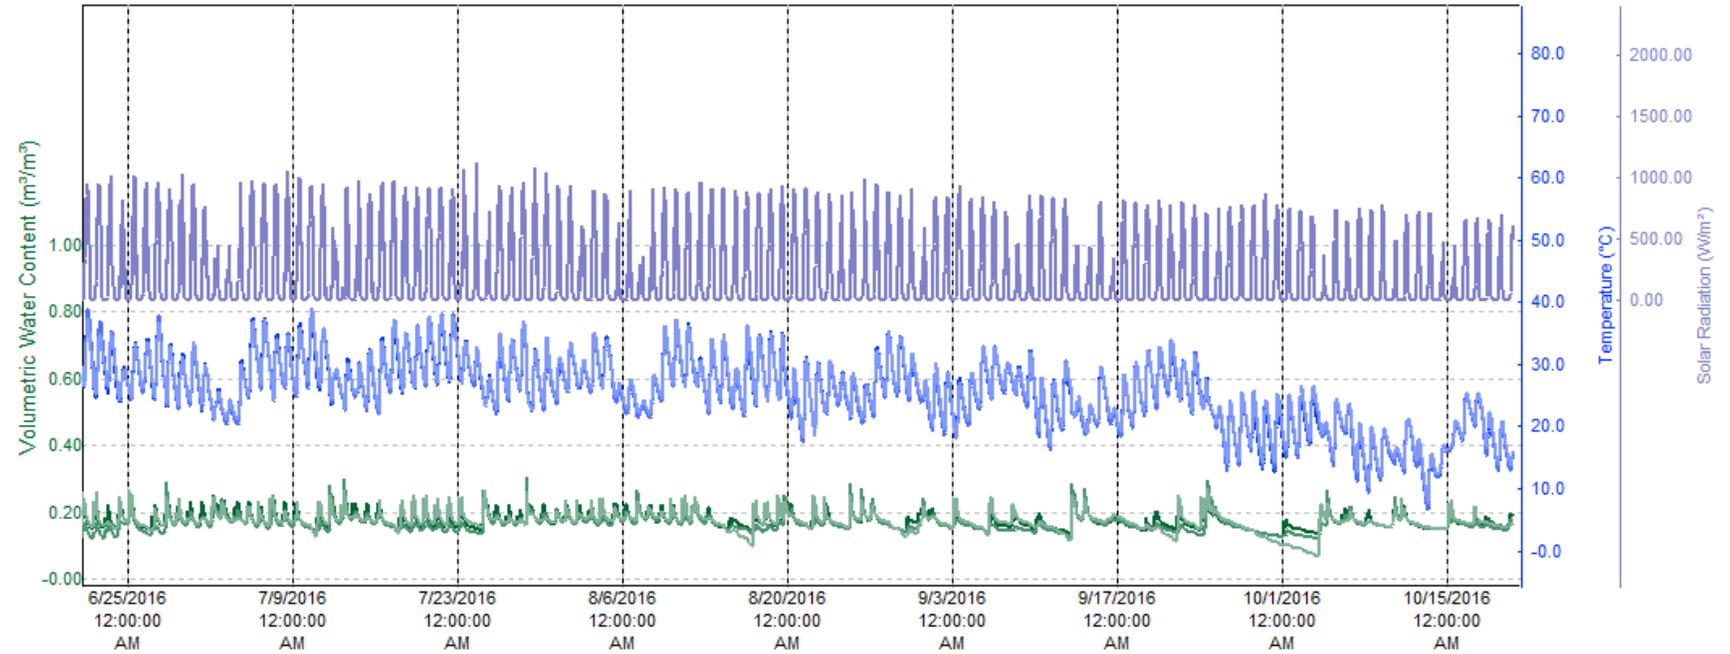
## Solar radiation and sub-surface temperature & soil moisture readings on WMS-GR

P1 - 5TM: m<sup>3</sup>/m<sup>3</sup> VWC   
  P2 - 5TM: m<sup>3</sup>/m<sup>3</sup> VWC   
  P3 - 5TM: m<sup>3</sup>/m<sup>3</sup> VWC   
  P4 - 5TM: m<sup>3</sup>/m<sup>3</sup> VWC   
  P1 - 5TM: °C Temp   
  P2 - 5TM: °C Temp   
  P3 - 5TM: °C Temp   
  P4 - 5TM: °C Temp   
  P5 - PYR: W/m<sup>2</sup> Solar

WMS-GR	High-South (P3)		High-Center (P2)		High-North (P1)	
	SM (VWC)	Temp (°C)	SM (VWC)	Temp (°C)	SM (VWC)	Temp (°C)
avg	0.19	23.20	0.16	23.40	0.20	23.10
min	0.11	9.20	0.07	9.10	0.11	8.90
max	0.38	39.80	0.35	38.10	0.36	40.60

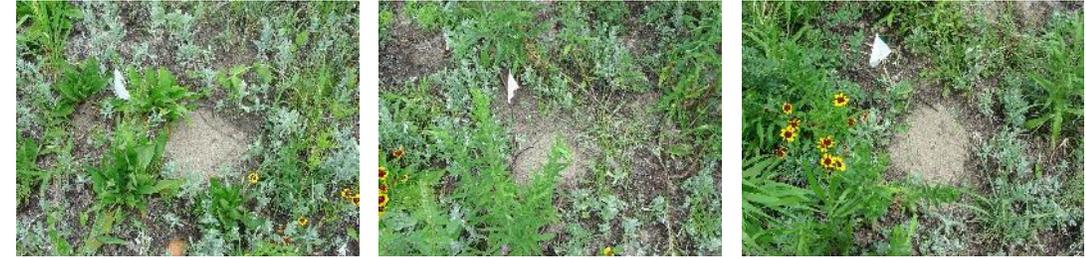
## EMS-GR (28 June 2016)

### Volumetric Water Content VWC m<sup>3</sup>/m<sup>3</sup>

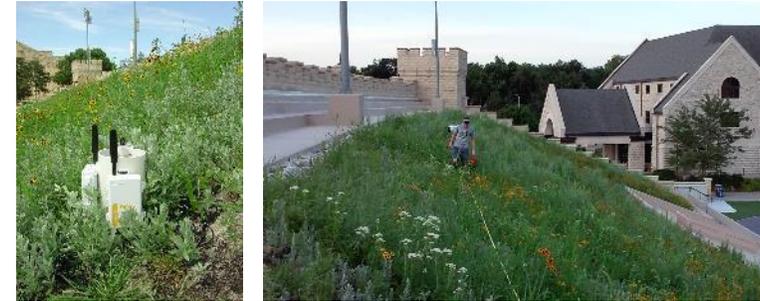
**EMS-GR –  
29-30 June 2016**

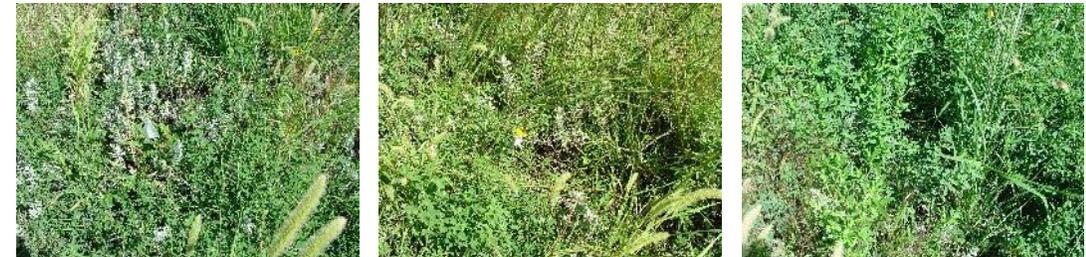
## EMS-GR (13 September 2016)

### Volumetric Water Content VWC m<sup>3</sup>/m<sup>3</sup>

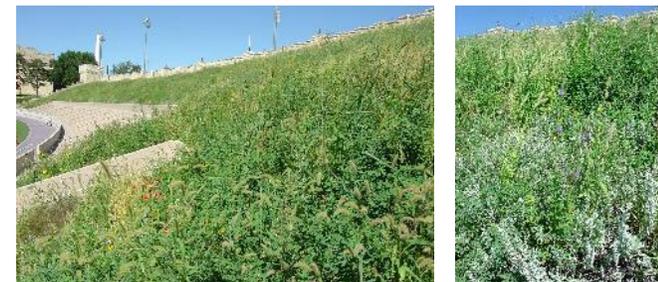
**EMS-GR –  
10 Sep. 2016**

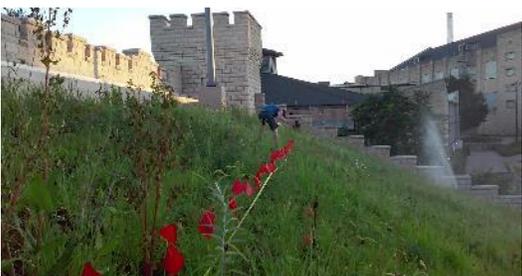
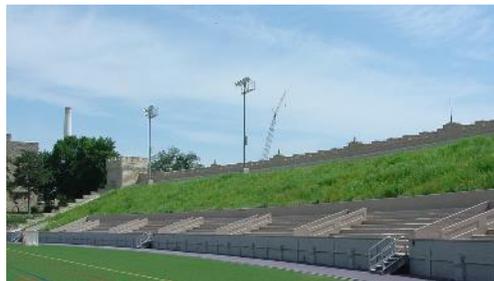
### Green roof vegetation characterization using color-infrared and thermal sensors mounted on a small unmanned aircraft system

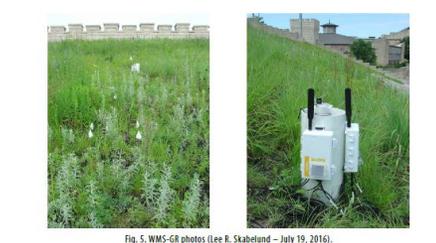
Fig. 4. Sensor Locations related to vegetative transect layouts and irrigation.

The WMS-GR was seeded and planted in June and July 2015. The EMS-GR was seeded and planted in March and April 2016. Nine (9) Decagon STM soil moisture/temperature sensors were installed in the center portion of each roof, with three (3) sensors positioned at high, mid, and low elevations. Sensors are buried three inches below the substrate surface within a geo-web cell with the prongs oriented downslope and vertical. Sand-based green roof substrate depths are six inches deep, with expanded chain added to lighter substrates on the EMS-GR. A single Prolog P18 solar radiation sensor was placed near the center of each roof. For STM and solar radiation sensors on the MS-GRs, we are collecting averaged 15-minute data, which is downloaded remotely from Decagon EMS loggers using DataTracK software. Sensors record soil moisture as volumetric water content (VWC), which is graphed in relation to a seven-day period associated with photo dates of vegetation present near each sensor. For this poster we have focused on important sensor readings, trends, and context (especially vegetative coverage) for the three highest elevation sensors on each green roof. An Unmanned Aerial Vehicle (UAV) was flown over each roof mid-day on July 5, 2015. Data from thermal camera imagery is shown on this poster (as synthesized by Deon van der Merwe).

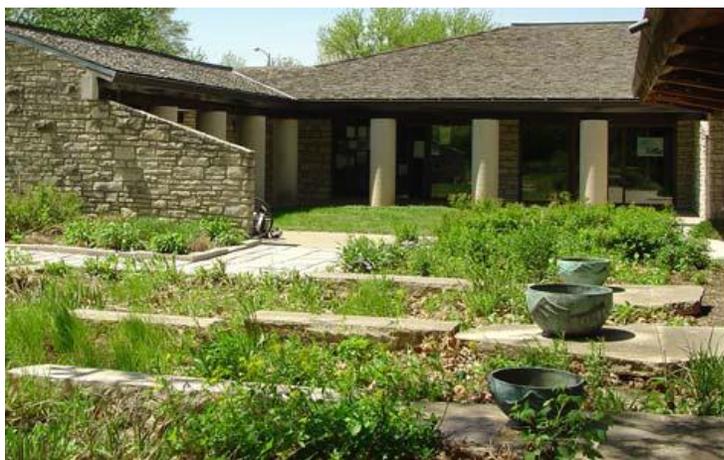
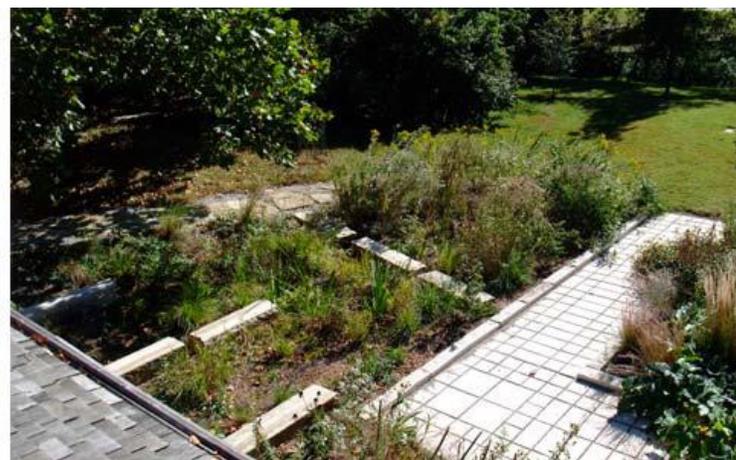
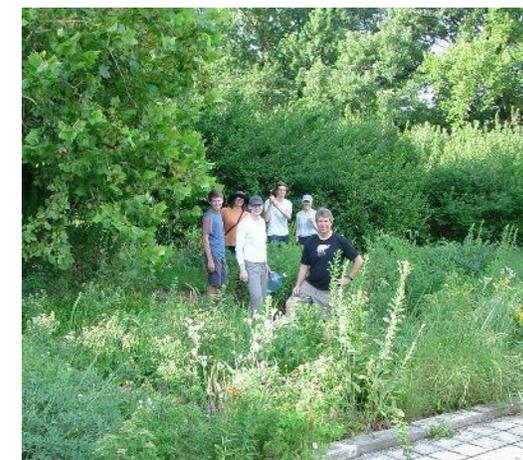
**turfgrass to garden; pipe to non-pipe**

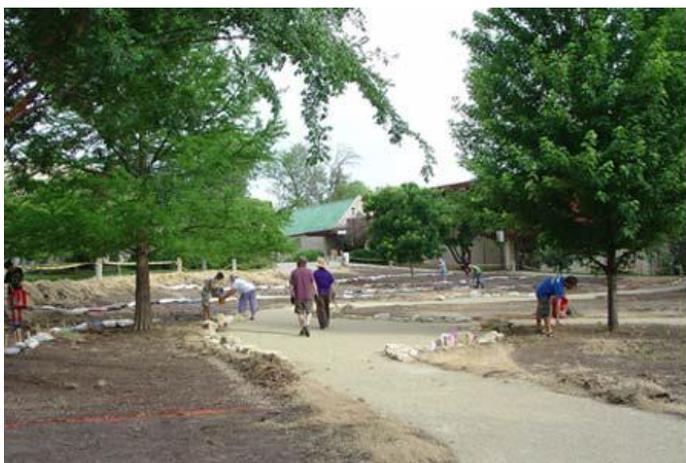
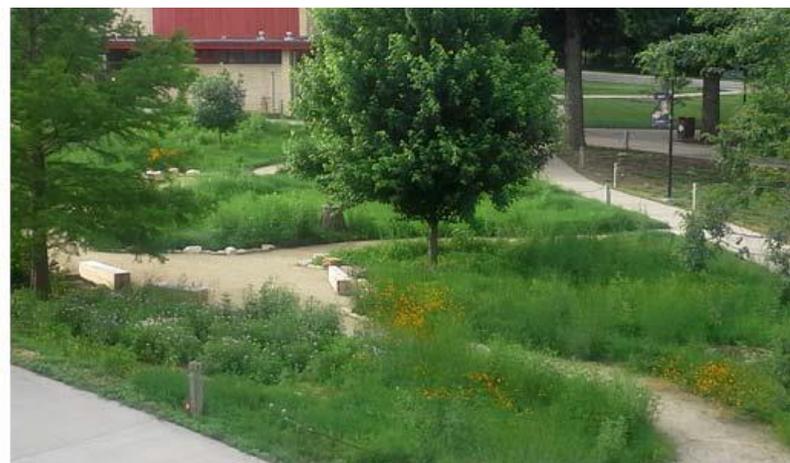
turfgrass to prairie-like meadow
