HILLSDALE RESERVOIR WATERSHED STREAMBANK EROSION ASSESSMENT

ArcGIS® Comparison Study: 1991 vs. 2008 Aerial Photography

DRAFT: July 2011

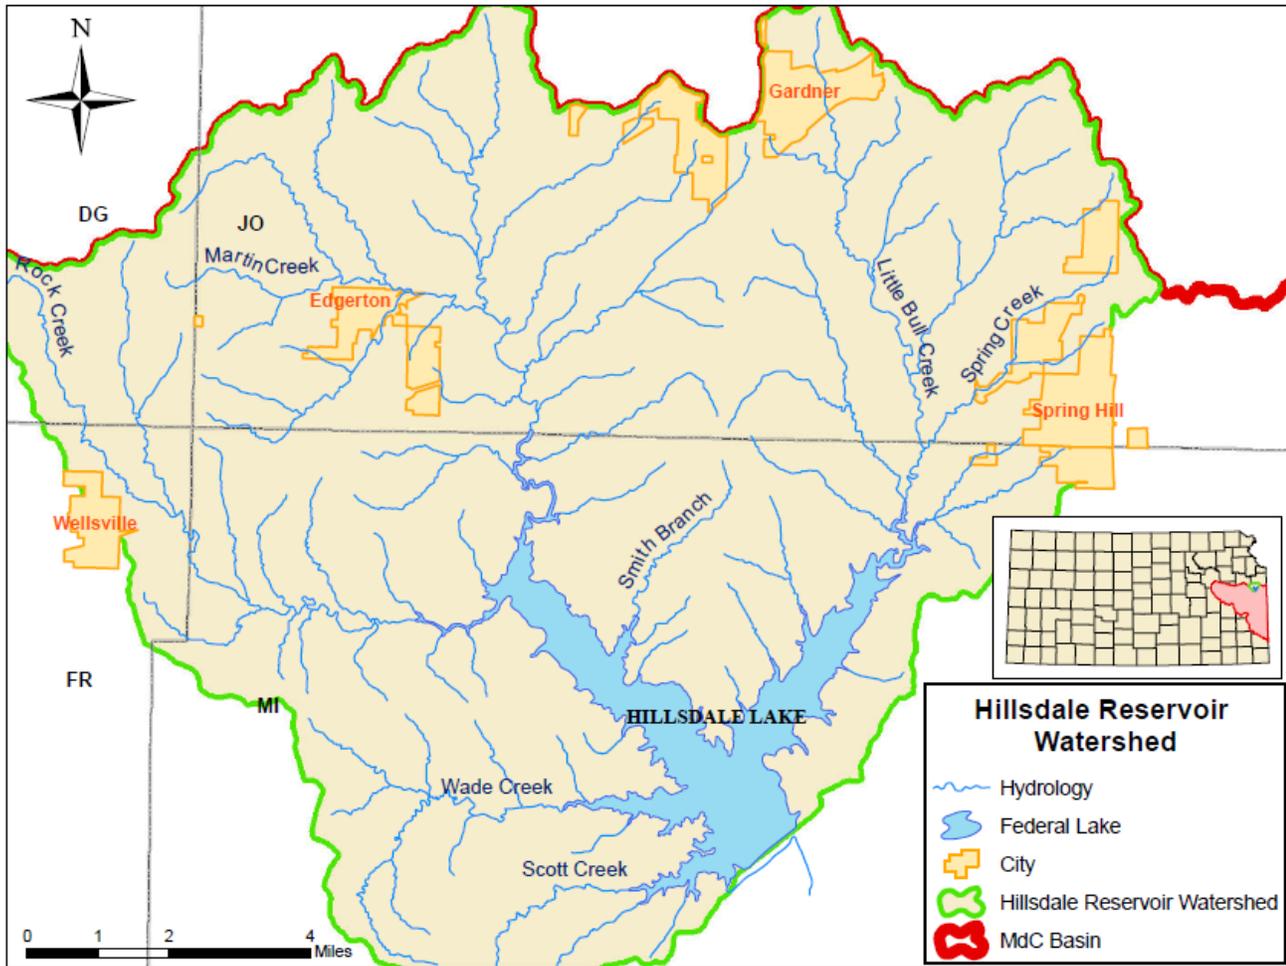
Figure 1. Hillsdale Reservoir Watershed Study Area

Hillsdale Reservoir was constructed on Big Bull Creek, at river mile 18.2, west of Hillsdale, Kansas and northwest of Paola, Kansas (Figure 1). The watershed drains about 144 square miles and includes portions of Douglas, Franklin, Johnson and Miami Counties. The U.S. Army Core of Engineers began construction of the reservoir in 1976 for flood control, navigation, water supply, water quality, recreation and fish and wildlife; navigation is not currently an operating purpose. Gates were closed in September 1981 and the conservation pool was filled in February of 1985. The original conservation pool and designed sedimentation rate of the reservoir were 82,207 acre-feet and 83 acre-feet per year, respectively. Major tributaries in the watershed include Rock Creek, Smith Branch, Spring Creek, Little Bull Creek and

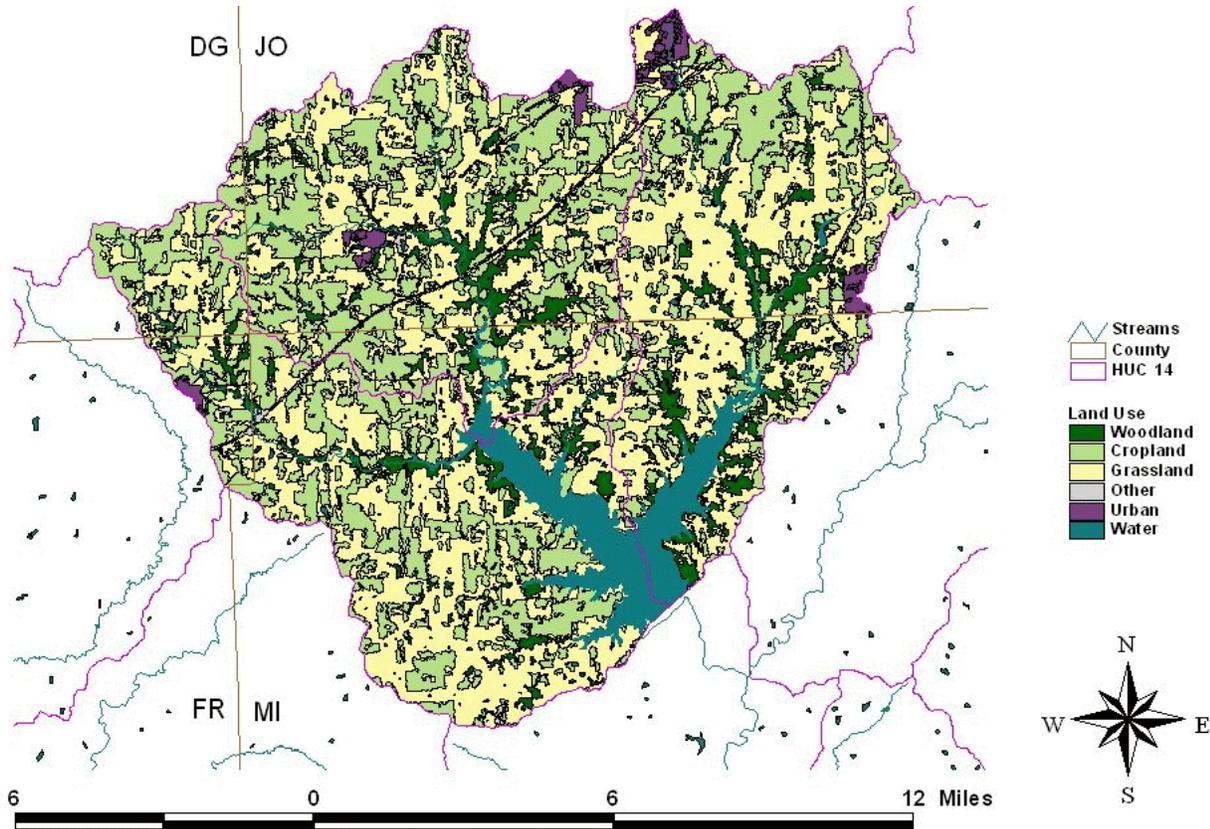
Figure 2. Land Use Land Cover for Hillsdale Reservoir Watershed, 1999

Land use in the Hillsdale Reservoir watershed consists of 50% grassland and 35% cropland, with the remaining 15% in feedlots and urban and residential development. Gently rolling uplands, with hilly areas along the streams, characterize the topography, with average annual rainfalls at 39 inches. The majority of the precipitation falls in late spring and early summer (Figure 2).

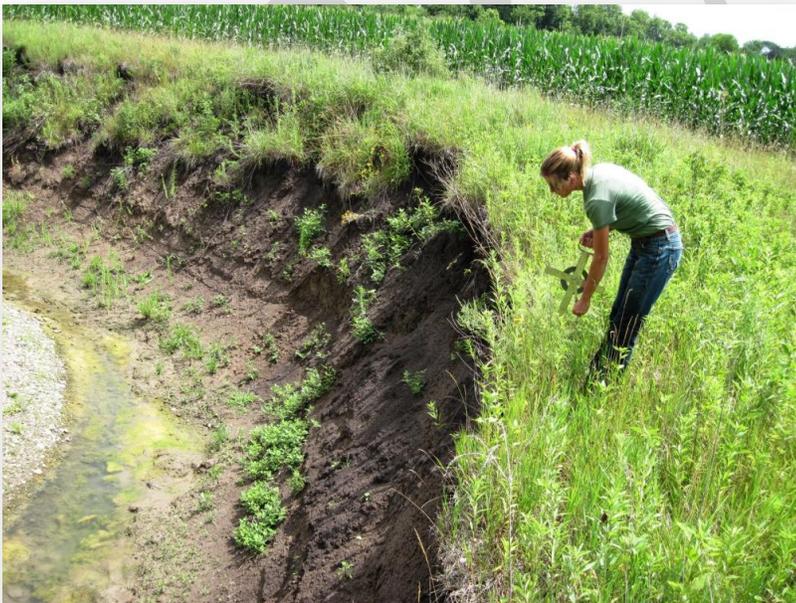
Figure 3. Assessment Field Verification Height Measurement on Little Bull Creek

Streambank height measurements, also used in the average soil loss rate equation, were obtained through on the ground field verification in several locations throughout the watersheds (Figure 4). Of the total sites identified, seven sites were selected, spread throughout the watershed, for field verification and streambank height measurements. These field verified streambank height measurements were the basis for extrapolating streambank height measurements for identified streambank erosion sites.

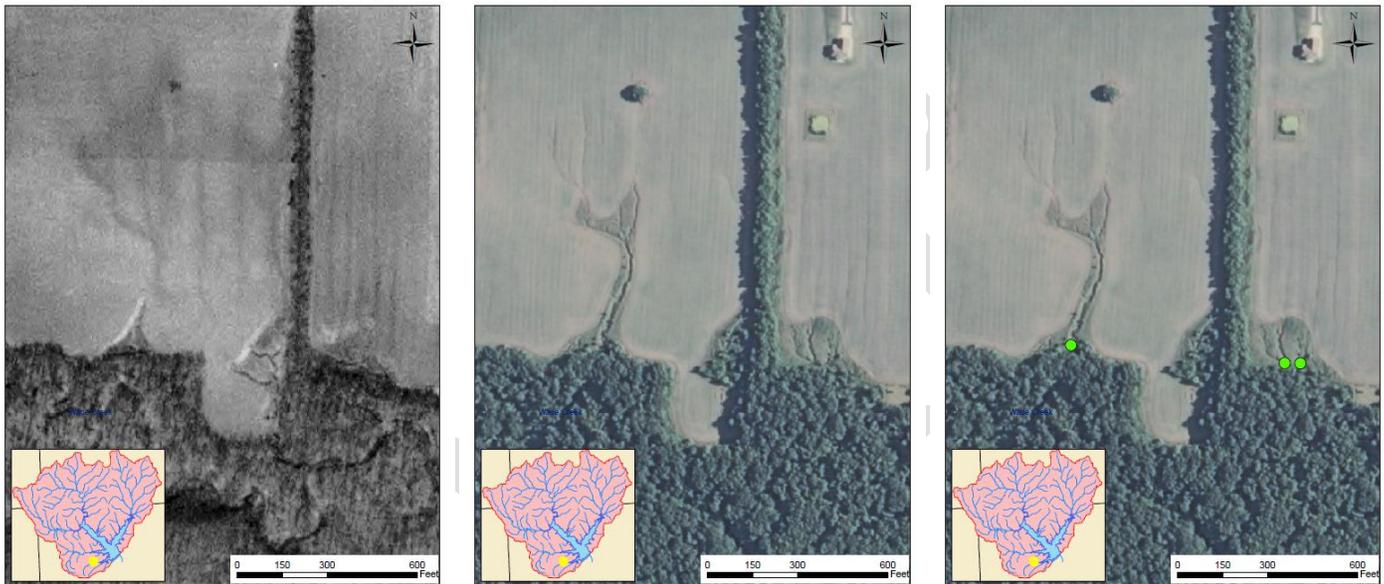
Figure 4. 1991 DASC & 2008 NAIP Aerial Photo Comparison; Gully Site Identification

The streambank gully erosion assessment was performed with similar techniques as the streambank erosion assessment. Using ArcMap® tools, streambank gully erosion sites were indicated by point features in the ArcGIS® software program

(Figure 4). Gully data was compiled and categorized by high, medium or low priority as another effort in rehabilitation prioritization. The identification of a low priority gully indicates that sheet erosion has been identified and a gully could form in the area that is perpendicular to the stream. A low priority gully does not indicate visible channel cutting or any visible streambank riparian erosion. A medium priority gully identifies visible channel cutting perpendicular to the streambank but no visible erosion of the riparian area of the streambank. High priority gullies identify a deeply incised channel cutting perpendicular to the stream, including a significant portion of the riparian area eroded from the streambank. In some instances, gullies were increased to a medium or high priority, even if they exhibit “low priority” gully identifiers, if there was a visibly identified sizeable amount of land erosion or gullies present in the same vicinity.

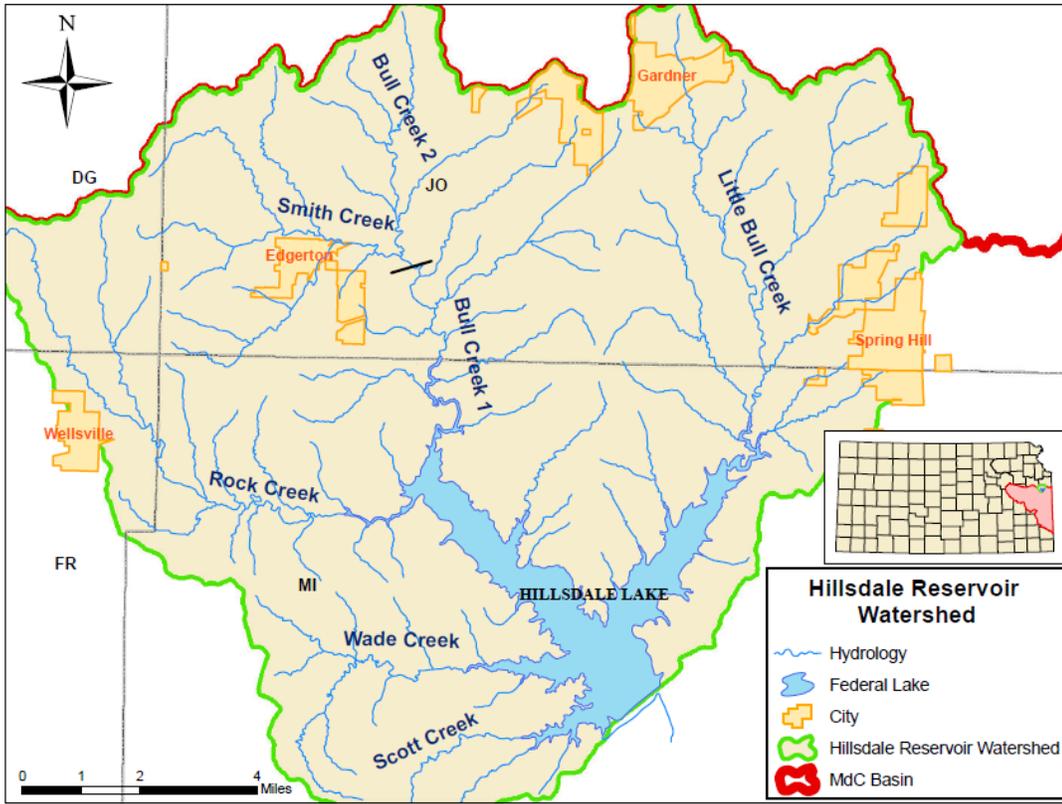
Figure 5. Streambank Erosion Assessment Stream Reach Sections

To accommodate streambank rehabilitation project focus, the Hillsdale Reservoir watershed study area was delineated into five stream reaches and three 12-digit Hydrologic Unit Code subbasins. Stream reach sections include: Rock Creek, Bull Creek 1, Bull Creek 2, Smith Branch and Little Bull Creek (Figure 5). Stream reach sections were delineated by the stream they are located on, and in one instance, a stream is broken into two sections to keep delineations relatively equal. 12-digit Hydrologic Unit Code (HUC12s) subbasins within Hillsdale Reservoir watershed include 102901020101, 102901020102 and 102901020103 (Figure 6).

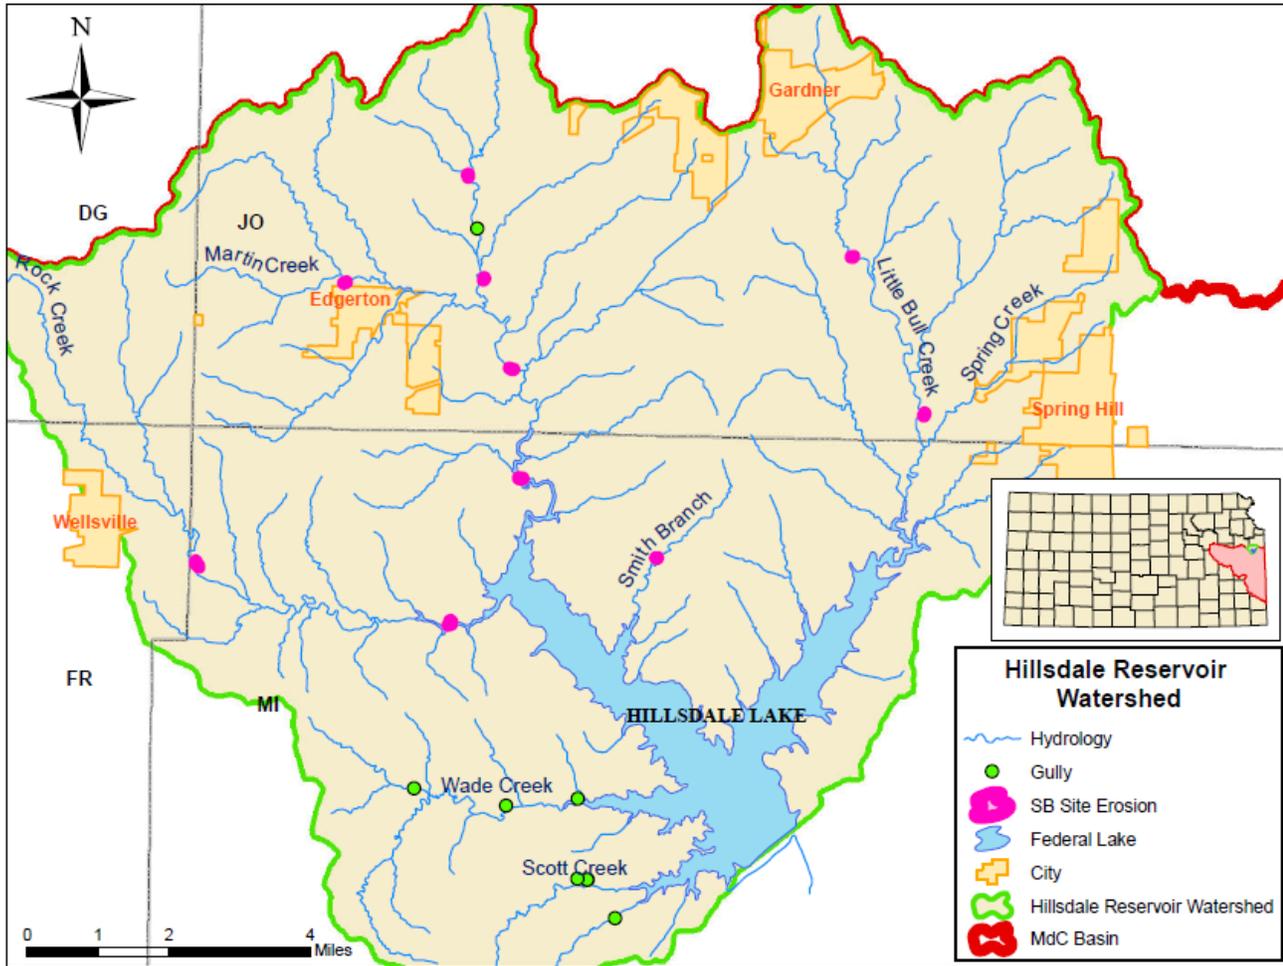
Figure 8. Assessment Identified Streambank Erosion and Streambank Gully Erosion Sites

The KWO 2011 assessment quantifies annual tons of sedimentation from streambank erosion sites between 1991 and 2008 in the Hillsdale Reservoir watershed. A total of 11 streambank erosion sites, covering 6,965 feet of unstable streambank were identified through the assessment, with 73% of the unstable streambanks identified as having poor riparian condition (Figure 8). The assessment also identified estimates totaling 1,073 tons of sediment being transported from the streambank erosion sites annually. Assuming a bulk density of 40 lbs/cubic foot sediment in Hillsdale Reservoir; streambank sources account for only 1.2 of the 166 acre feet (1%) of sediment annually deposited in Hillsdale Reservoir.

Several streambank gully erosion problems in areas adjacent to the streambanks were identified through the streambank gully erosion assessment. The assessment of streambank gully erosion in the Hillsdale Reservoir watershed concluded seven total gullies alongside streambanks, four in croplands and three in grasslands; all demonstrated identifications of high priority gullies, but were still in the beginning stages of headcutting. Locations of gullies included one in the upper headwaters of Bull Creek, three located on Wade Creek and three located on Scott Creek, refer back to Figure 8. Both Wade and Scott Creek are located in the southwestern portion of Hillsdale Reservoir watershed.

Based on estimated stabilization costs of \$71.50 per linear foot from an assessment conducted by TWI, streambank stabilization for all identified streambank erosion sites in the Hillsdale Reservoir would cost approximately \$498,000, with an estimated sediment reduction at 912 tons per year at an 85% stabilization restoration efficiency.
