# Streambank Stabilization: Why, How, and Is It Working?

Kari Bigham, PE and Tony Layzell, PhD (KGS)

August 25, 2020

# Assessing the Effectiveness of Streambank Stabilization Projects

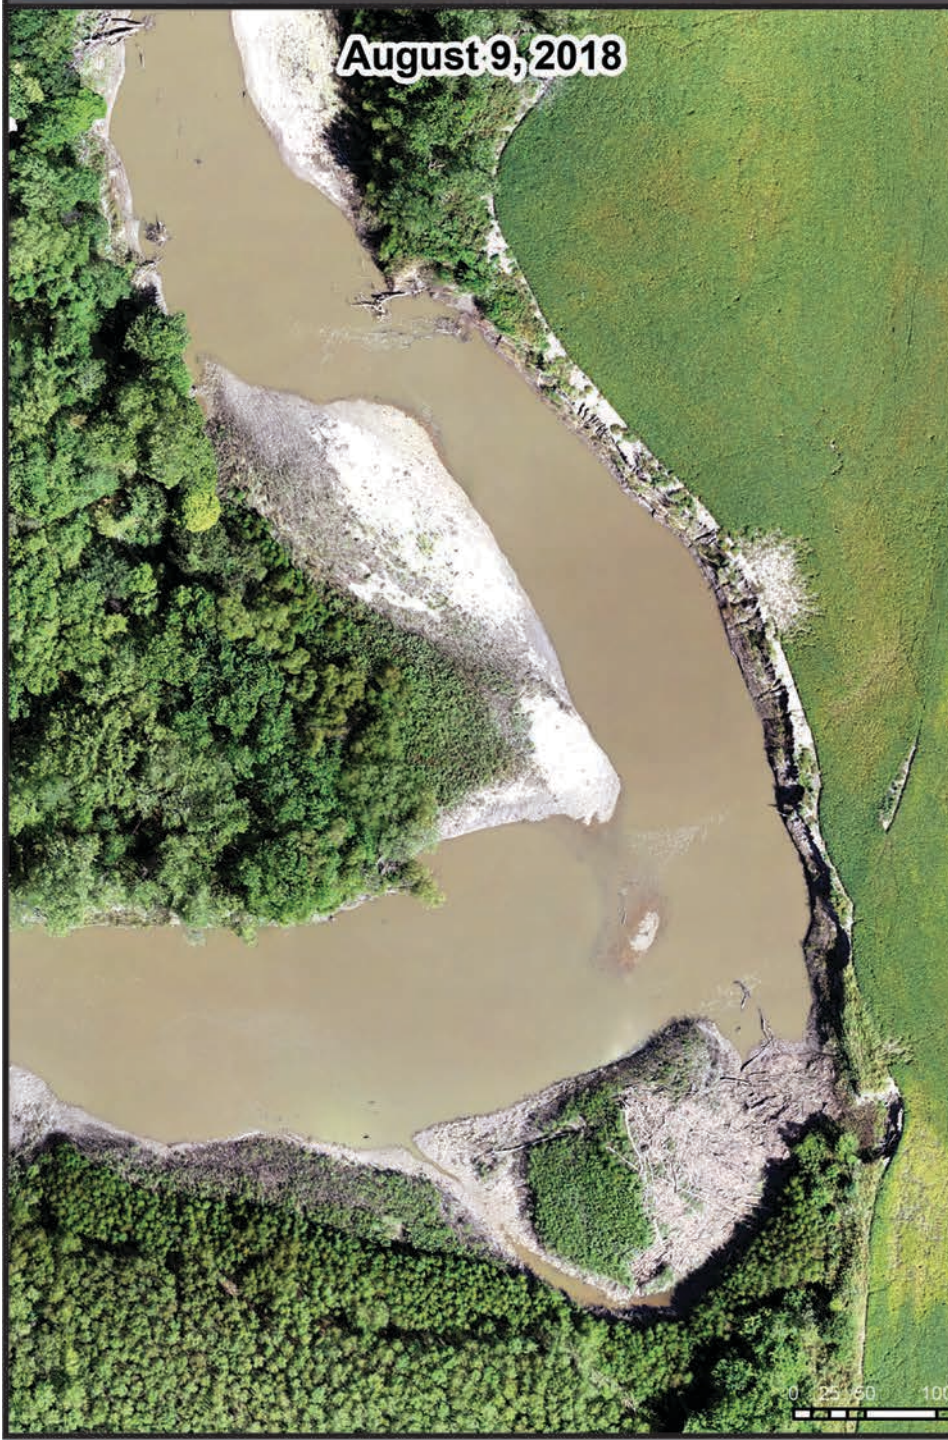
August 9, 2018

November 1, 2018

19,000 ft<sup>3</sup> of material eroded from streambank

37,000 ft<sup>3</sup> of material deposited on bar

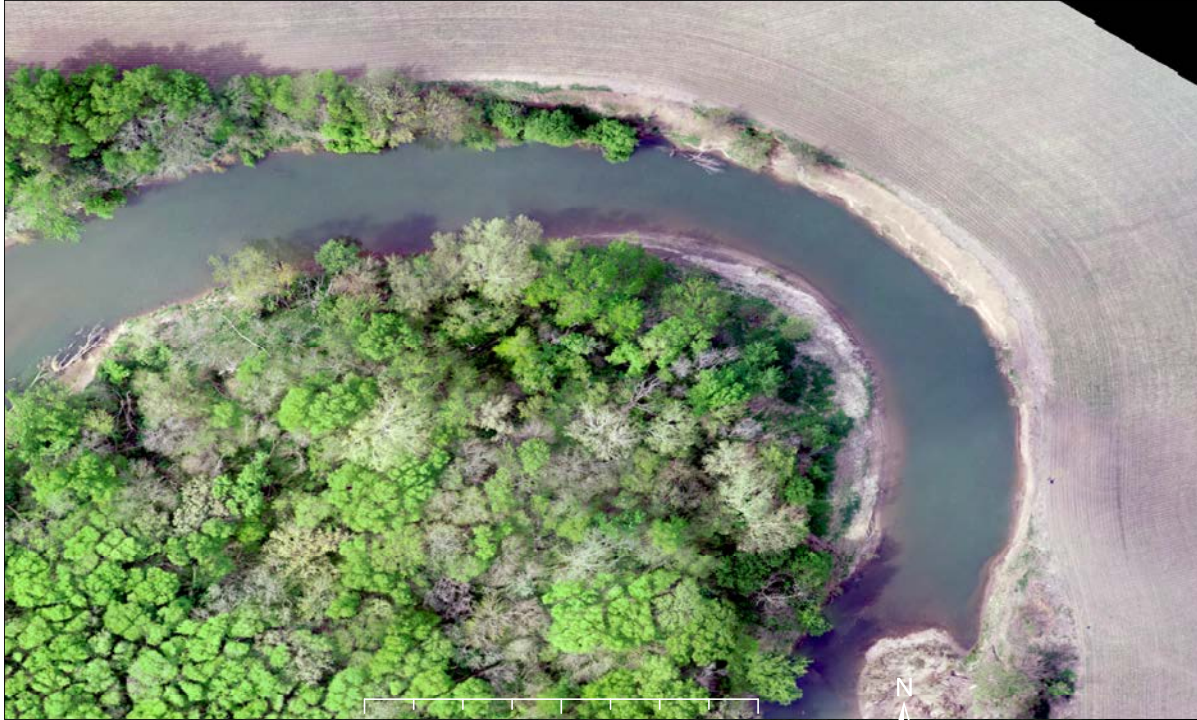
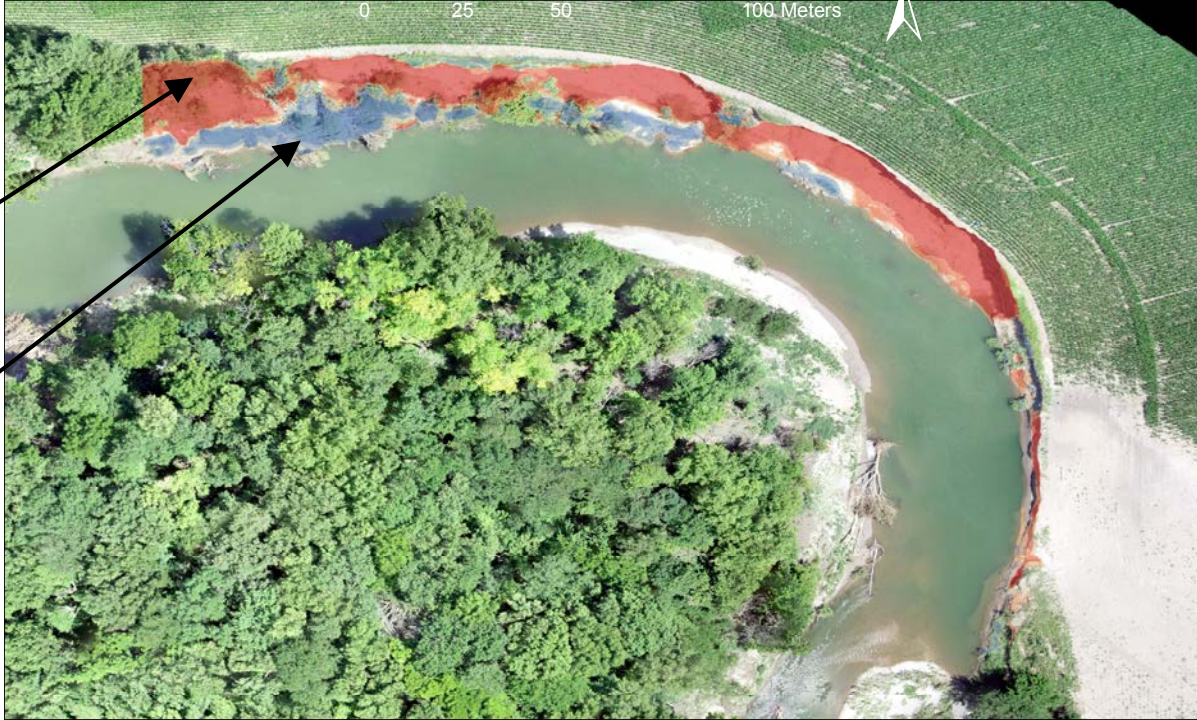
April 24, 2019

July 2, 2019

129,319 ft<sup>3</sup> eroded

26,551 ft<sup>3</sup> stored on bank toe

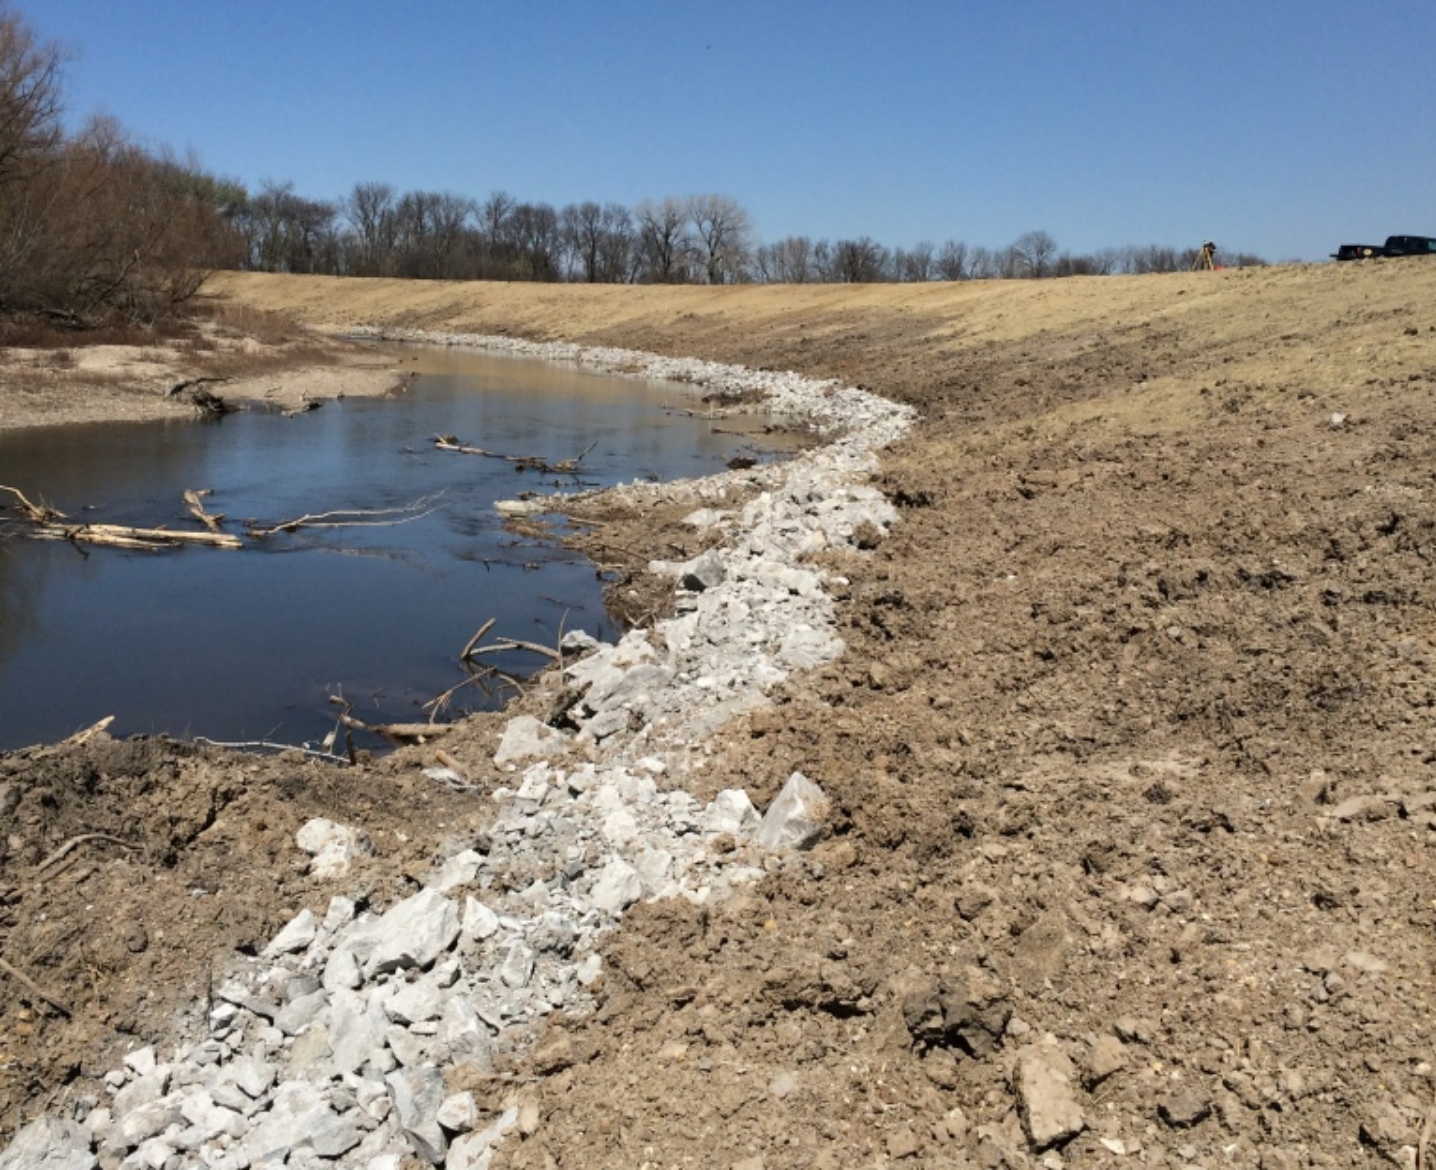
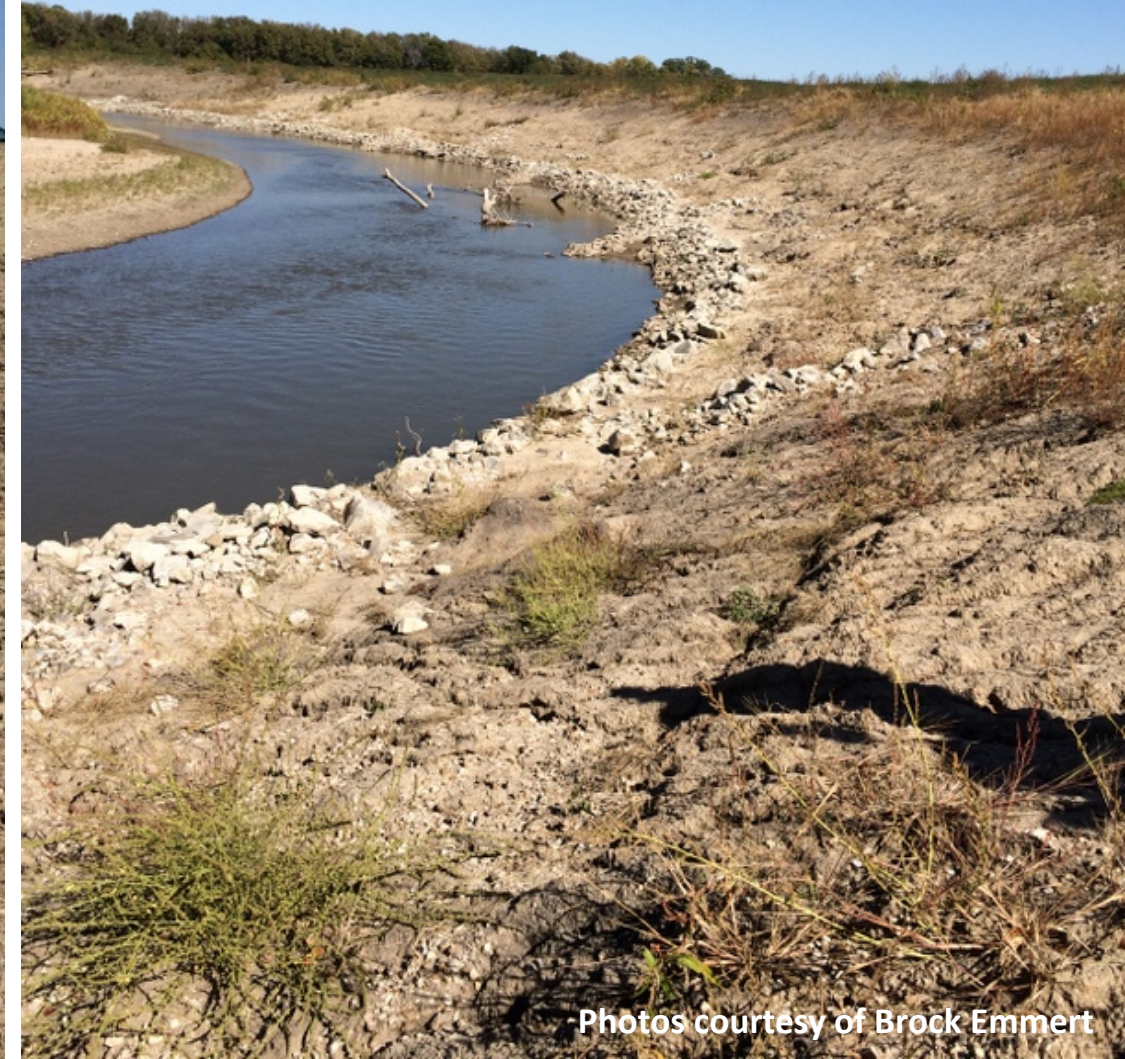
As built – April 2015

Post flood – October 2015

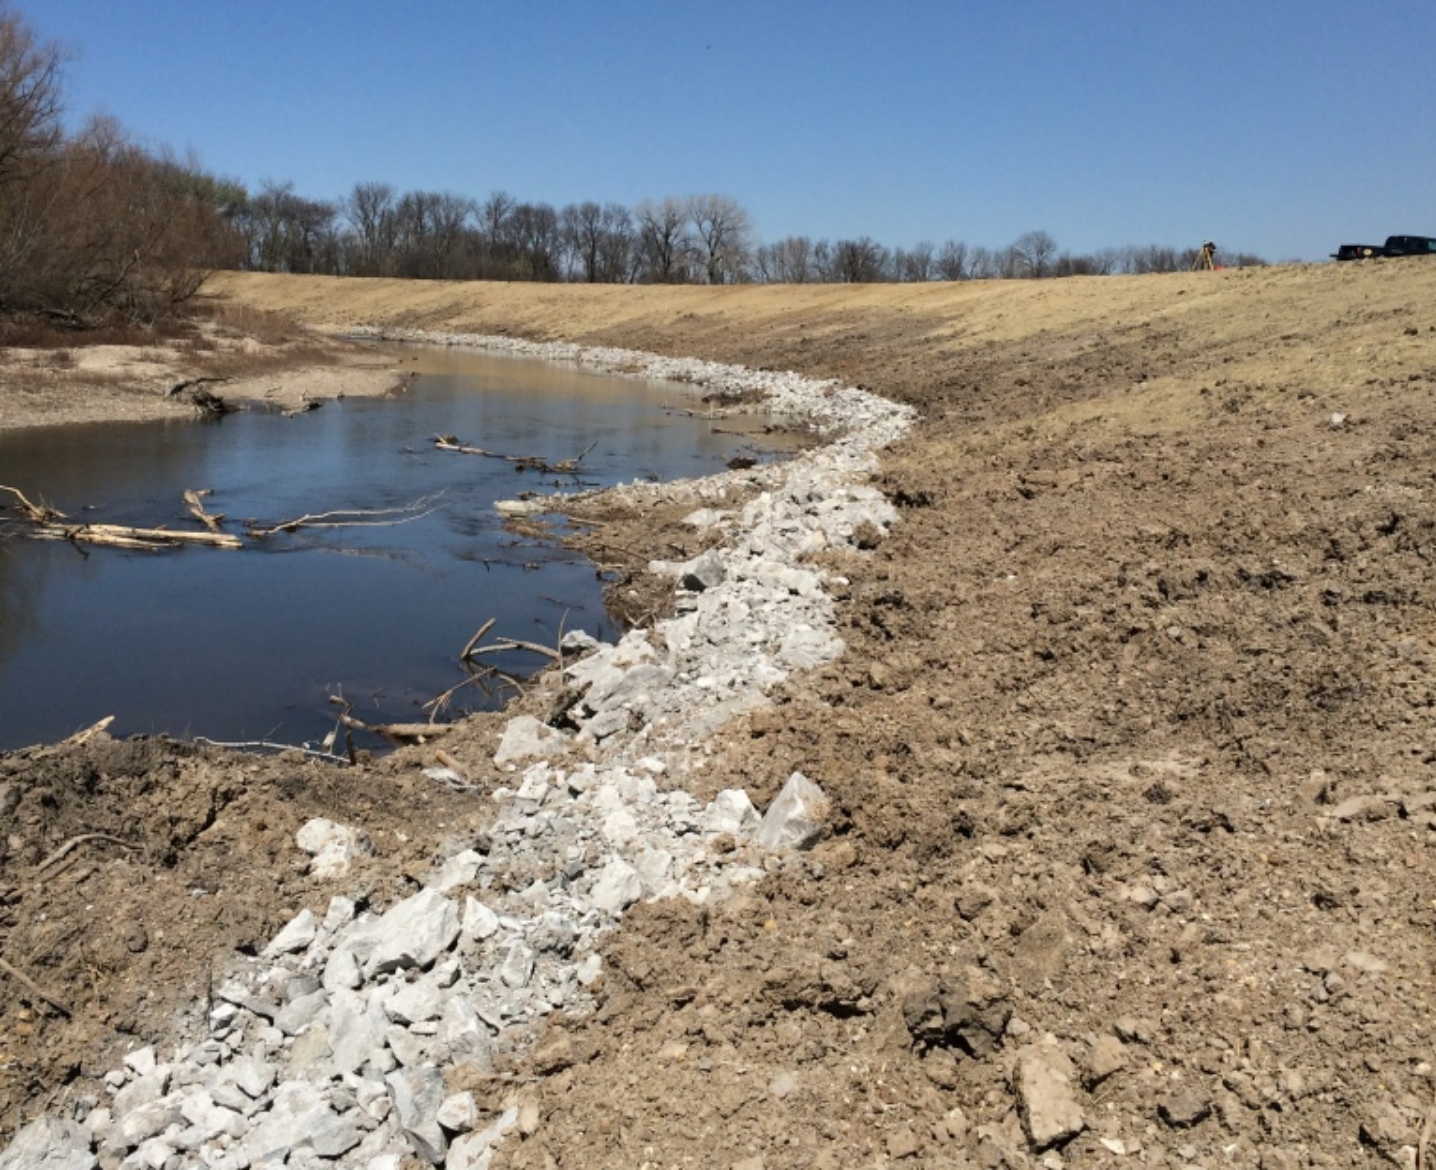
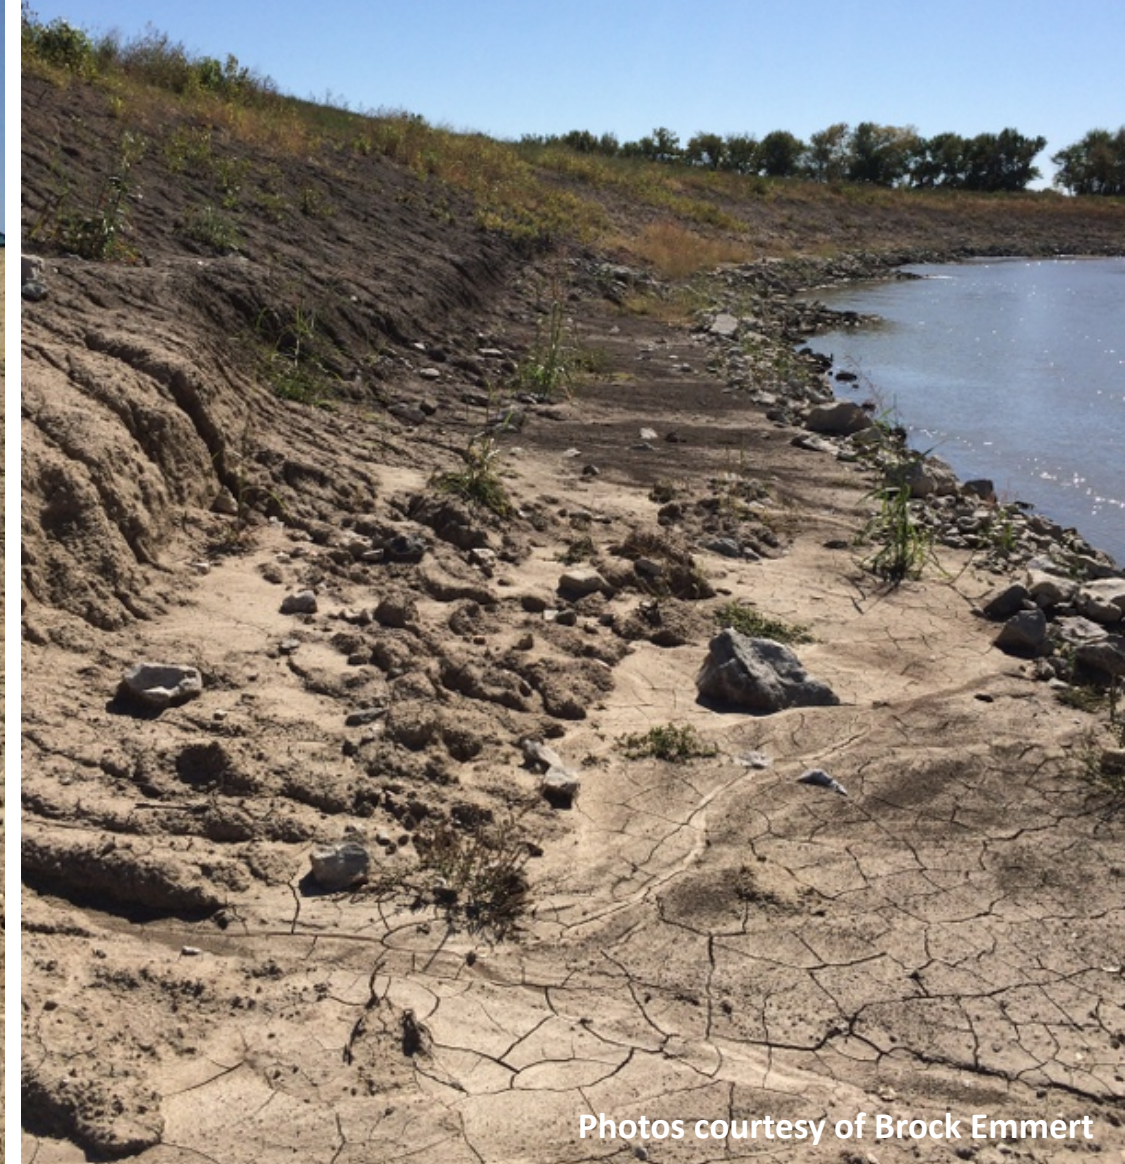
As built – April 2015

Post flood – October 2015

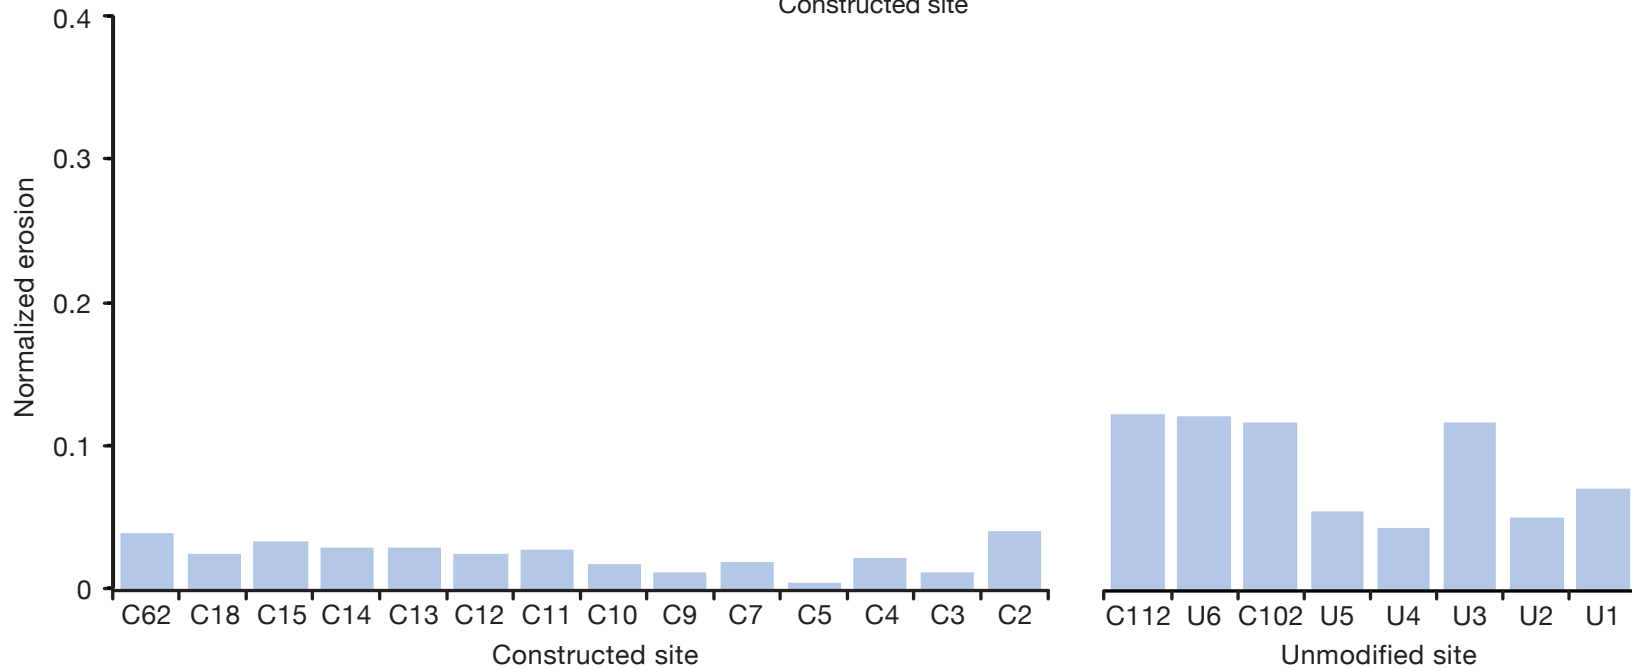
Average 75% efficiency in reducing sediment
