WALNUT BASIN STREAMBANK EROSION ASSESSMENT

ArcGIS® Comparison Study: 1991 vs. 2010 Aerial Photography

DRAFT: June 2012

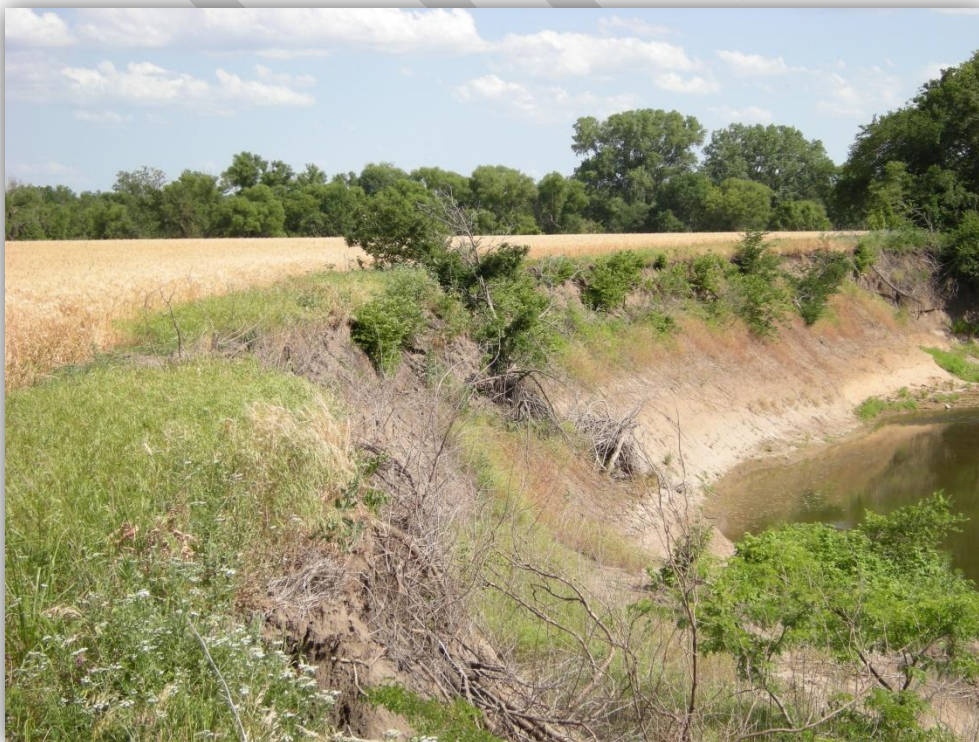
Figure 1: Walnut Basin Assessment Area

The Walnut River basin covers approximately 2,380 square miles and encompasses most of Butler and Cowley counties and small portions of five other counties in south central Kansas (Figure 1). The Walnut River rises in the northeastern part of Butler County, joining the Arkansas River at Arkansas City in Cowley County, about 120 miles to the south, and just north of the Kansas-Oklahoma state line.

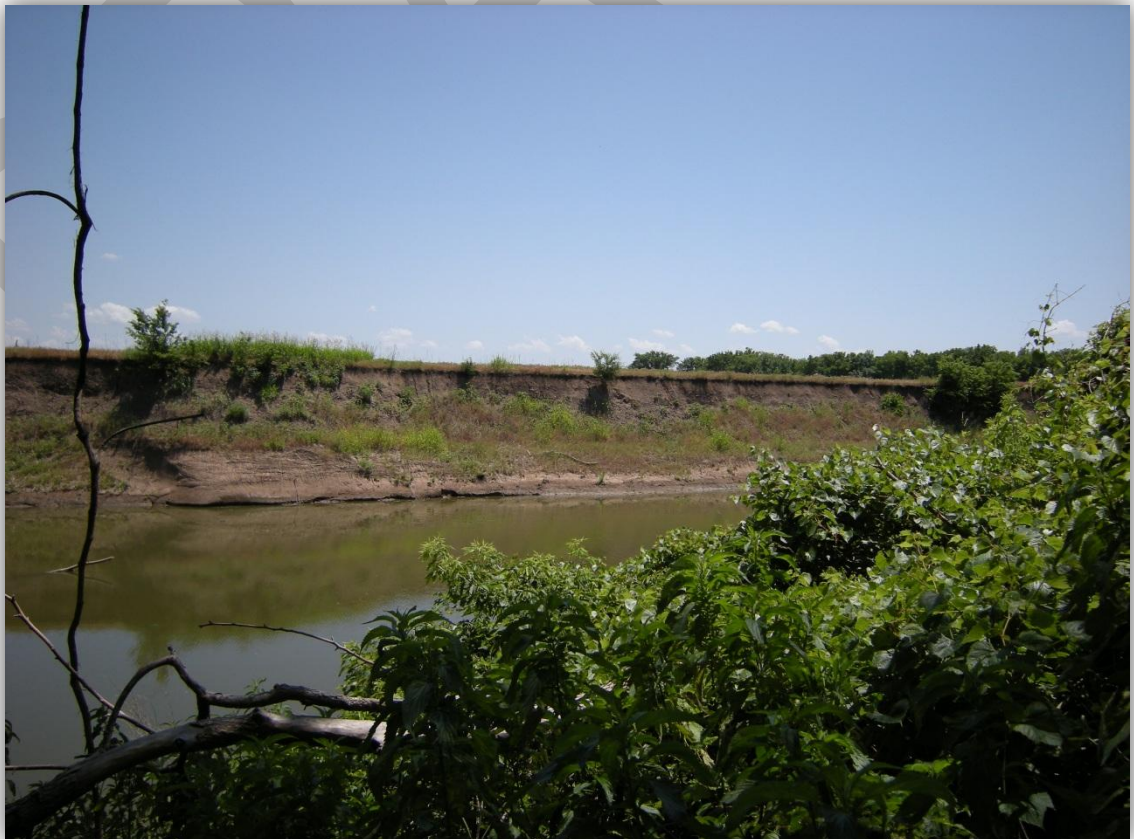
Figure 2: 1991 FSA & 2010 NAIP Streambank Erosion Site, Unique ID 0026, Whitewater River

The streambank erosion assessment was performed by overlaying 2010 NAIP county aerial imagery onto 1991 FSA county aerial imagery (Figure 2). Using ArcMap® tools, only those areas having “aggressive movement” of the streambank between 1991 FSA and 2010 NAIP aerial photos were identified, at a 1:4,000 scale, as a site of streambank erosion. “Aggressive movement” represents an area of roughly 2,500 sq. feet or more of streambank movement based on changes from 1991 FSA and 2010 NAIP aerial photos. Streambank erosion sites were denoted by geographic polygons features “drawn” into the ArcGIS® software program through the ArcMap® editor tool. The polygon features were created by sketching vertices following the 2010 streambank and closing the sketch by following the 1991 streambank at a 1:4,000 scale. Data provided, based on the geographic polygon sites include: basin location, unique ID, stream name, and type of riparian vegetation.

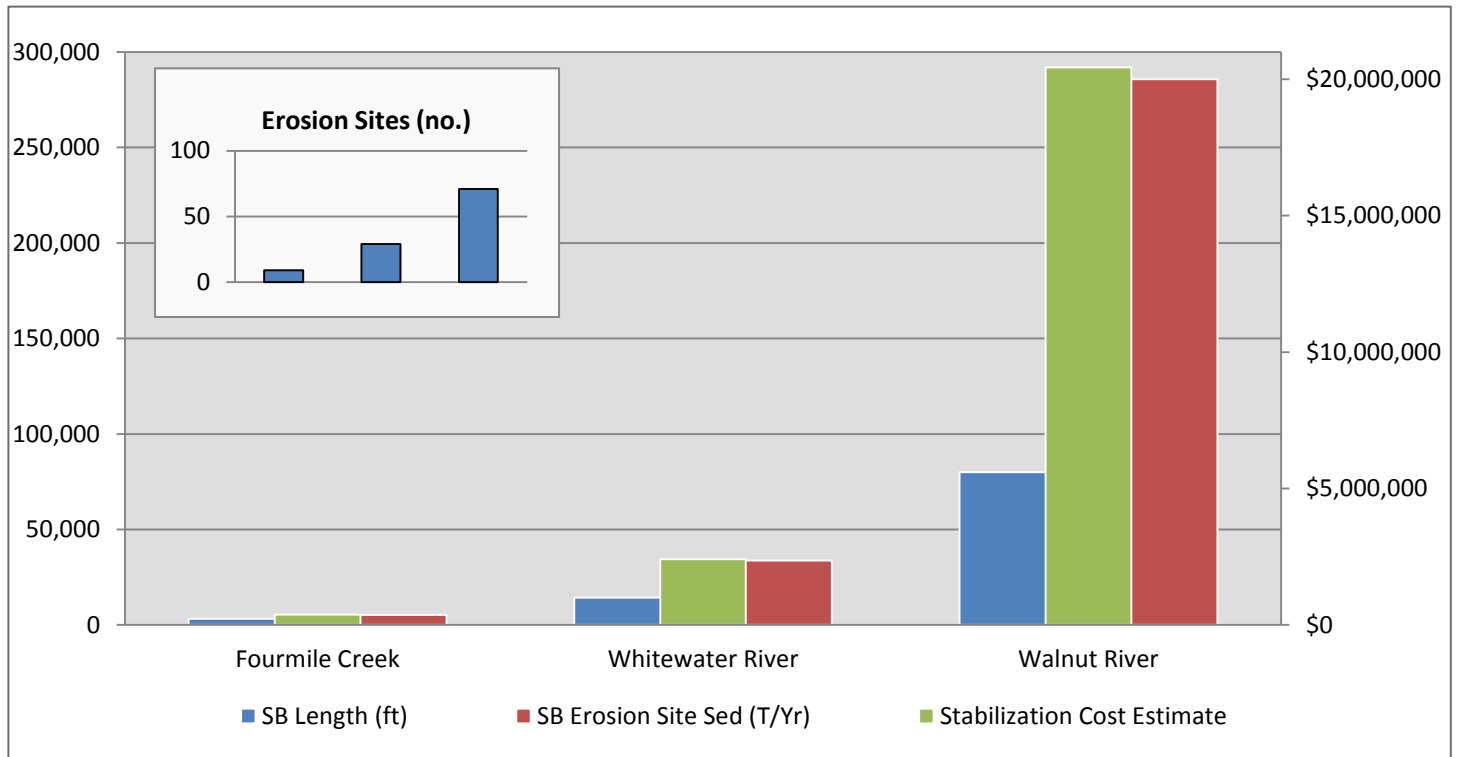
Figure 12: Walnut Basin Streambank Erosion Assessment Graph by Stream Reach

The KWO 2012 assessment quantifies annual tons of sediment eroding over a 19 year period between 1991 and 2010 within the Walnut basin. A total of 109 streambank erosion sites were identified, covering 97,535 feet of unstable streambank and transporting 324,759 tons of sediment downstream per year. A substantial quantity of the identified eroded sediment in the basin is transported annually from the streambanks of the Walnut River, accounting for approximately 285,791 tons of sediment annually or 88% of sediment eroding from all identified streambank erosion sites. These identified reaches account for an estimated \$20,434,057 of total stabilization cost needs in the basin.
