# Rattlesnake Creek Field Work

# Previous Studies

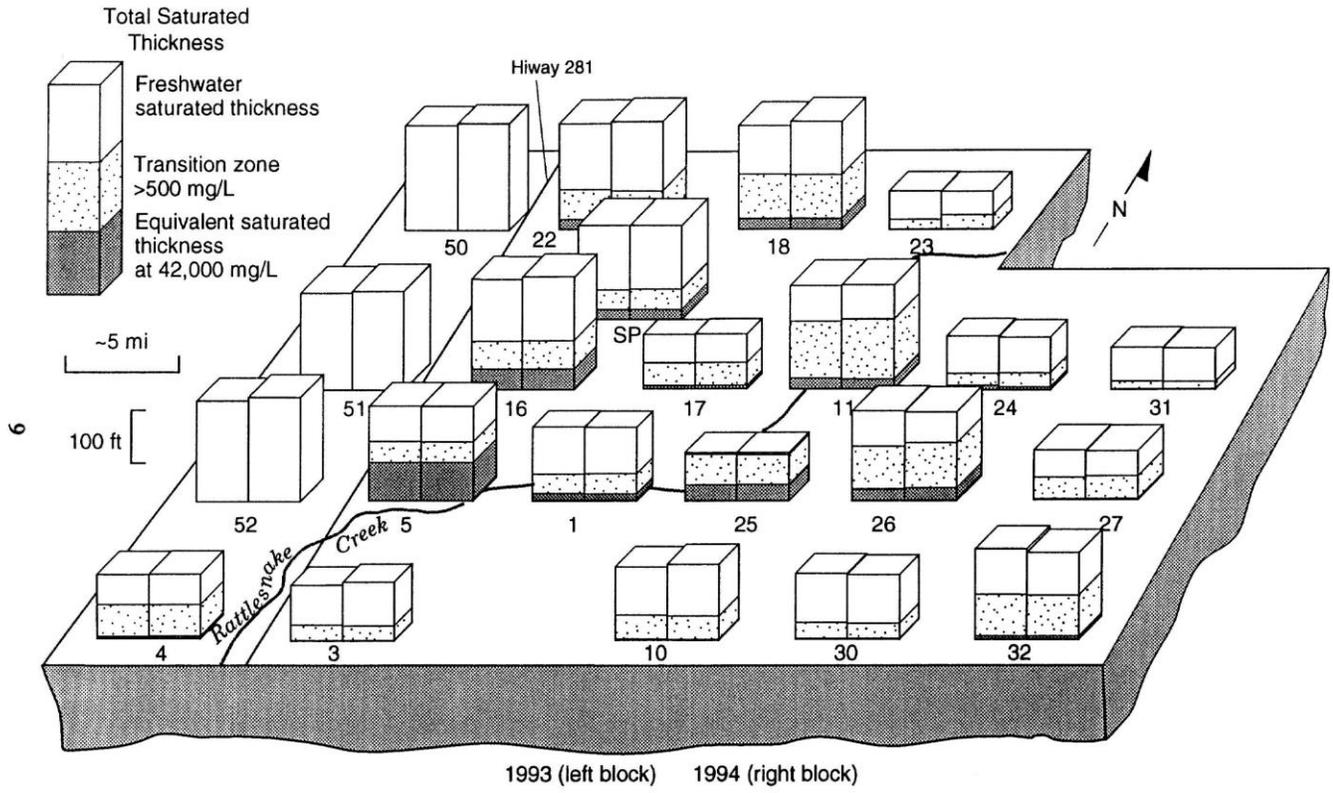
Figure A5. A representation of the total saturated thickness (height of column) and the saturated thickness that would be occupied by the volume of Permian brine equivalent to the salt content of the total water column (height of dark column). At each site, 1993 values are on the left, 1994 on the right. The height of 500 mg/L limit of the mixed zone is shown by light stippling; this has no budgetary significance, but shows the extent of vertical mixing and the amount of usable fresh water at each site.

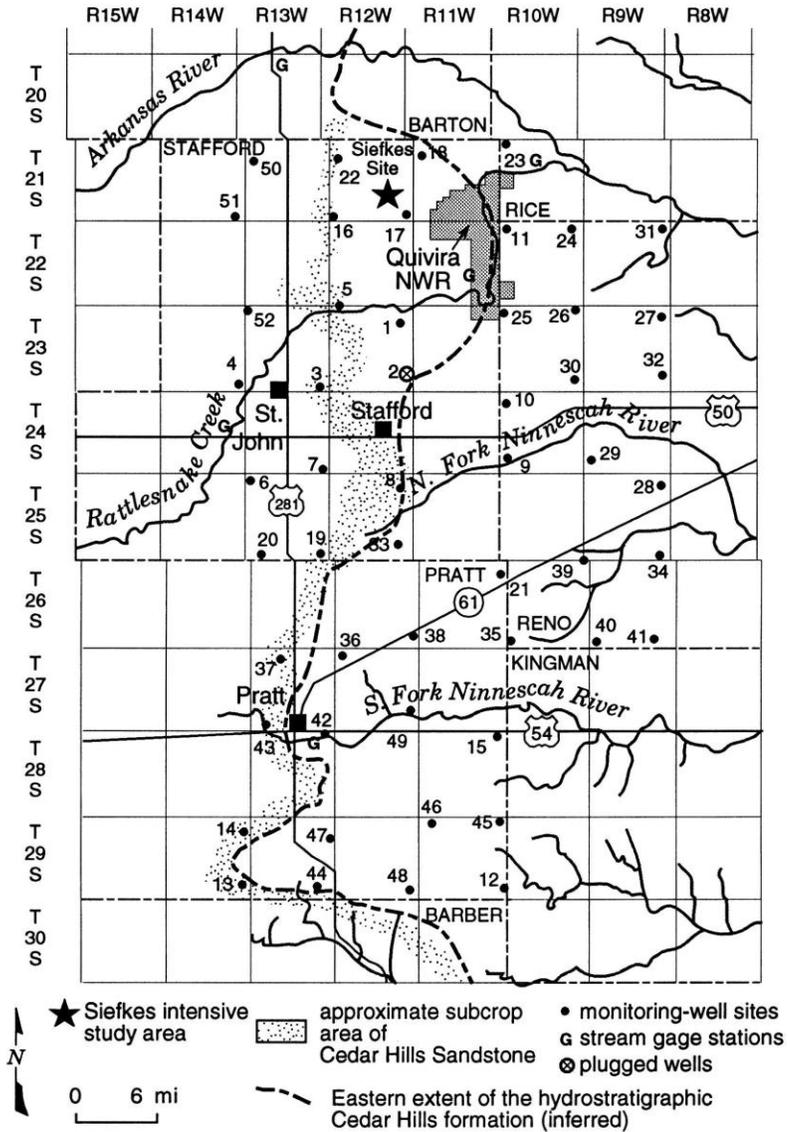
Figure A2. Observation wells and other physical features in the area of the KGS/GMD5 monitoring-well network.

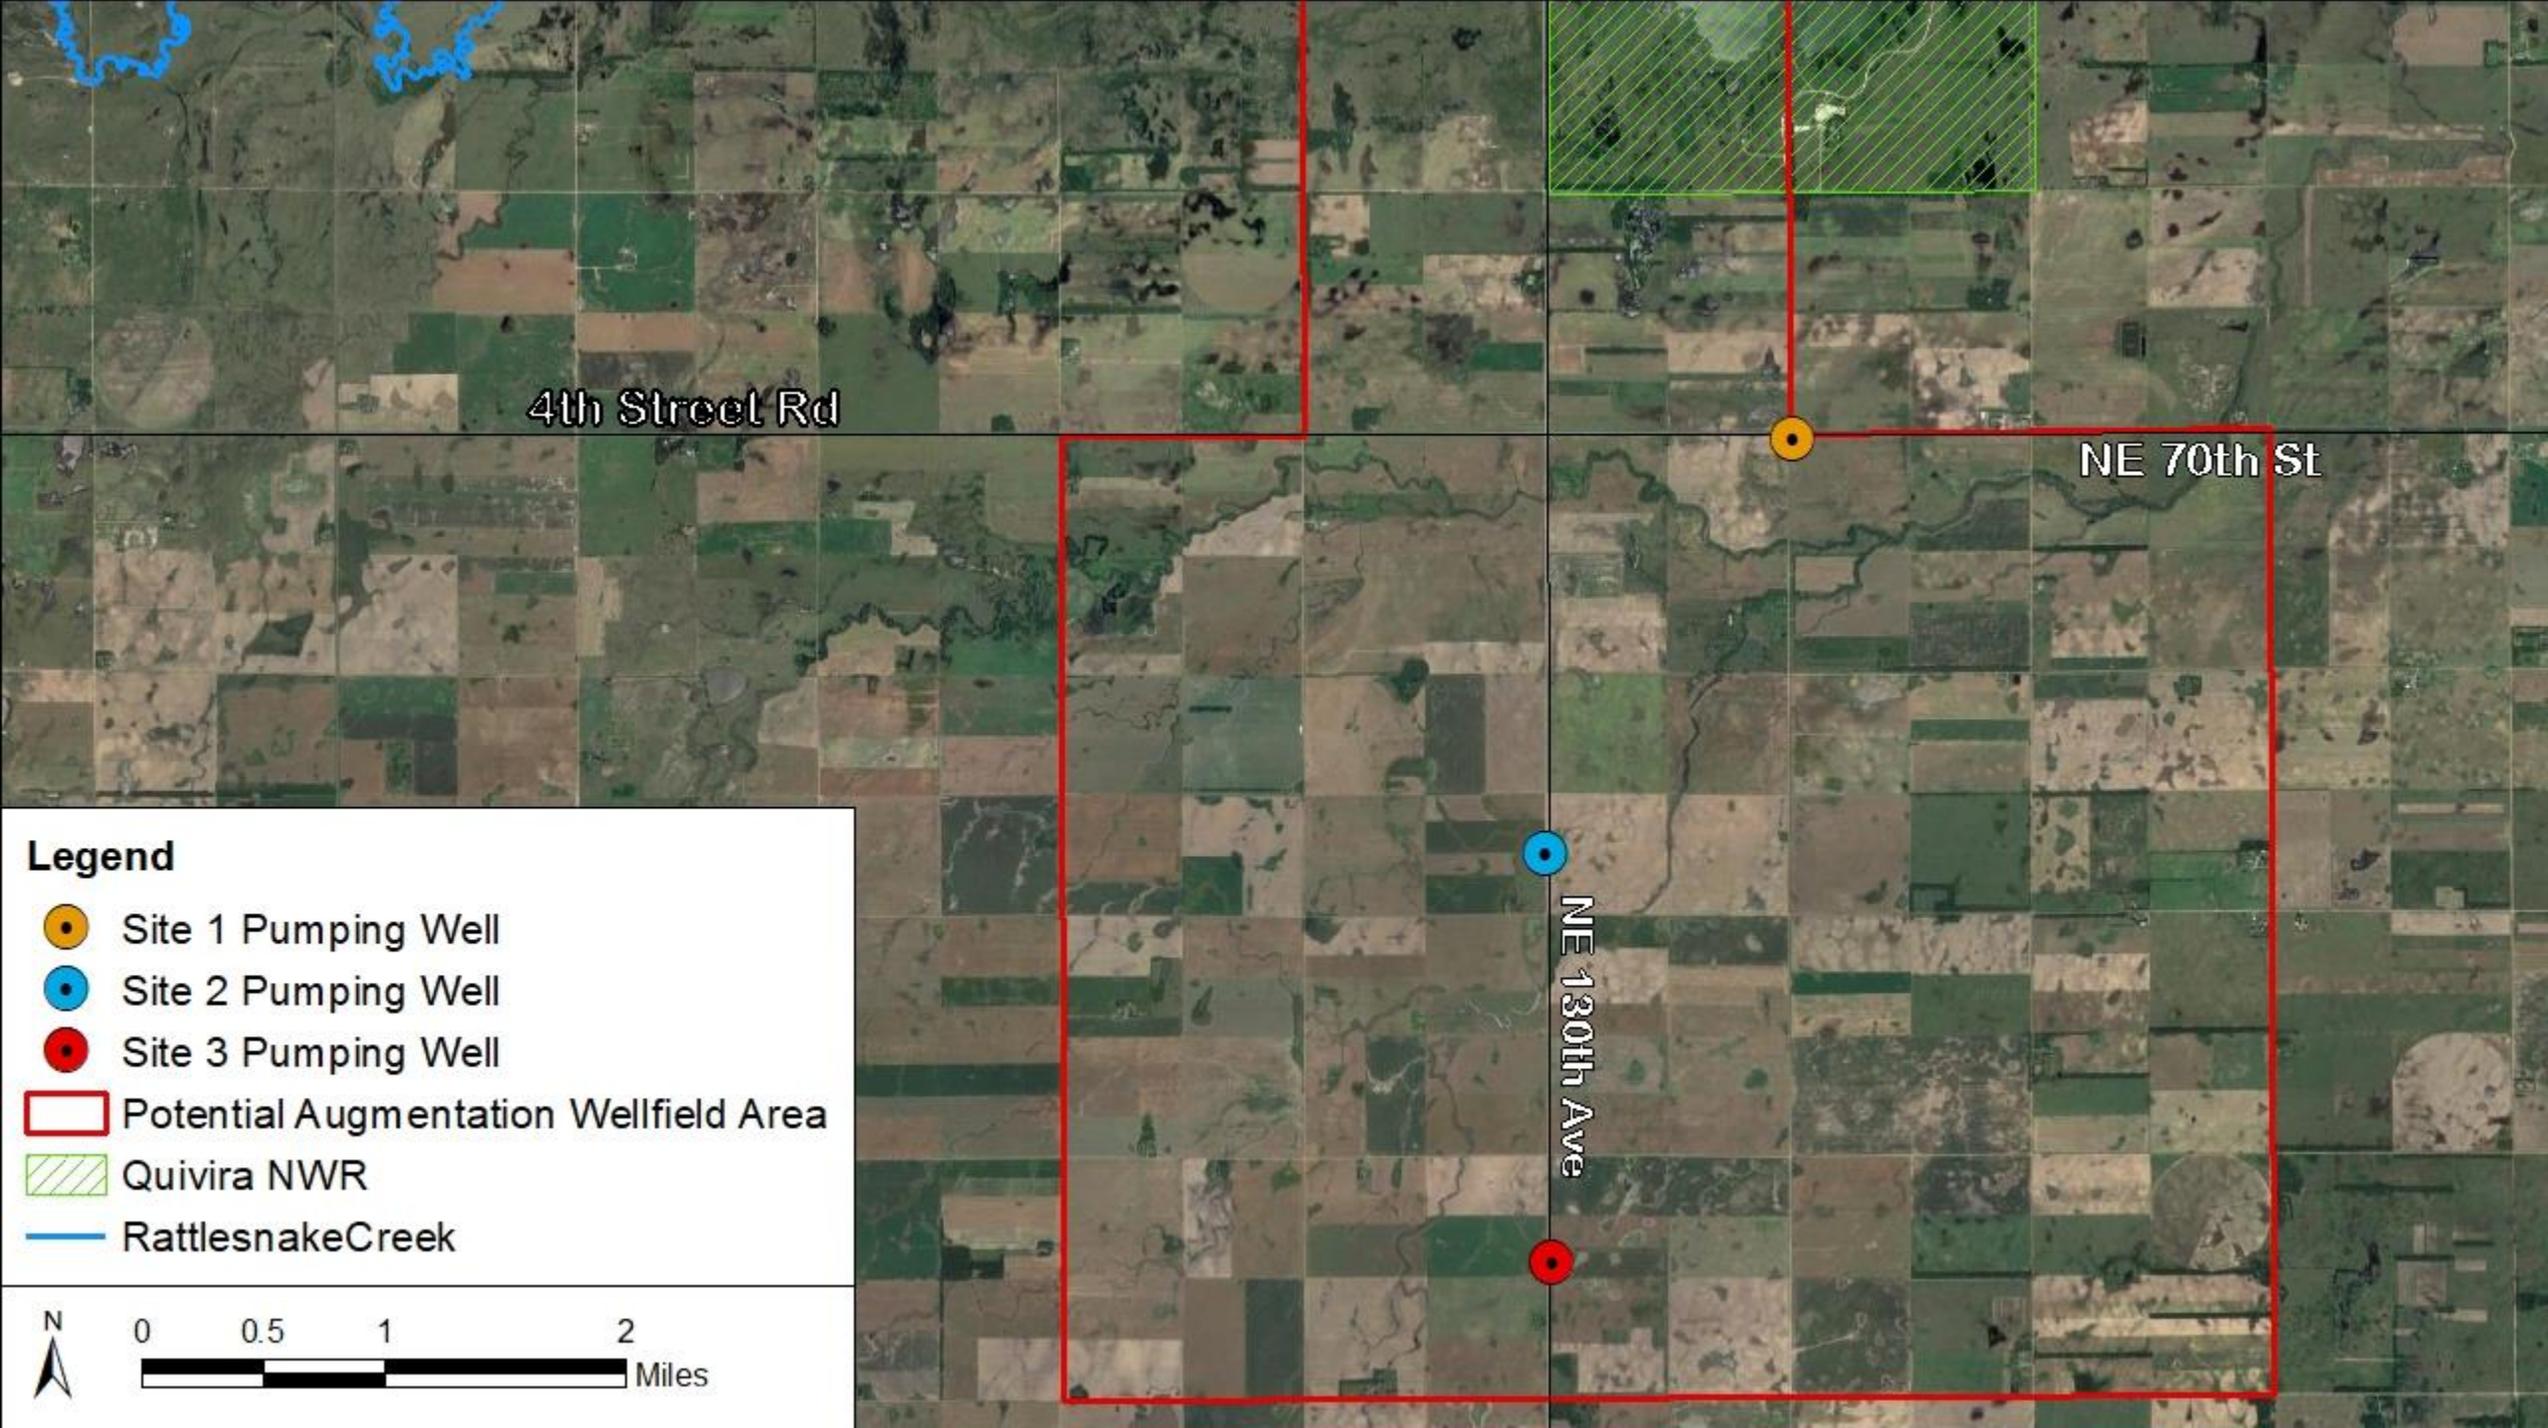
- Site 1 Pumping Well
- Site 2 Pumping Well
- Site 3 Pumping Well
- Potential Augmentation Wellfield Area
- ▨ Quivira NWR
- RattlesnakeCreek

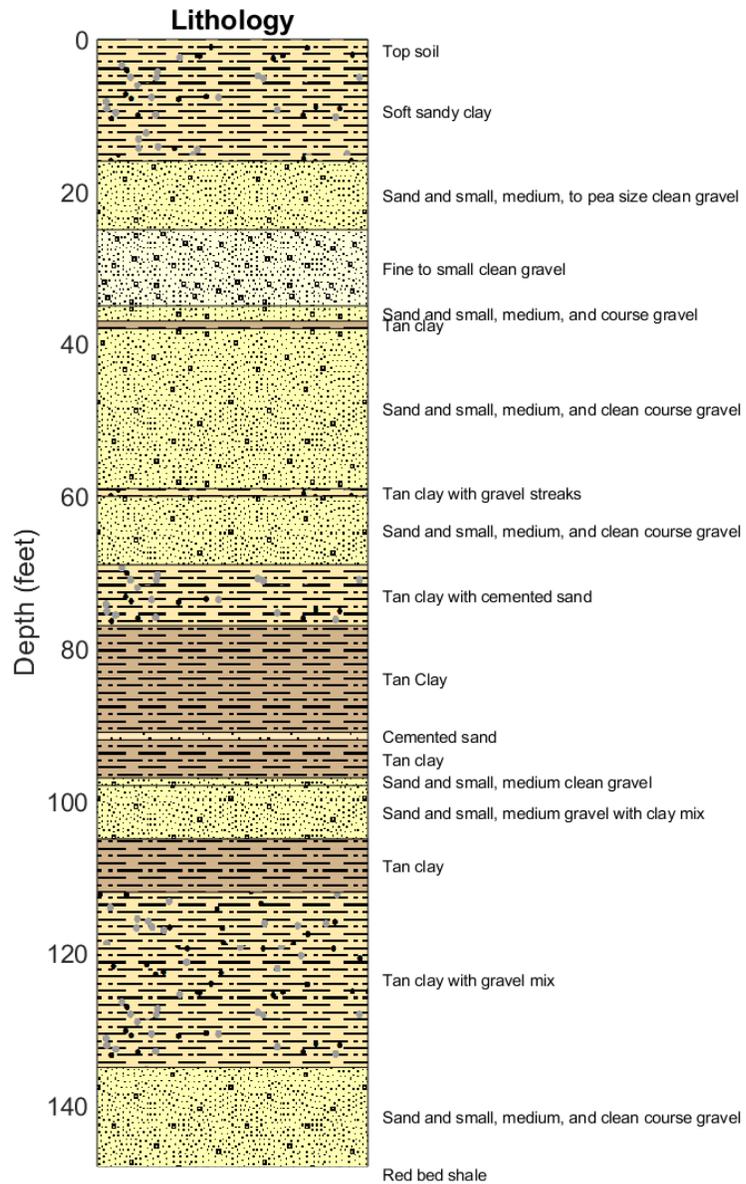
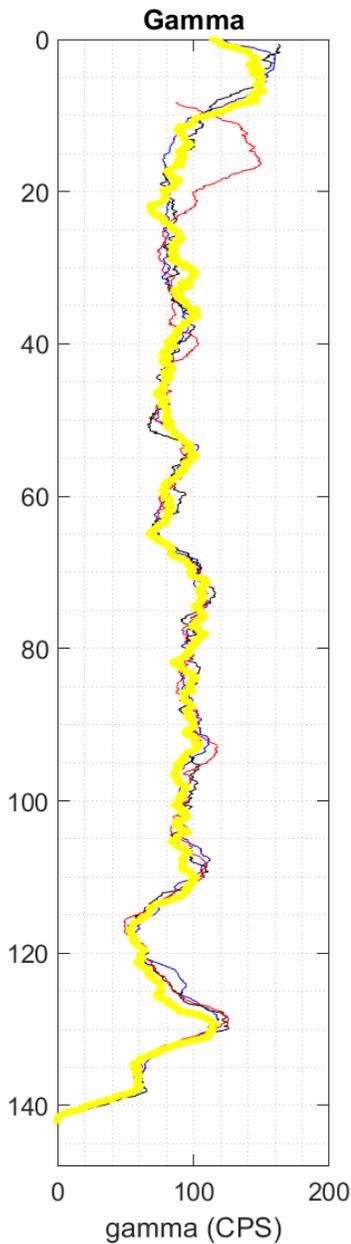
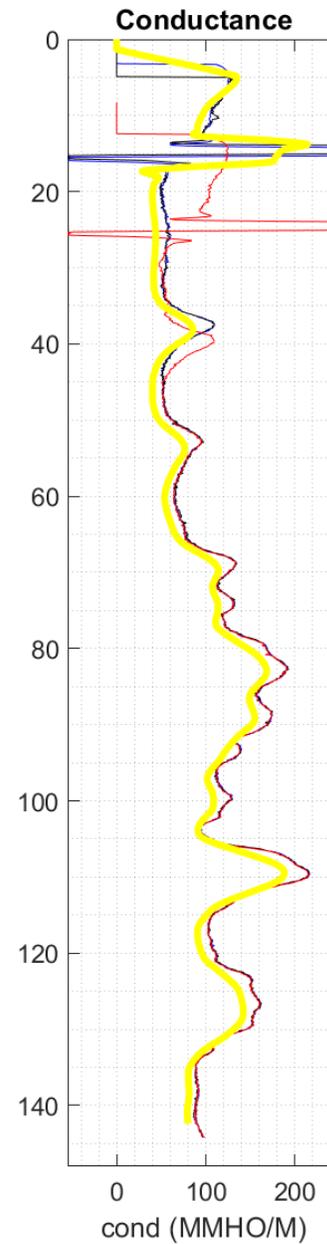
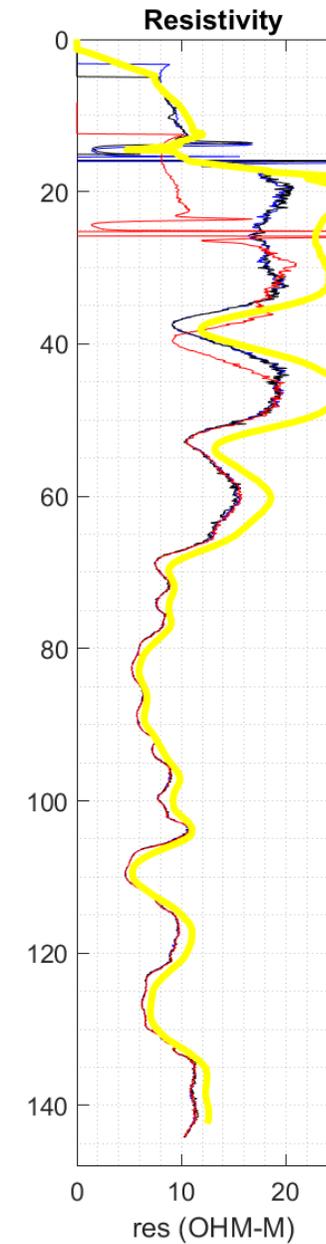
# Site 2 Well Log (RSC-2-A)

— Before Pump Test 1    — Before Pump Test 2    — Before Pump Test 3    — After Pump Test

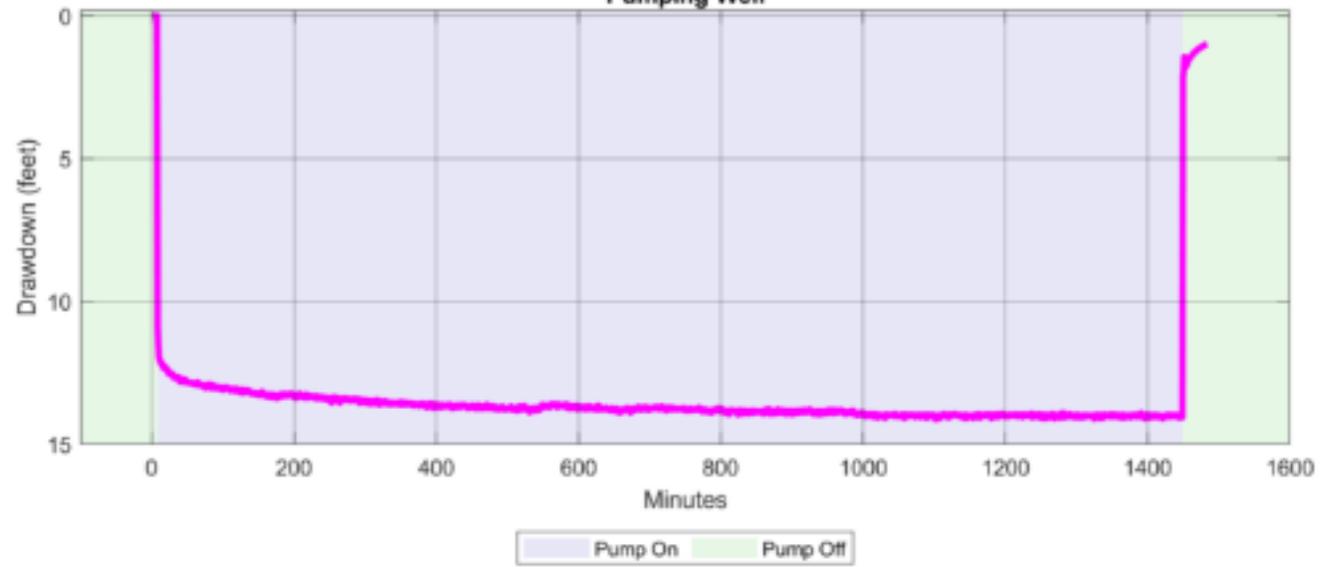
24-hour pump test at Site 1  
Pumping Well

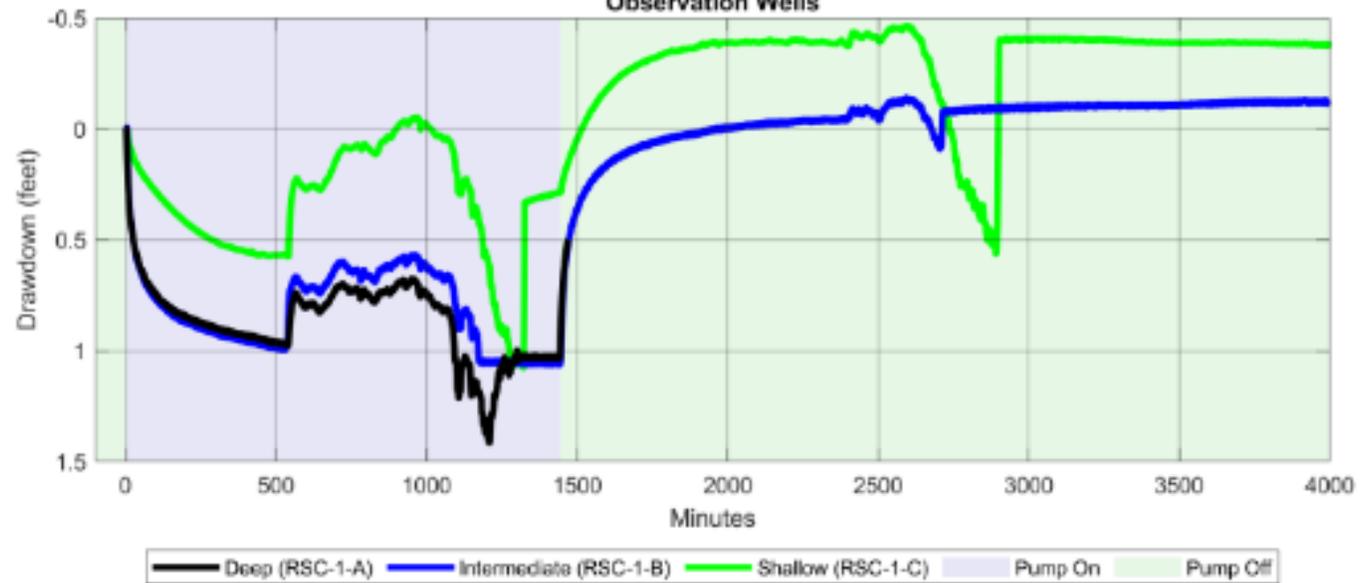
24-hour pump test at Site 1  
Observation Wells

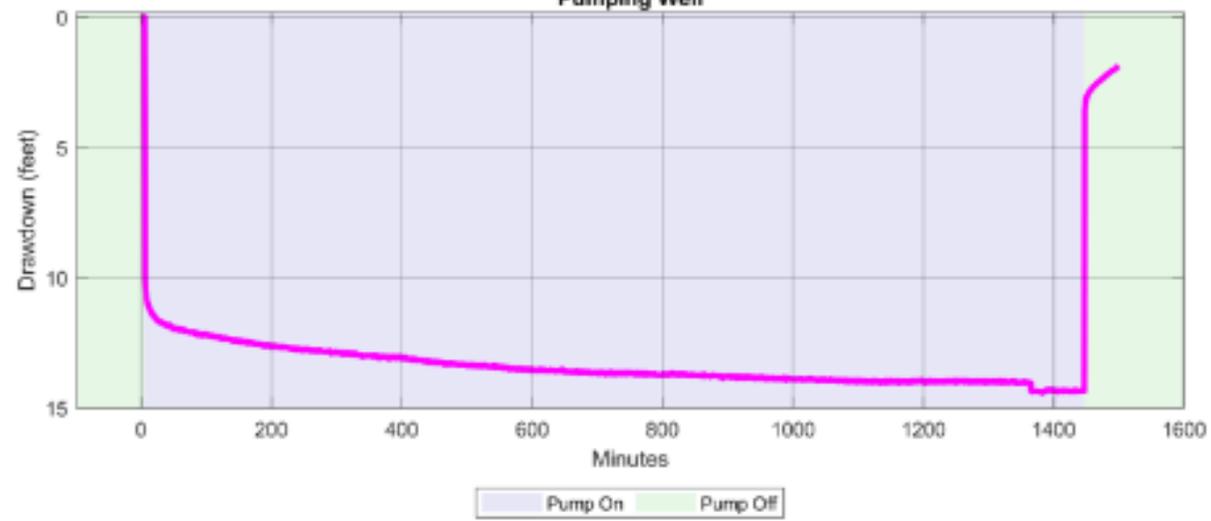
24-hour pump test at Site 2  
Pumping Well

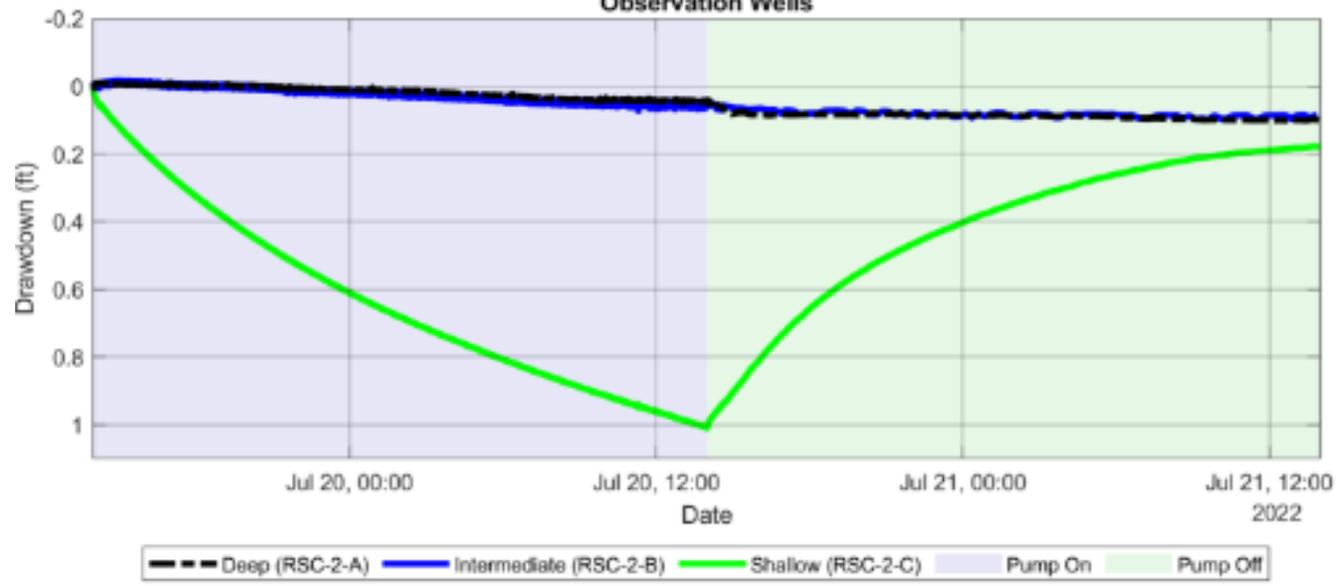
24-hour pump test at Site 2  
Observation Wells

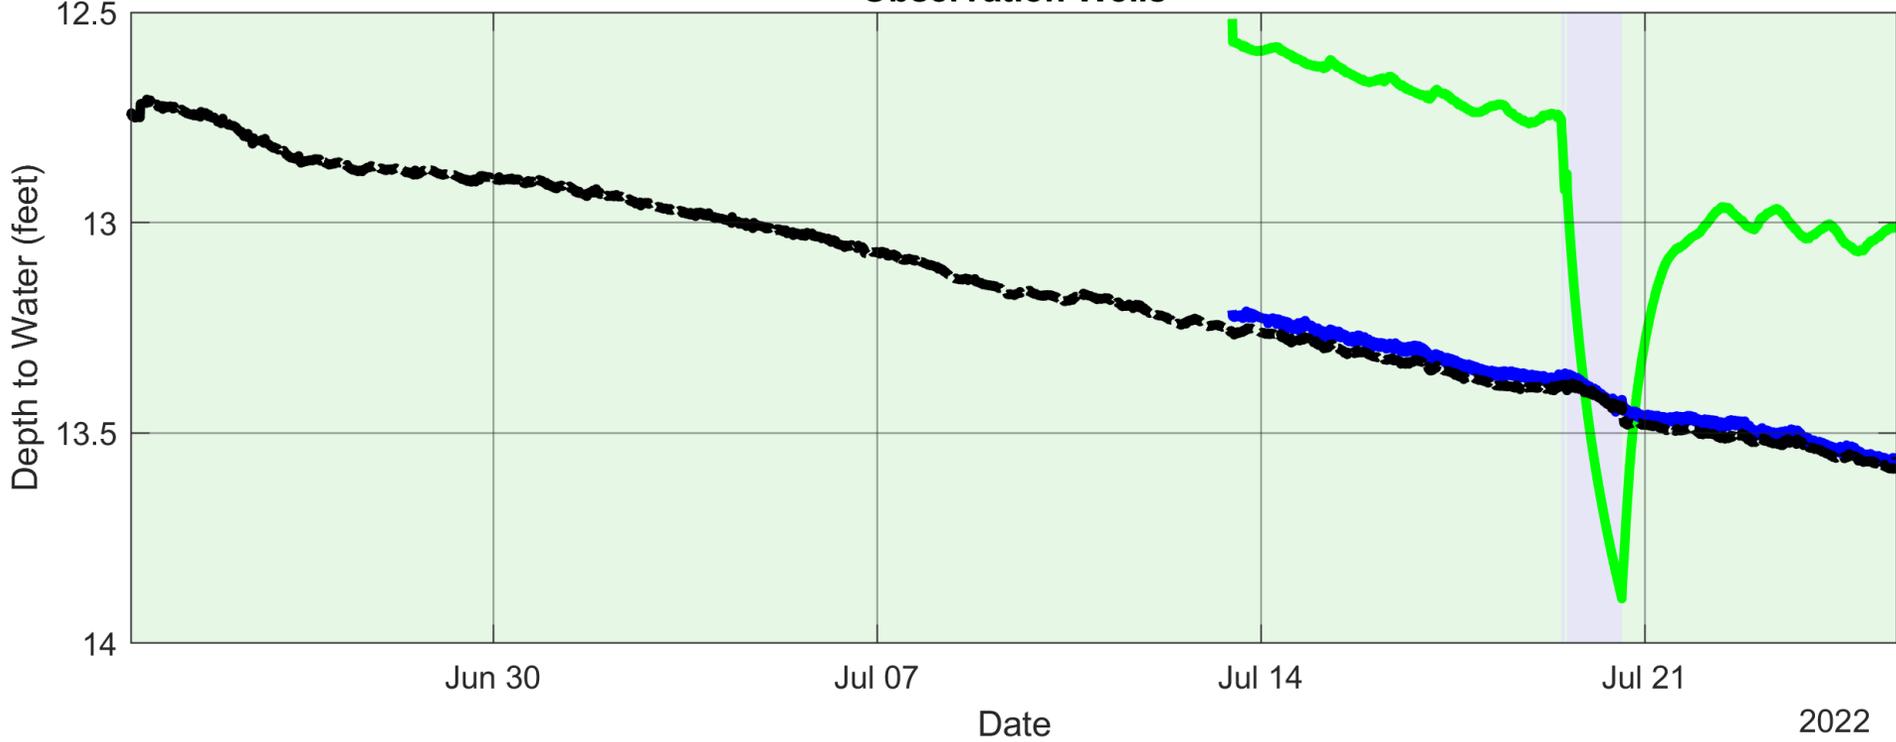
### Site 2 Depth to Water Monitoring Observation Wells

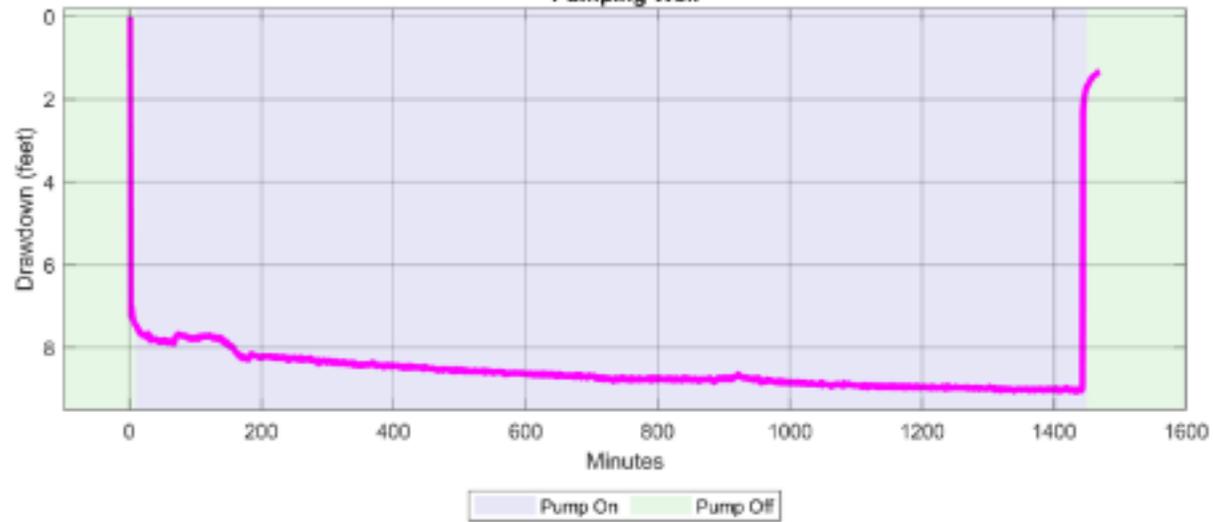
24-hour pump test at Site 3  
Pumping Well

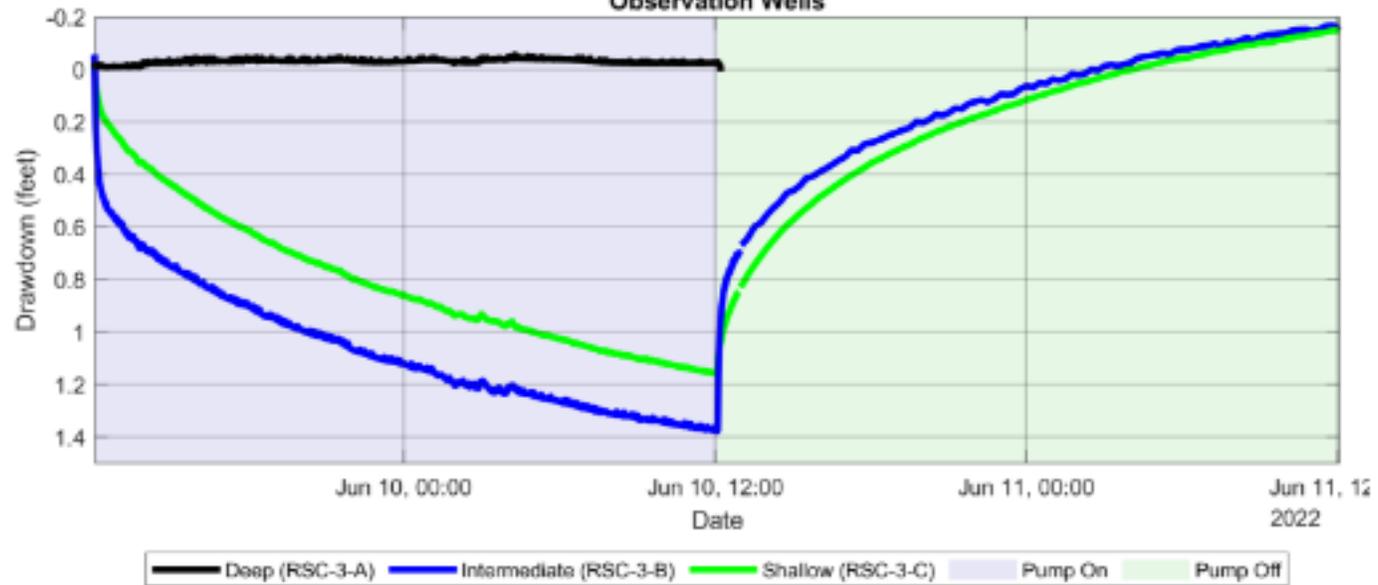
24-hour pump test at Site 3  
Observation Wells

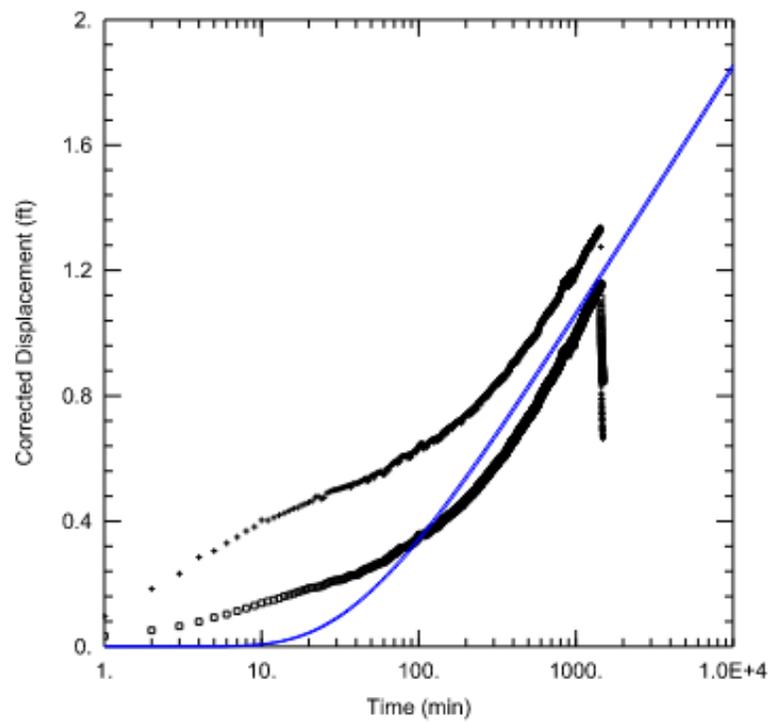
WELL TEST ANALYSIS

Company: Olsson  
Client: GMD5  
Project: 021-00451  
Location: Stafford KS  
Test Well: Site 3  
Test Date: 06/09/2022

Pumping Wells			Observation Wells		
Well Name	X (ft)	Y (ft)	Well Name	X (ft)	Y (ft)
RSC-3 PW	0	0	• RSC-3-C	300	0
			• RSC-3-B	306	0

Aquifer Model: Unconfined  
T = 15.34 ft<sup>2</sup>/min  
Kz/Kr = 1

Solution Method: Theis  
S = 0.01808  
b = 120 ft

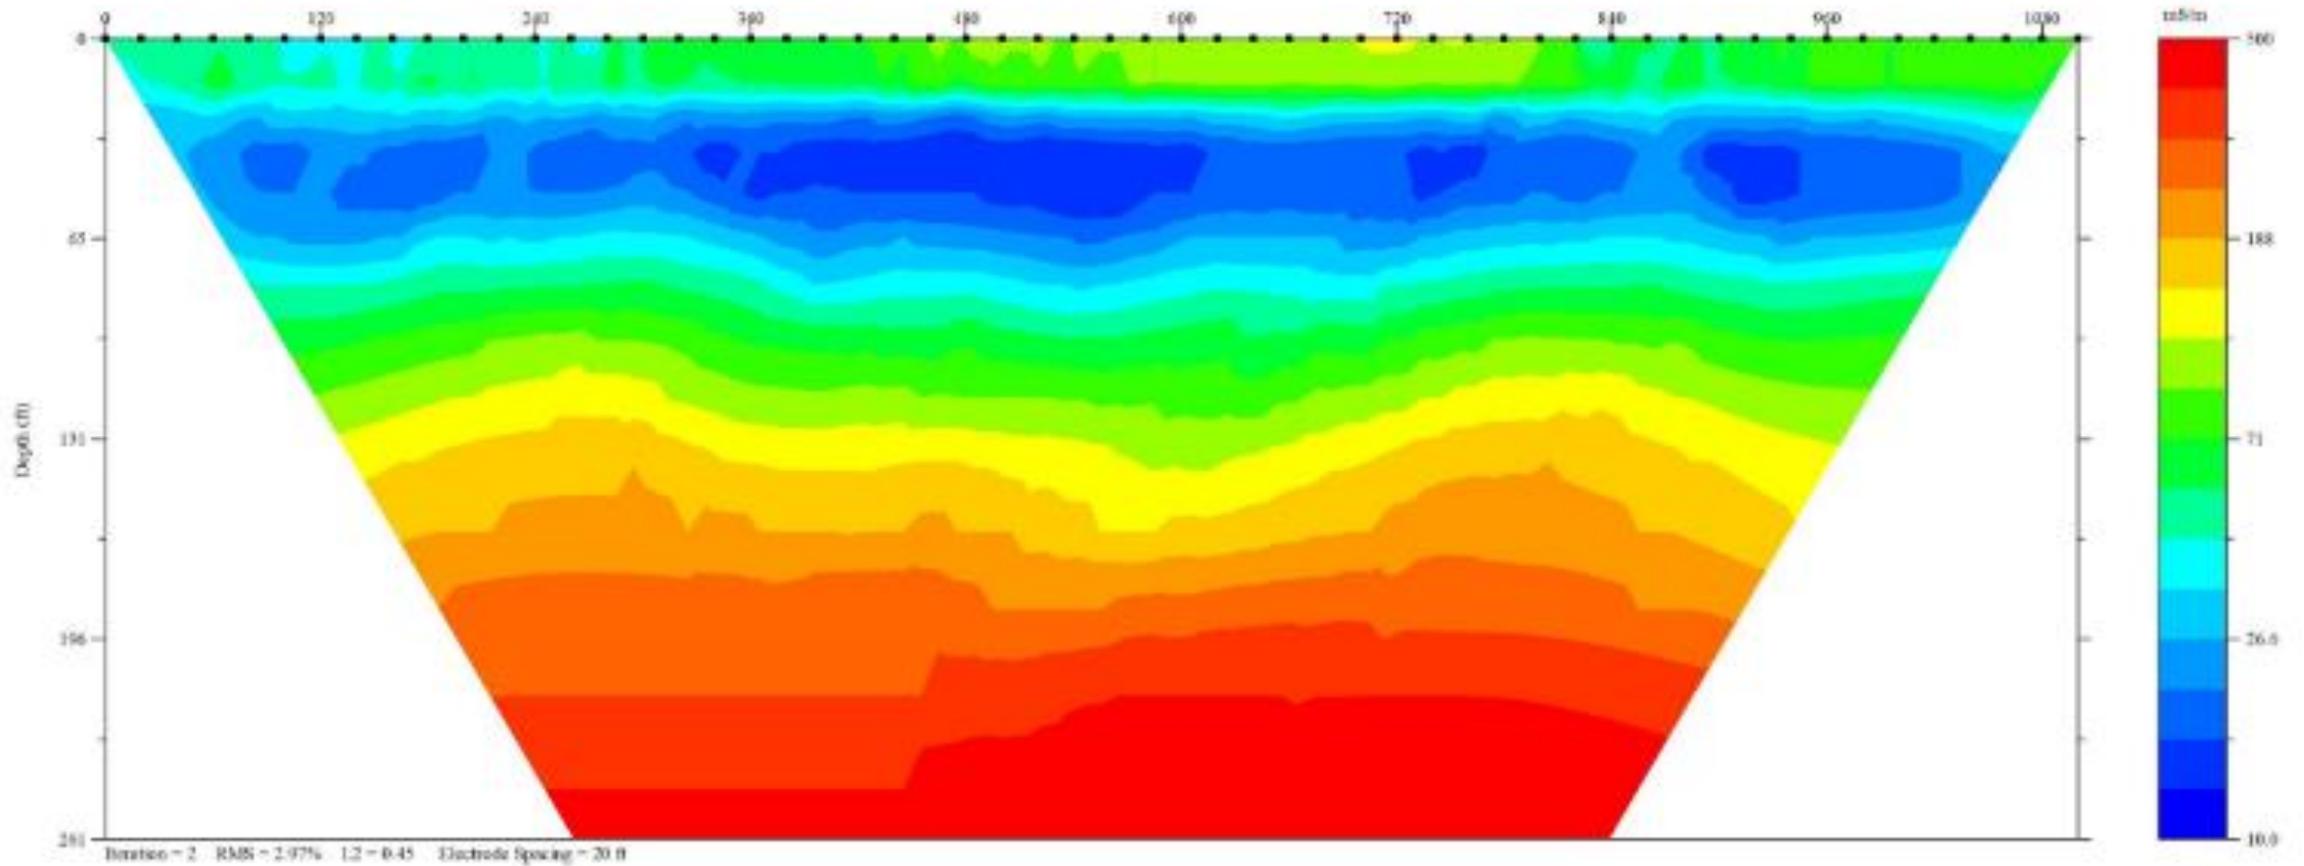
# Site 3

Inverted Conductivity Section

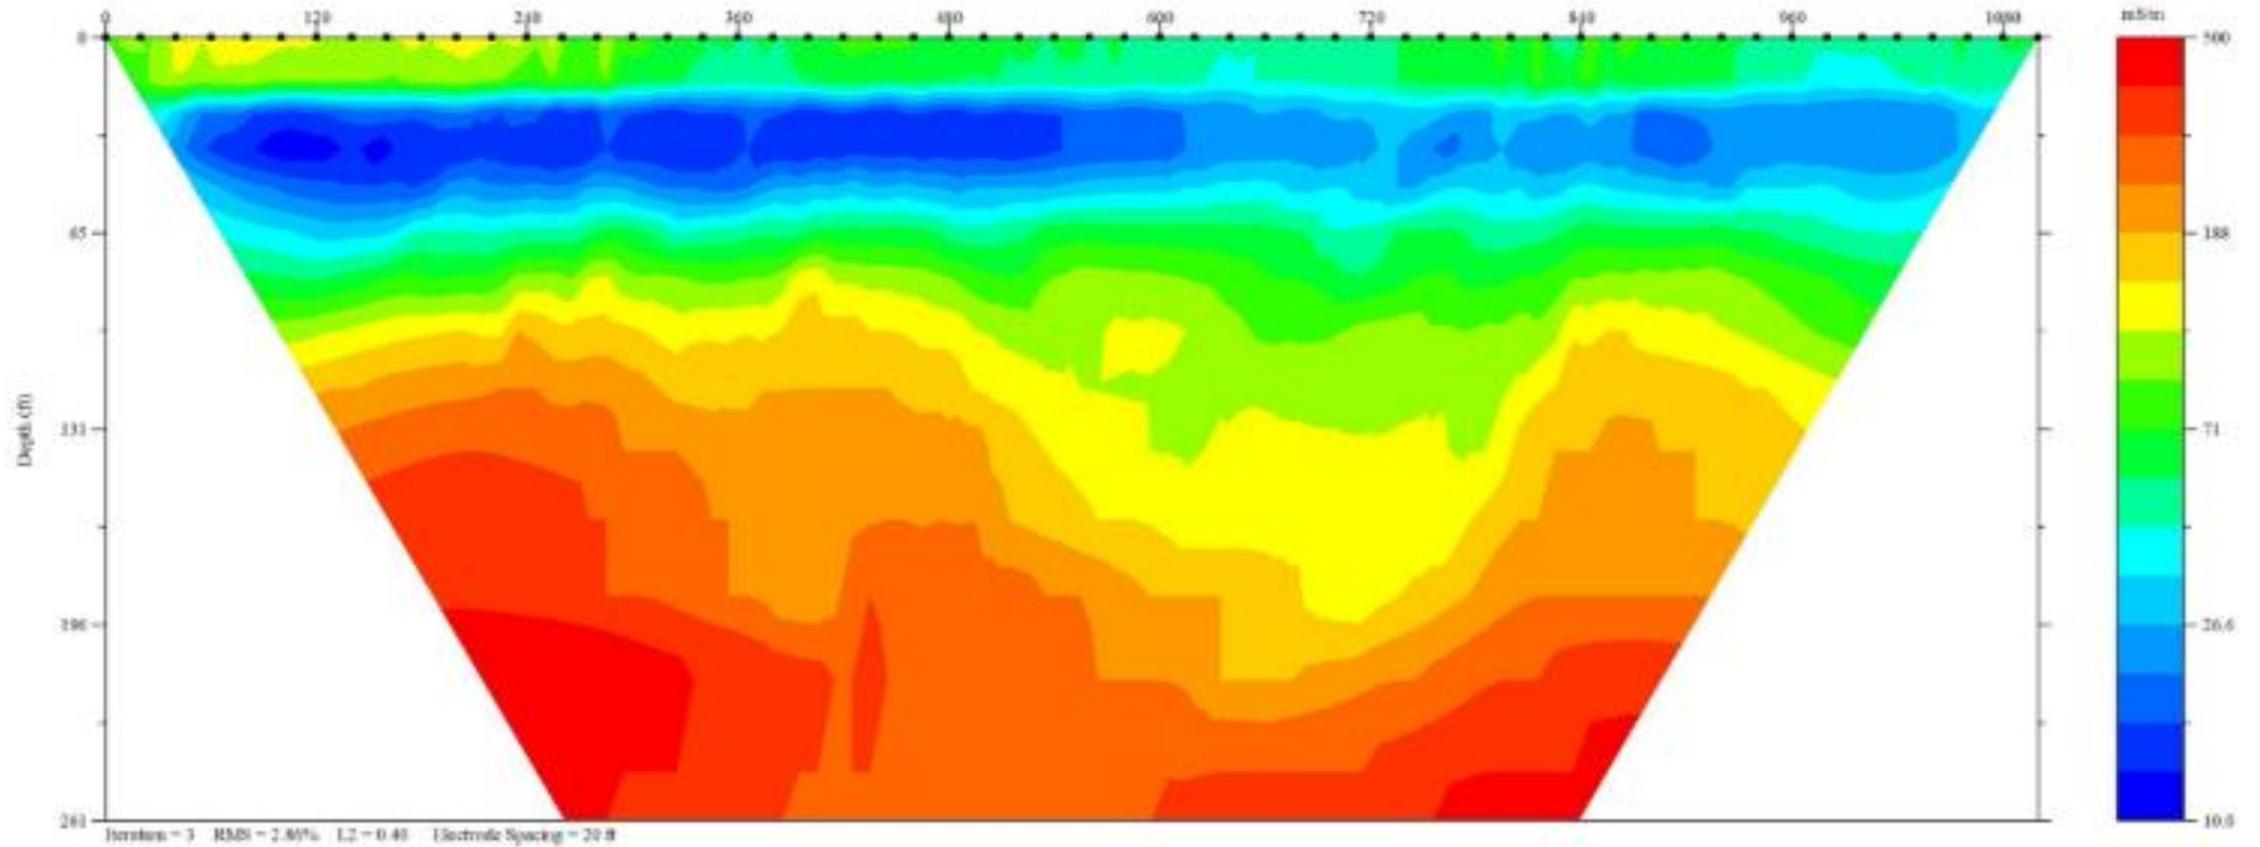
# Site 6

Inverted Conductivity Section
