# MARYSVILLE DAM FAILURE SEDIMENT CONTRIBUTIONS

Michael Mansfield  
River Engineering  
Kansas City District  
November 17<sup>th</sup>, 2022

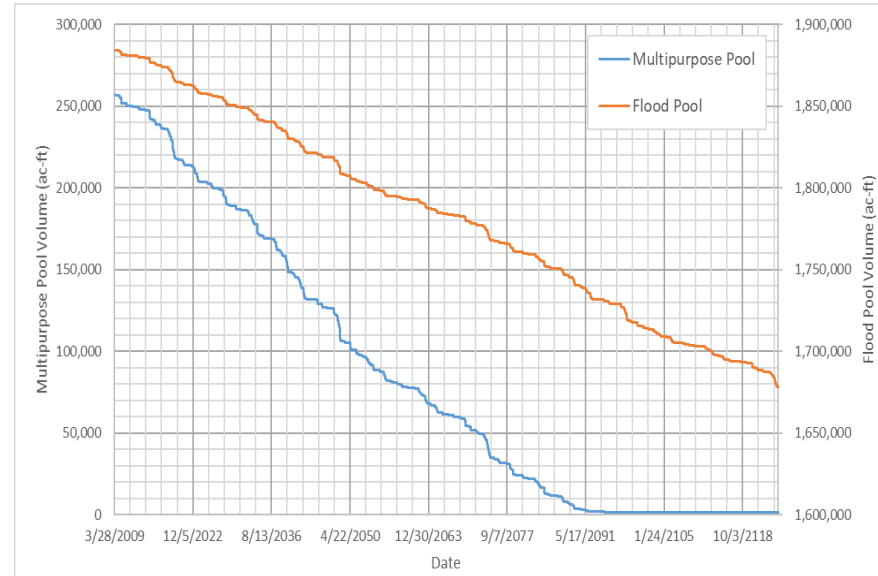
# TUTTLE CREEK LAKE SEDIMENTATION

Year	2009	2024	2049	2074	2124
Cumulative Deposition Multi-Purpose Pool (ac-ft)	167,298	207,742	271,266	317,813	395,065
Average Annual MPP Deposition Since 2024 (ac-ft/yr)	3,351	2,773	2,541	1,862	1,545
Average Annual MPP Deposition over Increment (ac-ft/yr)	-	-	2,541	2,201	1,873
Cumulative Deposition Flood Control Pool (ac-ft)	58,393	91,037	161,758	204,383	330,358
Average Annual FCP Deposition Since 2024 (ac-ft/yr)	1,170	2,238	2,829	1,705	2,520
Average Annual FCP Deposition over Increment (ac-ft/yr)	-	-	2,829	2,267	2,393

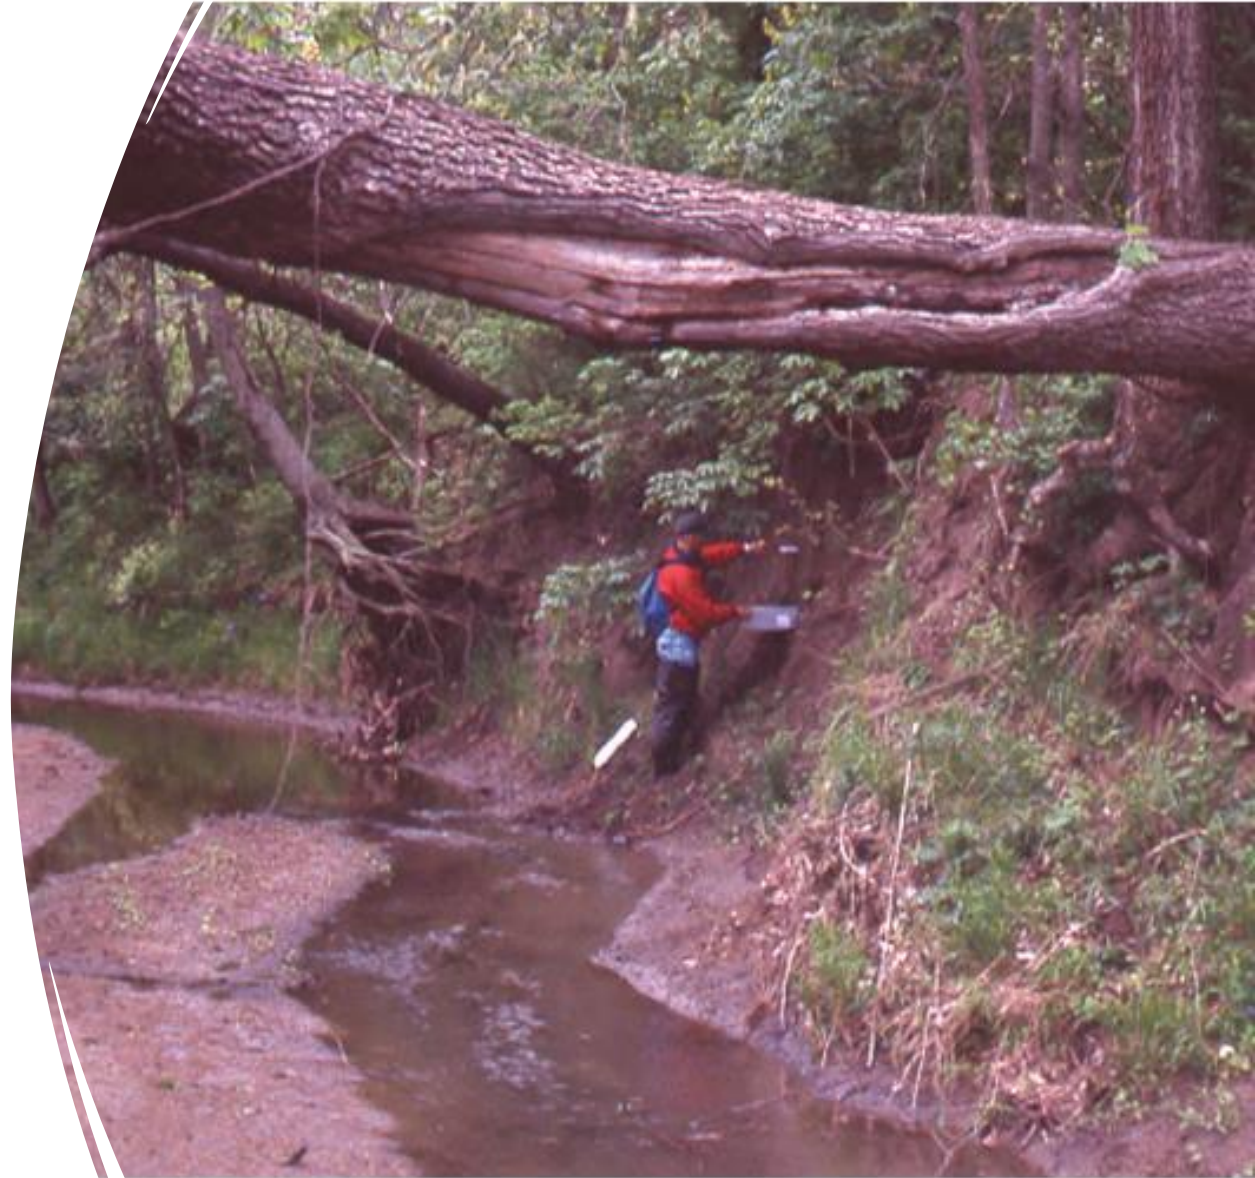
Both channel-bank erosion and surface soil contribute significantly to sedimentation in reservoirs. In Perry Lake, channel-bank erosion was dominant. (Juracek and Zeigler, 2007)

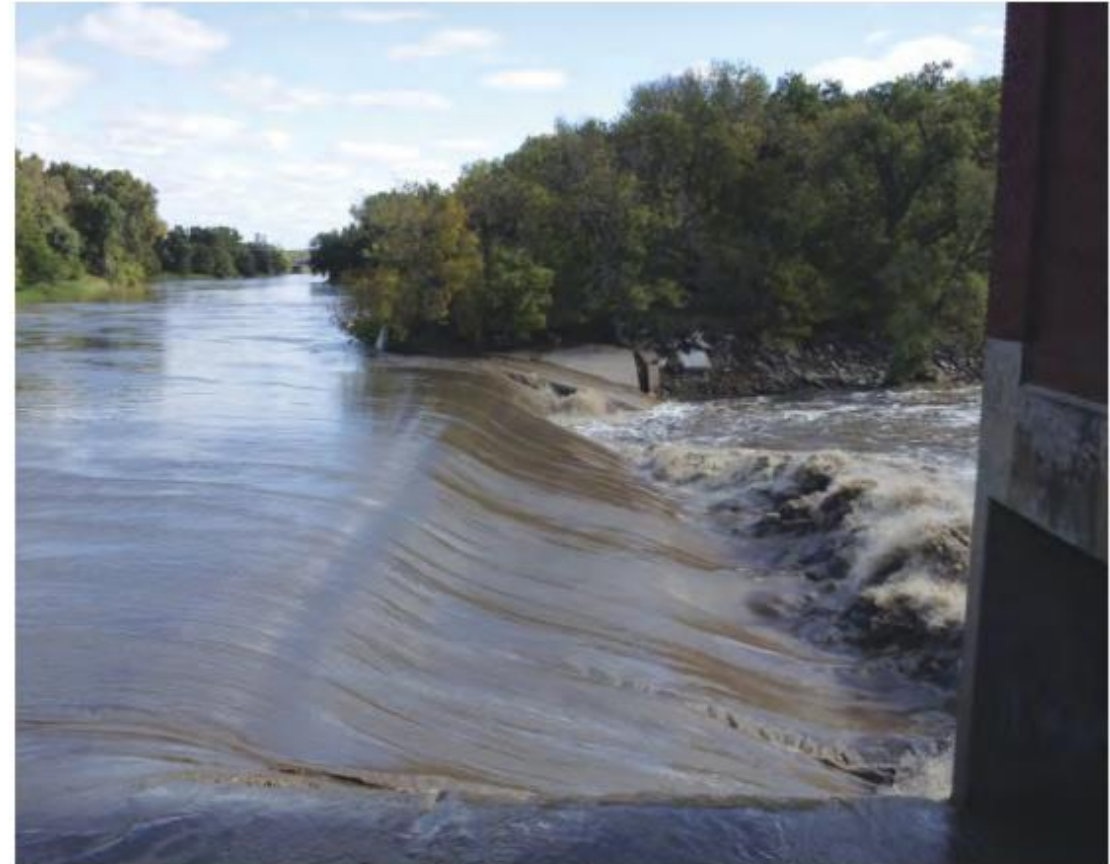
**Big Blue River as it appeared on October 3, 2014, with approximately 9,000 c.f.s. spilling over the dam. Erosion of the face of the dam is clearly evident on the far end. Streamflow over the dam on May 4, 2018, when it ultimately failed was approximately 4,000 c.f.s.**

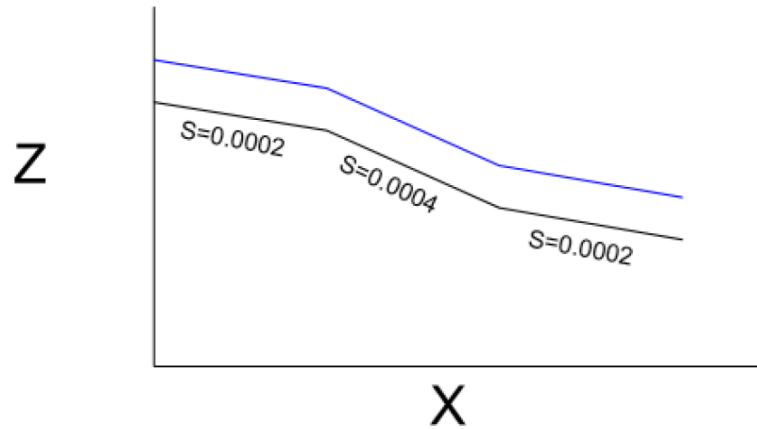
Figure 13: Scenario 1: Channelization

Headcuts refer to bed degradation that works its way upstream
