Kansas River Basin Regional Sediment Management Section 204 Stream and River Channel Assessment

March 2010

Final Report

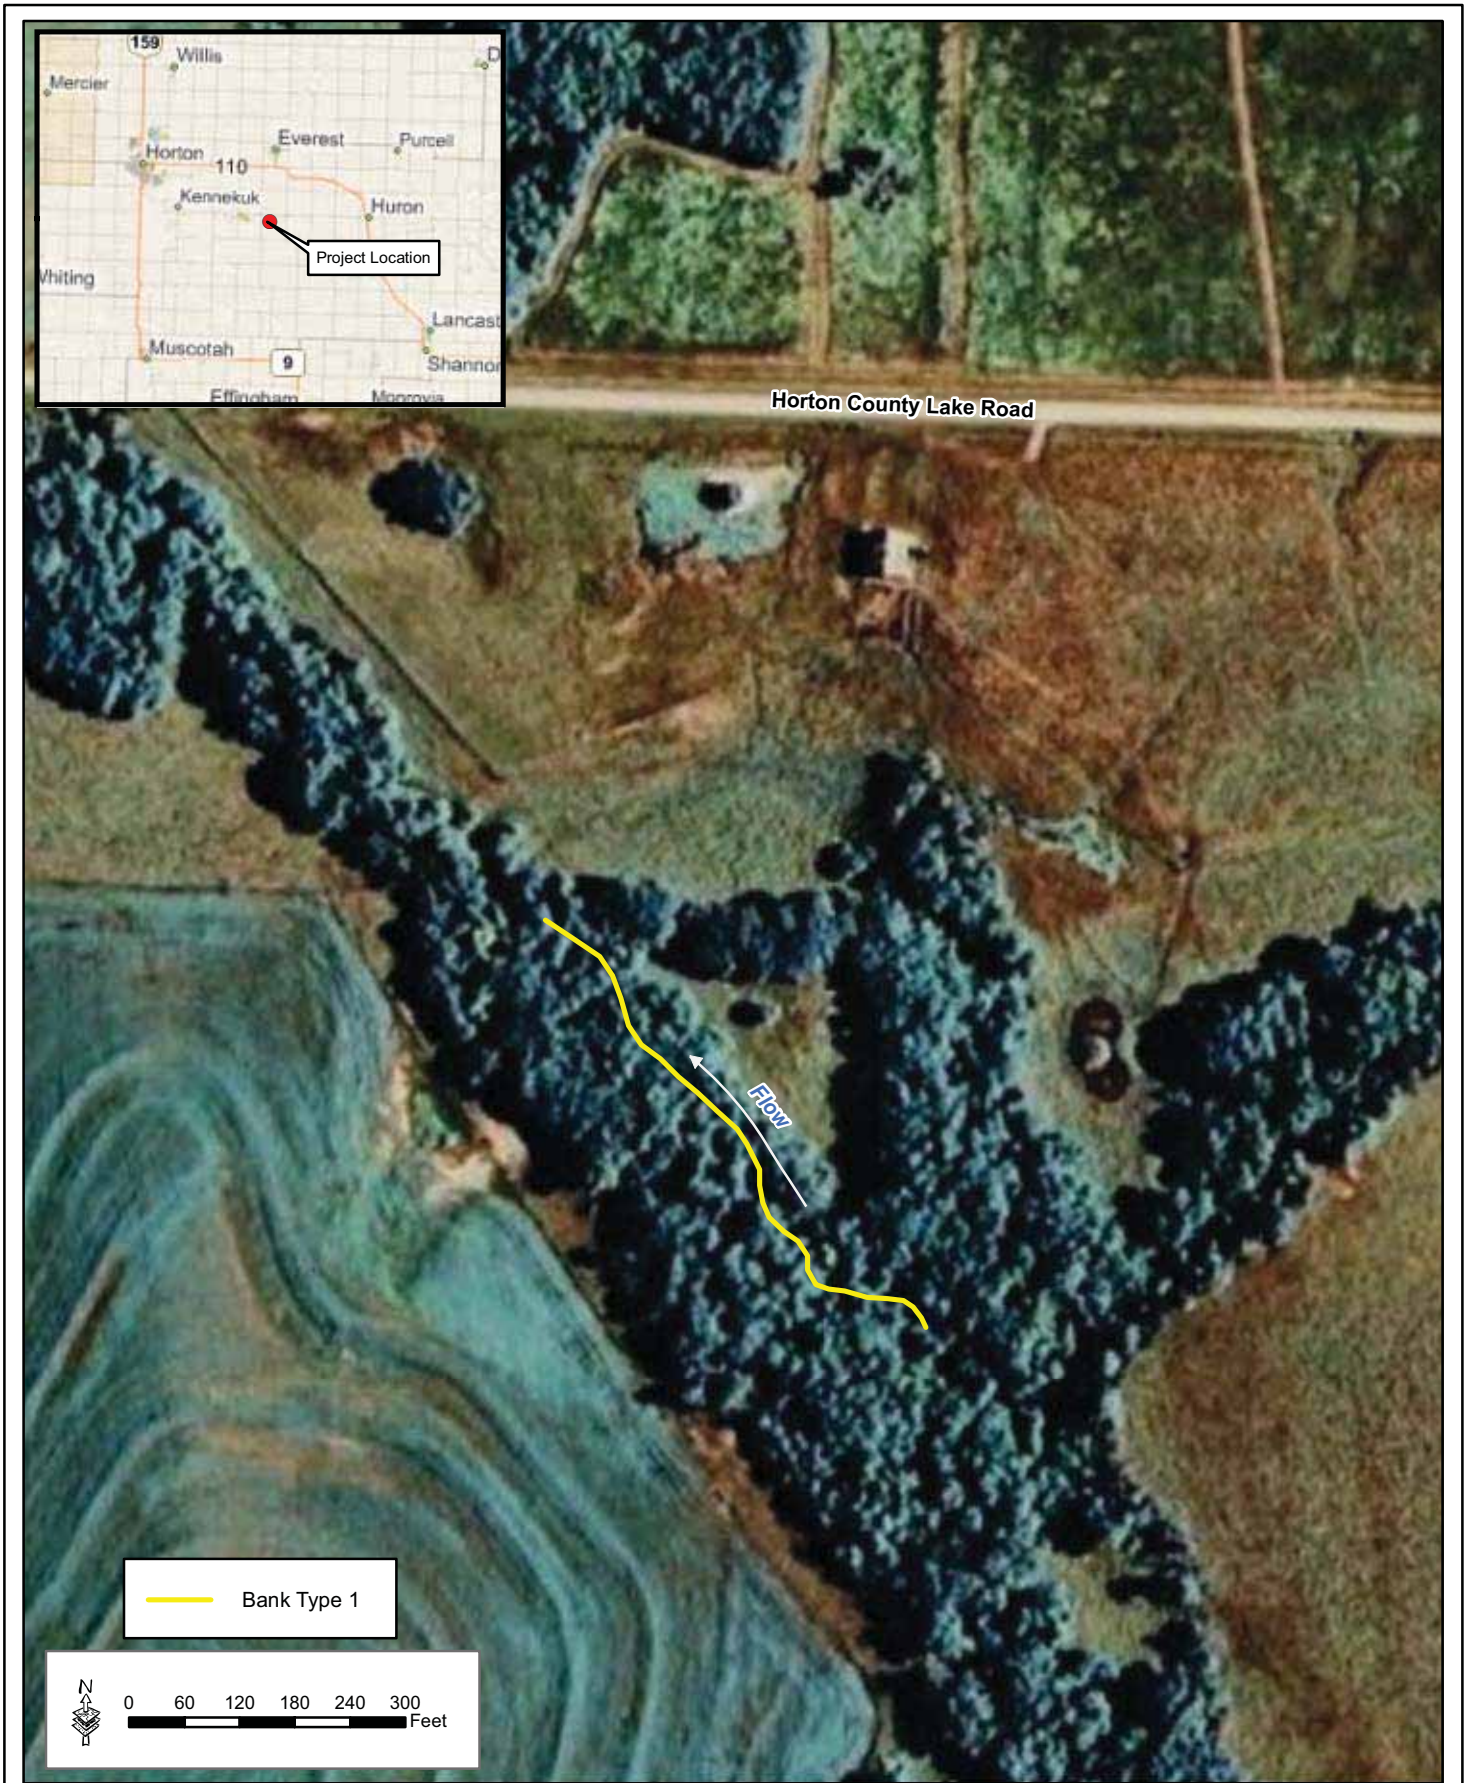
Figure 4-3: Bank Types at Tributary to Clear Creek Survey Site 2

Only one consistent bank type was observed at Survey Site 2. The bank condition consisted of clay loam materials, and the slope of the streambank was moderately steep (Photograph 4, Appendix F). The riparian vegetation provided moderate rooting density and depth that extended down through the entire bank profile. The streambank height was typically two times the bankfull height increasing the bank erodibility. Exposed roots and trees beginning to lean into the stream channel were observed. The NBS rating was high due to a high d_{nb}/d_{bkf} ratio. The predicted erosion loss was derived from monitoring data from the Black Vermillion River watershed. Table 4-6 summarizes the erosion potential for the bank type. Figure 4-3 presents the stream reach at Survey Site 2, which consists of one bank type.

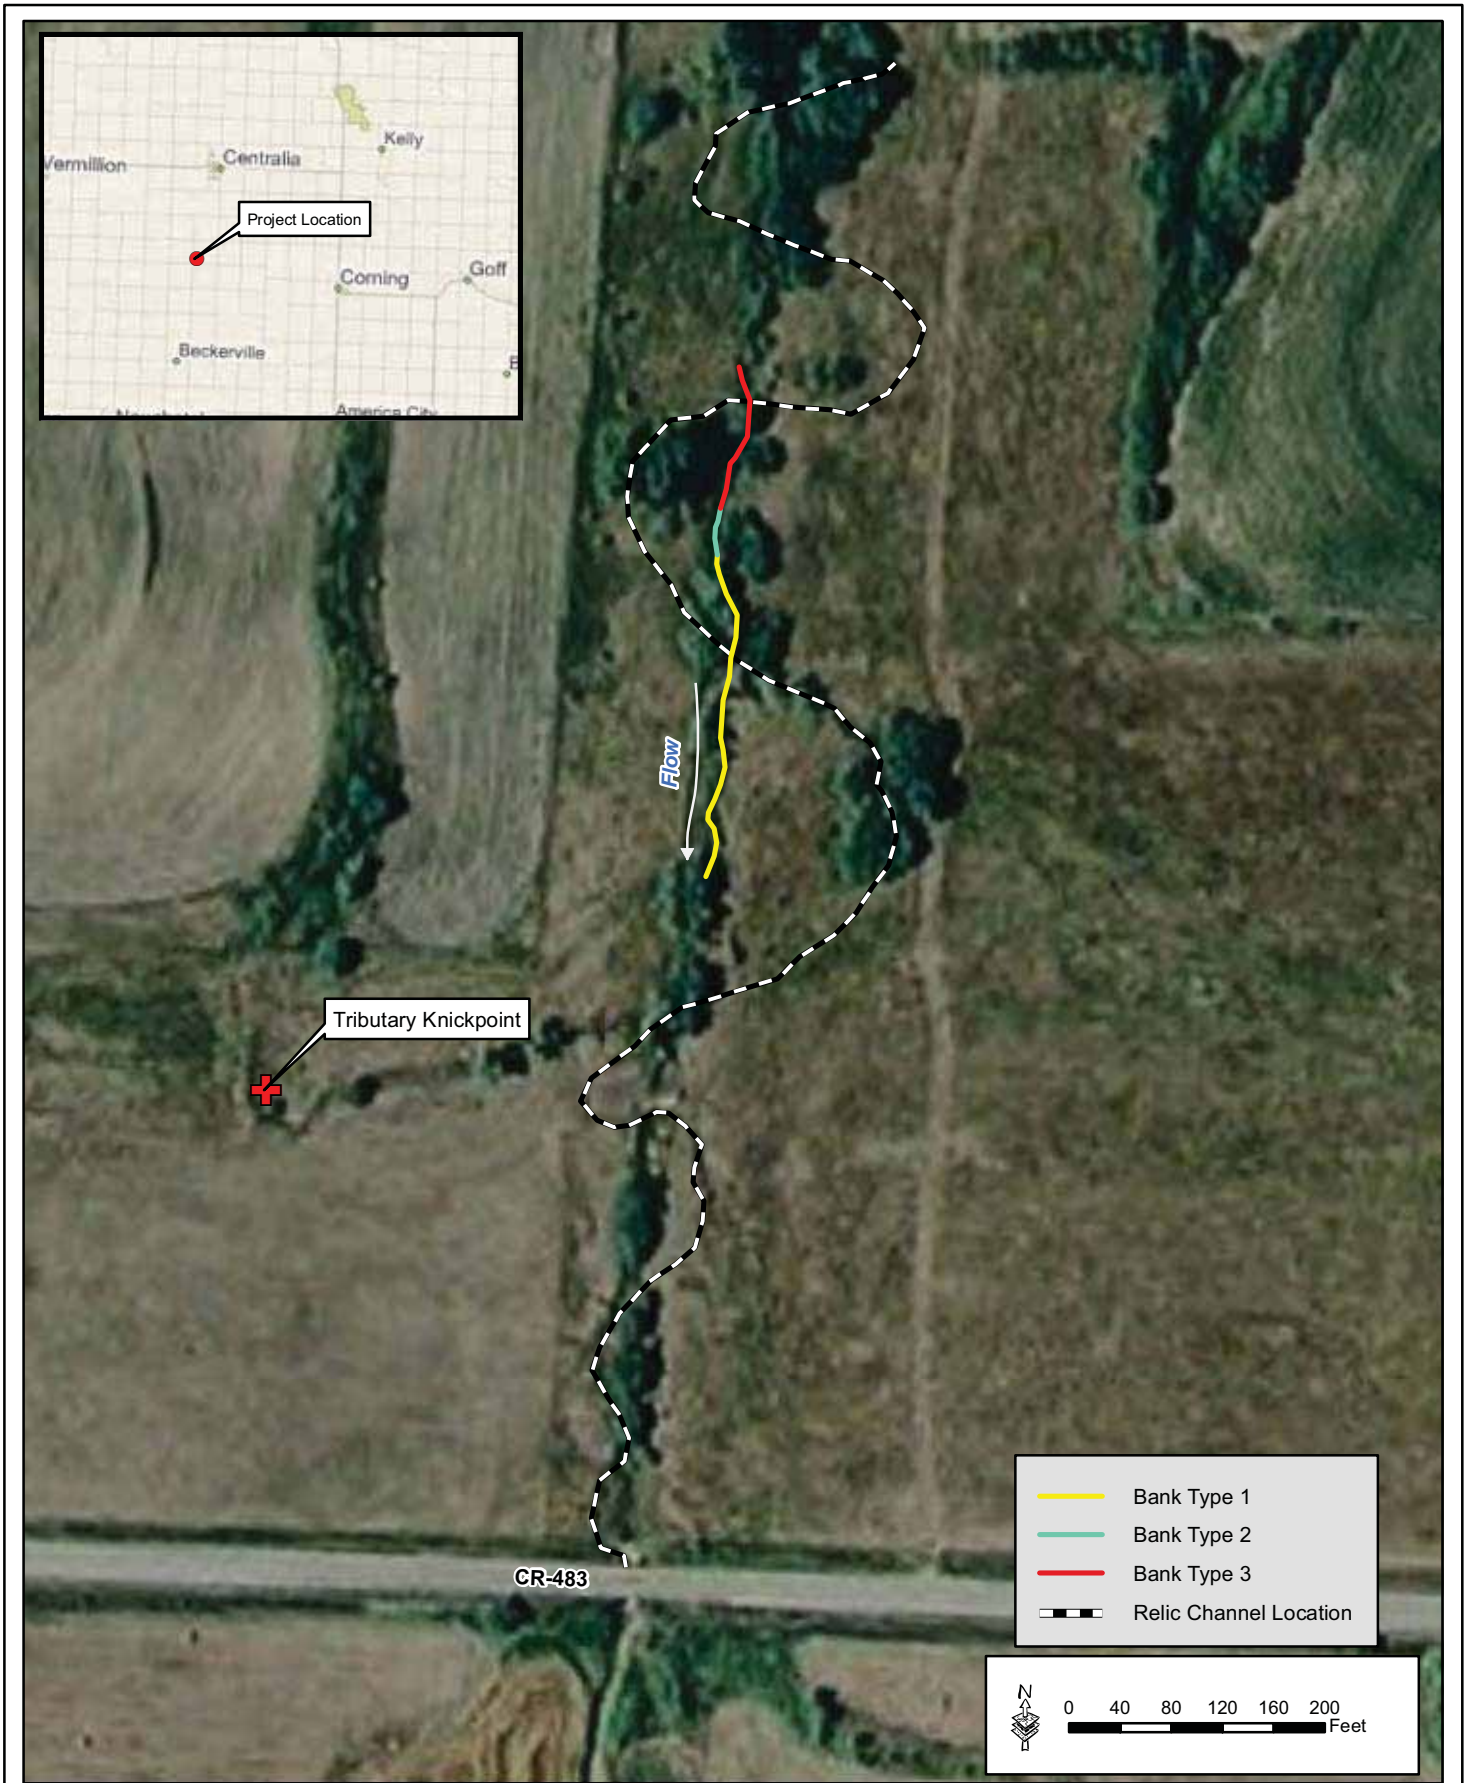
Figure 4-4: Bank Types at Tributary to Centralia Lake Survey Site 3

The riparian corridor was a cool-season pasture. In the past, the vegetative community would have consisted of bluestem prairie (Kuchler 1974). A relic stream channel was found adjacent to the existing stream reach, which is depicted in Figure 4-4. The relic channel area contained cottonwood-willow community that was slowly being replaced by osage orange and green ash. Stormwater runoff contributes most of the water flow to the tributary, which is characteristic of a first-order stream (KDHE 2008a). The stream reach has been straightened and there are no consistent meander patterns or depositional features along most of the survey area. The channelization has created a narrow, incised channel that was starting the Simon Stage V evolution sequence (see Figure 3-2).

To gain further insight on relic channel dimensions, a channel cross section was surveyed (Cross Section 5, Appendix B). The old channel bottom has likely filled, but the bankfull cross section area was similar to the active channel. The width/depth ratio was larger (11.54) than the active channel (5.12) suggesting the present stream channel will continue to evolve. Finally, a knickpoint on an east-flowing tributary was observed (Photograph 10, Appendix F) and the

location is marked on Figure 4-4. Table 4-9 summarizes the survey data utilizing Rosgen's stability indices.

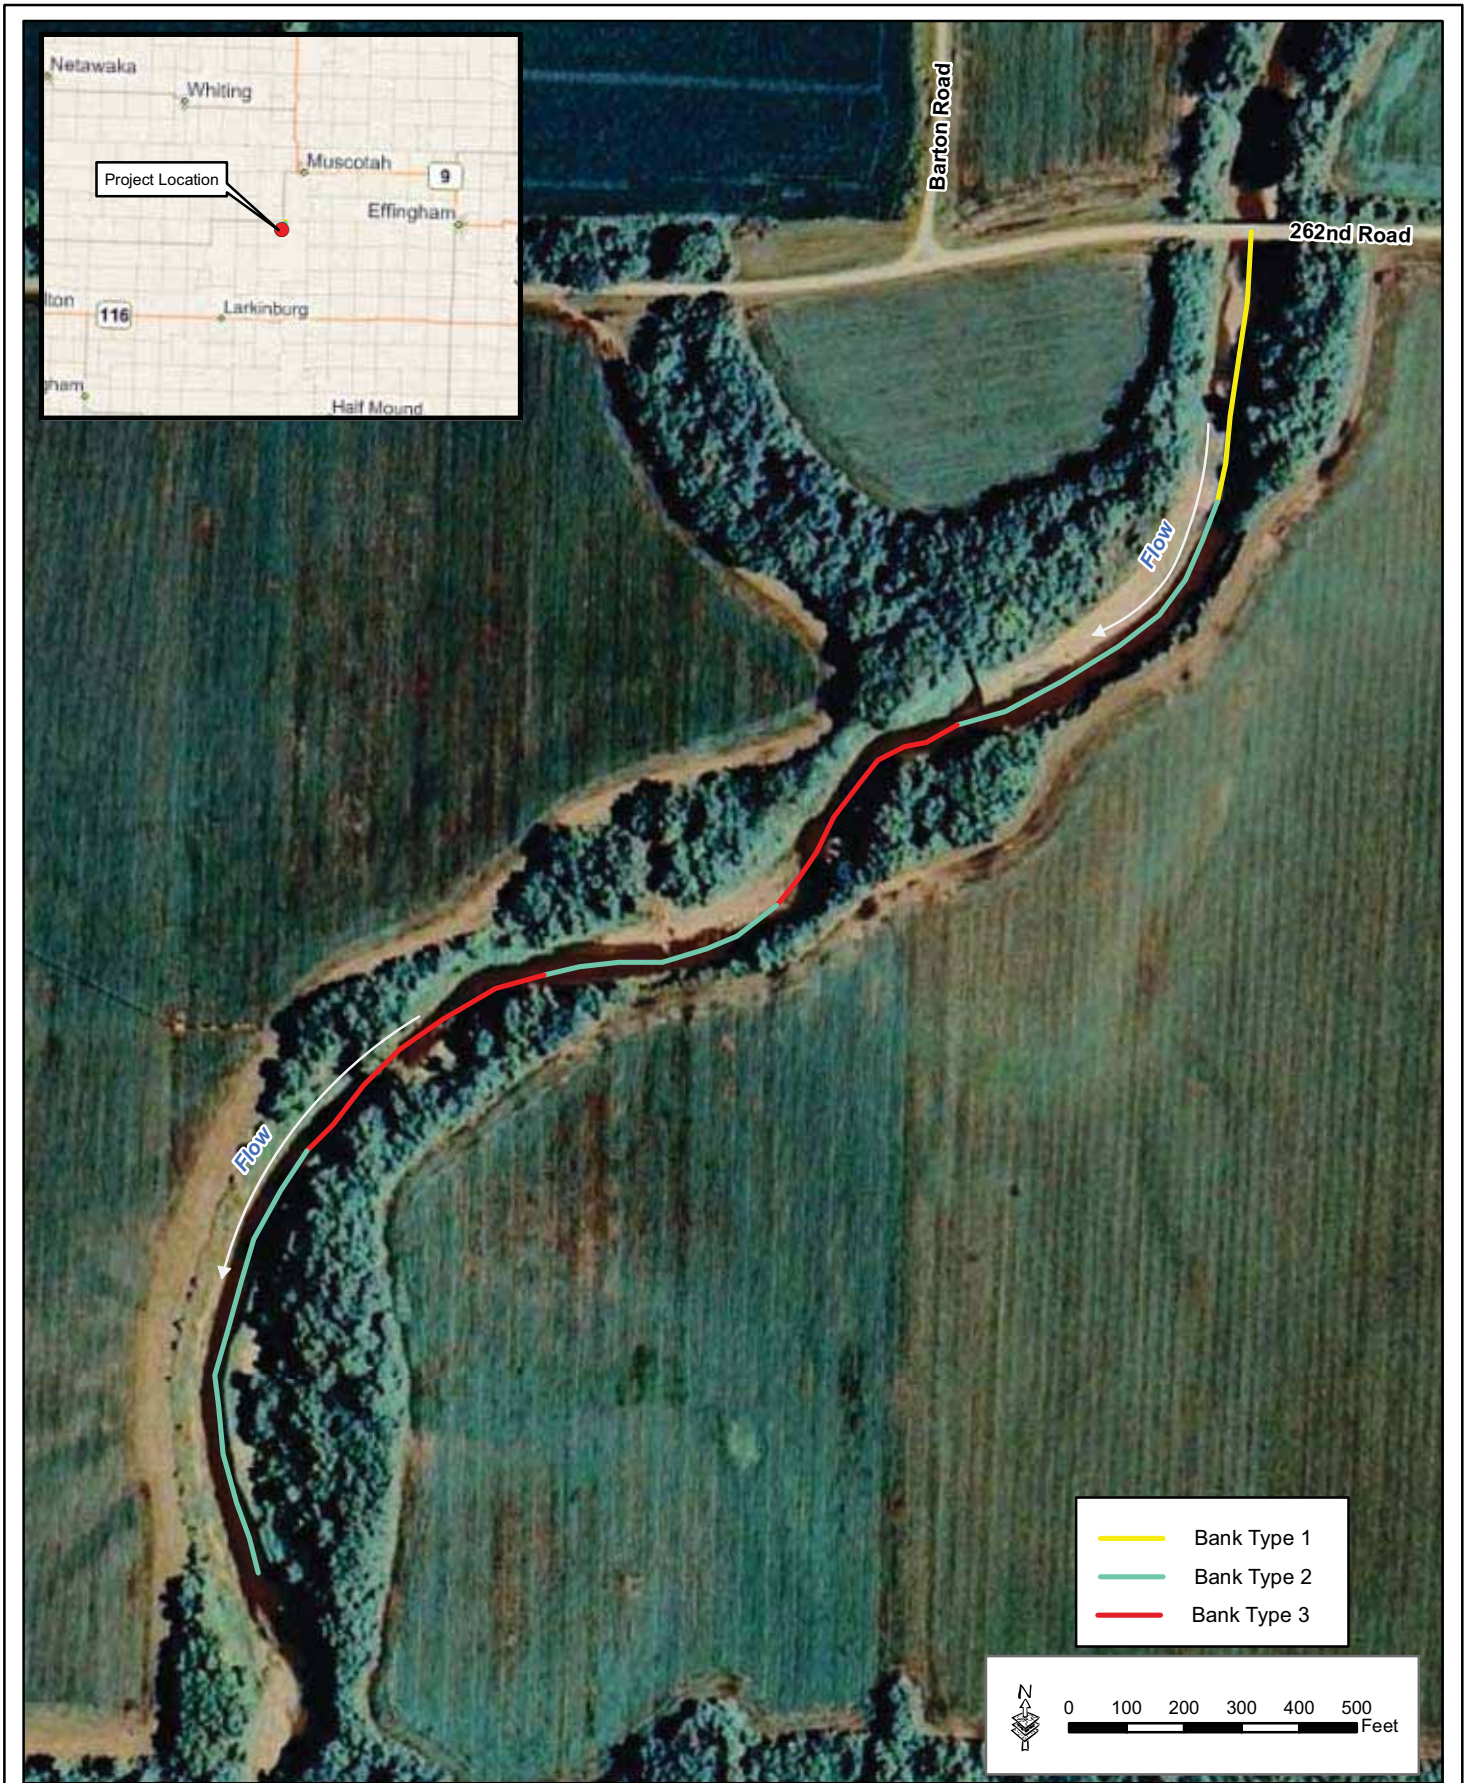
Figure 4-5: Bank Types at Delaware River at USGS Muscotah Gauge Survey Site 4

Bank type 3, was located along two meanders (26% of survey) that had a more established riparian corridor. The banks were more gently sloping and supported a thick stand of willows on the lower bank (Photograph 13, Appendix F). Table 4-10 summarizes the erosion potential of Survey Site 4. Figure 4-5 presents the location of the three bank types present at Survey Site 4.

The channel was deeply incised and the width/depth ratio was moderately unstable. Due to extensive channelization, the river was laterally confined. The channel was classified as Stage V due to the presence of large bars and channel aggradations (see Figure 3-2). Table 4-11 summarizes survey data by utilizing Rosgen's stream stability indices. Figure 4-5, presented previously, shows the location of Survey Site 4.

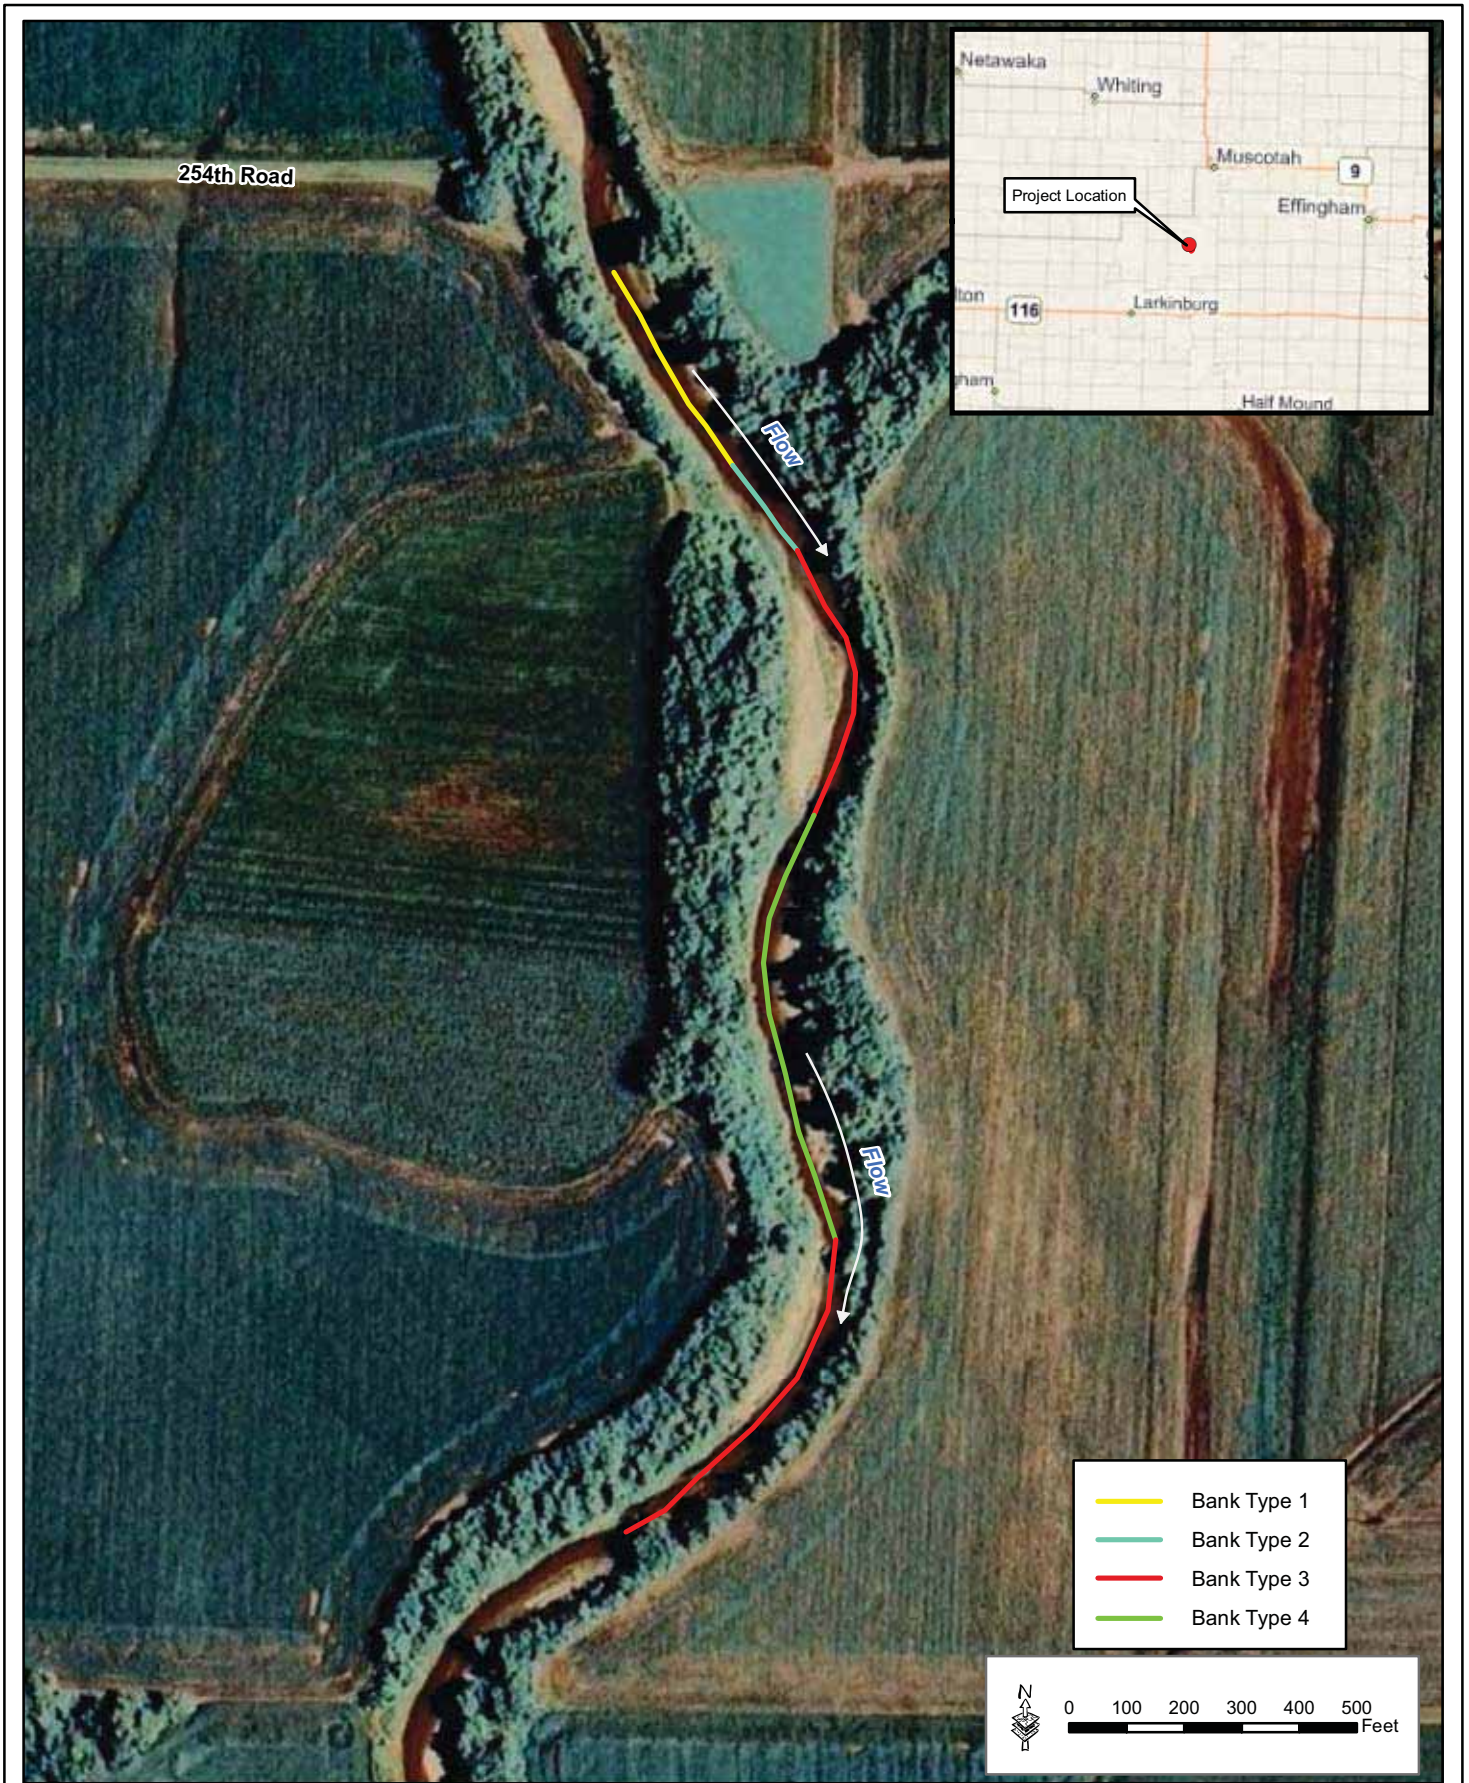
Figure 4-7: Bank Types at Delaware River at Highway 254 Bridge Survey Site 5

Bank type 4 encompasses 31% of the survey and is located between the two bank type 3 reaches. Bank type 4 was similar to bank type 1, but with a more gentle slope. The lesser slope supports a greater root density and there was more soil surface protection (Photograph 19, Appendix F). Some bank toe erosion was observed, but the erosion point was small and the rate of erosion appeared slow. Table 4-12 summarizes the bank types and Figure 4-7 presents the location of the bank types along the survey reach.

The vegetative species inhabiting the riparian corridor are native to the region. The width of the riparian buffer was not consistent and becomes fairly narrow in places. The river is a fifth order stream and the Rosgen stream size classification is an S-8 (100 to 150 feet bankfull width) (Appendix G, Page G-2). Regular meanders (M-1) with point bars and a few mid-channel bars were observed, as well as moderate blockages from fallen trees (Appendix G, Page G-3). The channel was deeply incised; however, width/depth ratio was stable. Due to past channelization, the stream reach was moderately confined and was in a Stage V evolution phase (Figure 3-2).

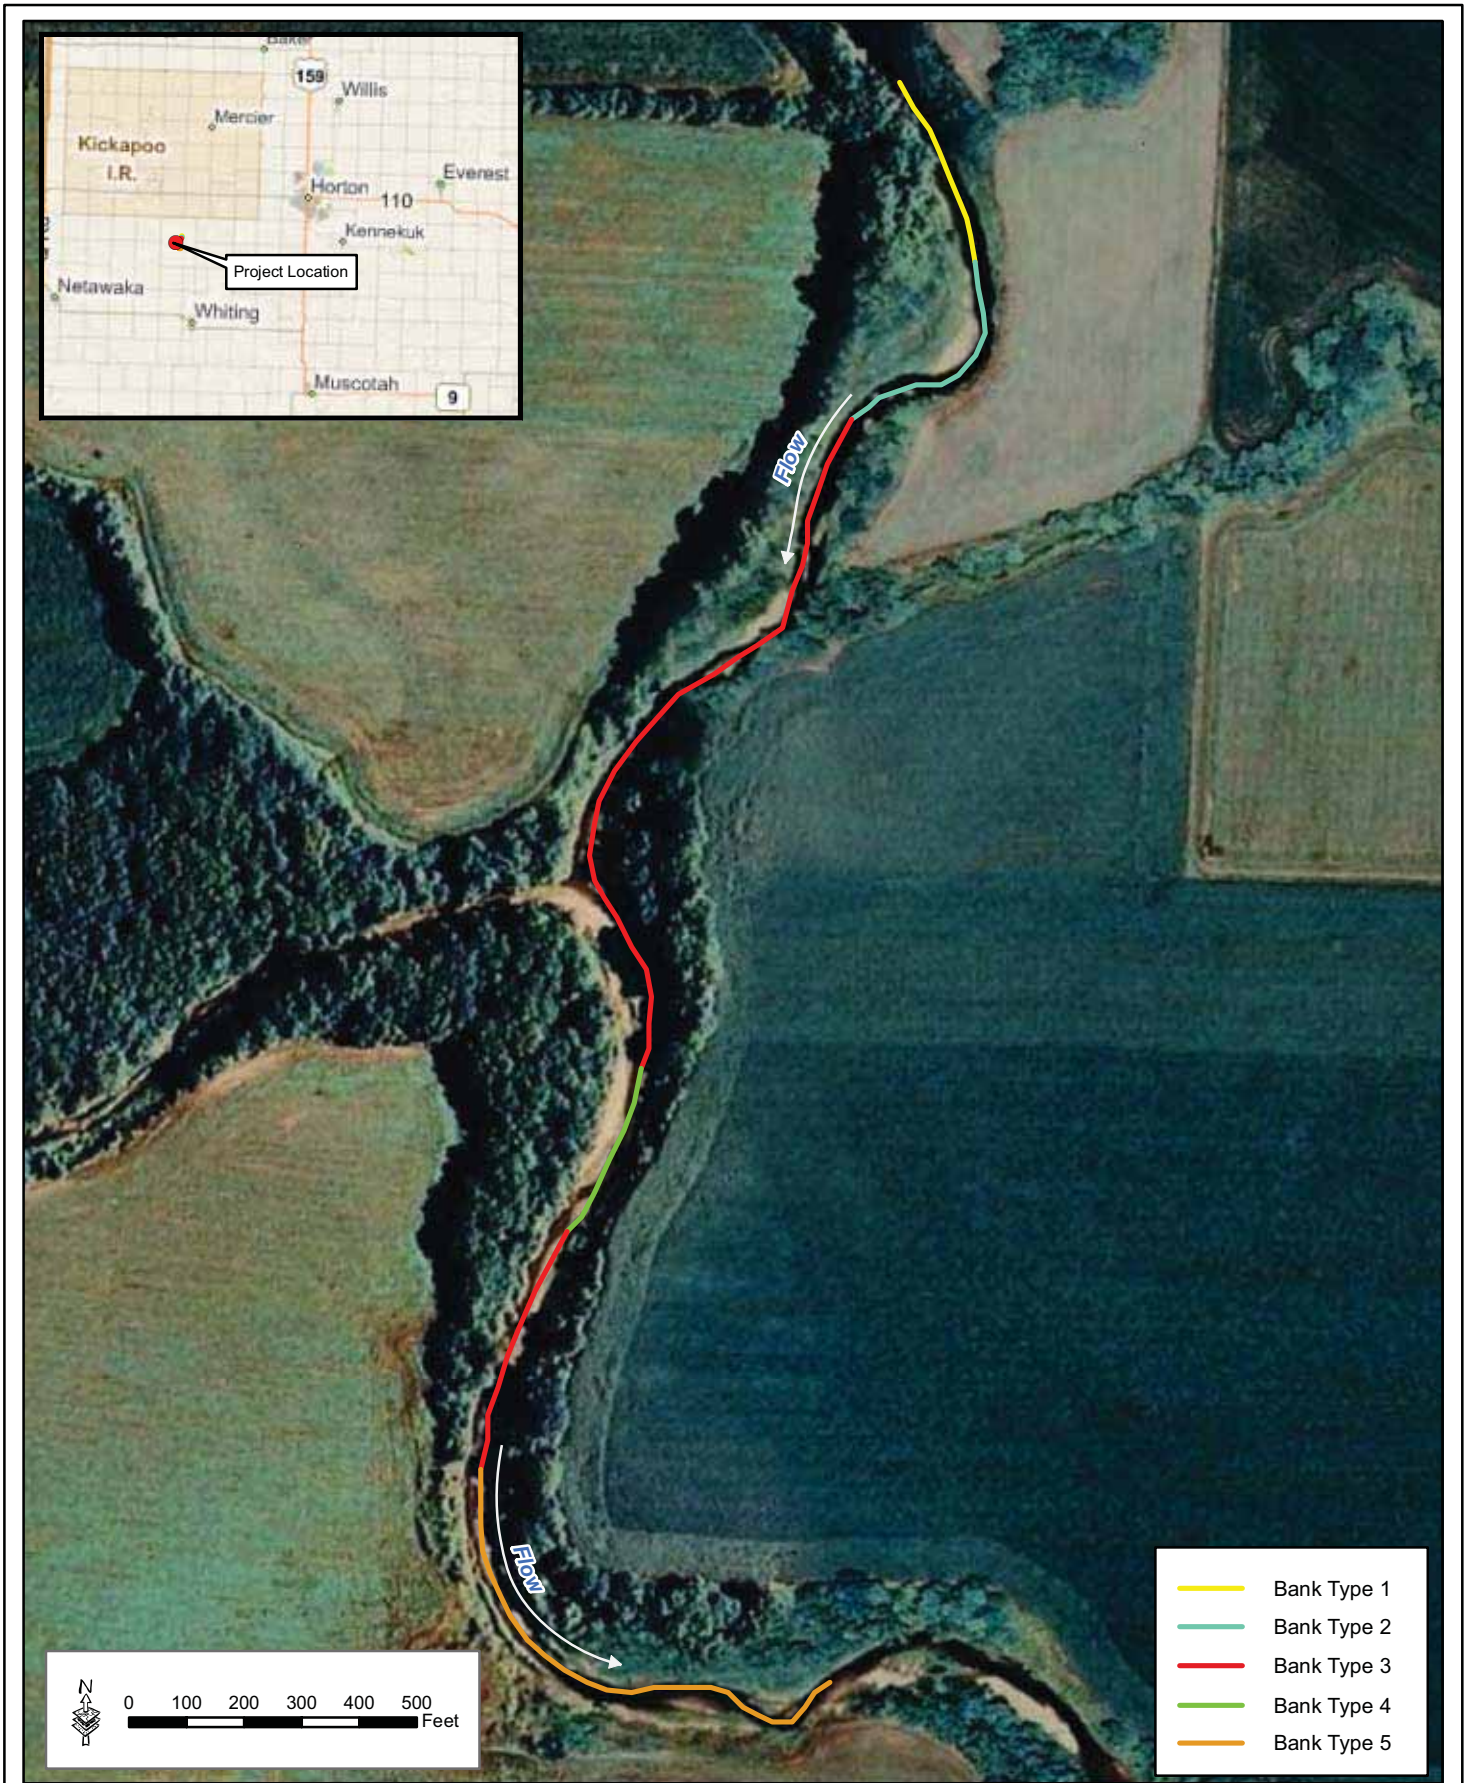
Figure 4-8: Bank Types at Delaware River at Muddy Creek Confluence Survey Site 6

and 28, Appendix F). Table 4-14 summarizes the bank types and Figure 4-8 presents the location of the bank types along the survey reach.

The riparian vegetation was similar to the vegetation historically found in the area, but the corridor width was variable. The river was determined to be a fourth order stream above the Muddy Creek confluence and becomes a fifth order stream at the confluence (KDHE 1996). The meander pattern most resembles regular meanders, but the pattern was inconsistent due to past channelization. There are large point bars with a few mid-channel bars. The width/depth ratio was moderately unstable, and the channel was slightly incised. The presence of a bankfull bench reduced the degree of channel incision. This bench was not wide, but helps to dissipate energy during high flow events. Past channelization has created a confined channel and the survey results indicate that the stream reach is Stage V in the evolution sequence (Figure 3-2). Table 4-15 summarizes the survey data by utilizing Rosgen's stream stability classifications.

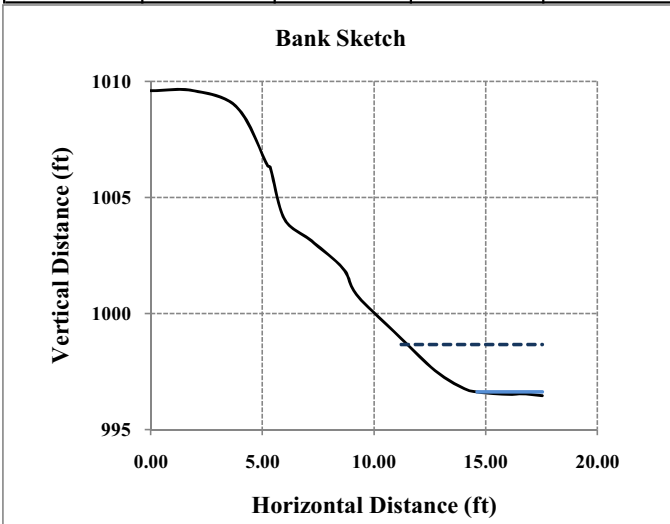
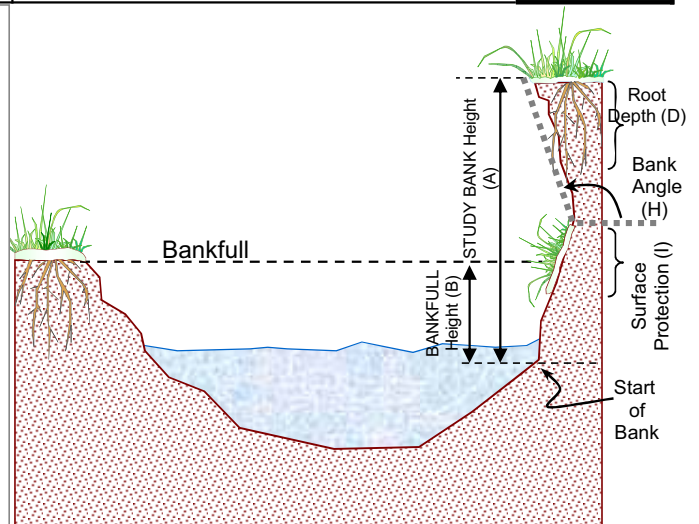
Study Bank Height / Bankfull Height (C)				BEHI Score (Fig. 5-19)	
Study Bank Height (ft) =	11.05 (A)	Bankfull Height (ft) =	1.67 (B)	(A) / (B) = 6.61677 (C)	10
Root Depth / Study Bank Height (E)					
Root Depth (ft) =	11.05 (D)	Study Bank Height (ft) =	11.05 (A)	(D) / (A) = 1 (E)	1
Weighted Root Density (G)					
Root Density as % =	50 (F)	(F) x (E) = 50 (G)		4.32	
Bank Angle (H)					
Bank Angle as Degrees =	60 (H)			3.9	
Surface Protection (I)					
Surface Protection as % =	10 (I)			9	
Bank Material Adjustment:					
<ul style="list-style-type: none"> Bedrock (Overall Very Low BEHI) Boulders (Overall Low BEHI) Cobble (Subtract 10 points if uniform medium to large cobble) Gravel or Composite Matrix (Add 5–10 points depending on percentage of bank material that is composed of sand) Sand (Add 10 points) Silt/Clay (no adjustment) 				Bank Material Adjustment	0
				Stratification Adjustment	0
				Add 5–10 points, depending on position of unstable layers in relation to bankfull stage

Very Low	Low	Moderate	High	Very High	Extreme	Adjective Rating and Total Score	Moderate
5 – 9.5	10 – 19.5	20 – 29.5	30 – 39.5	40 – 45	46 – 50	28.2	28.2

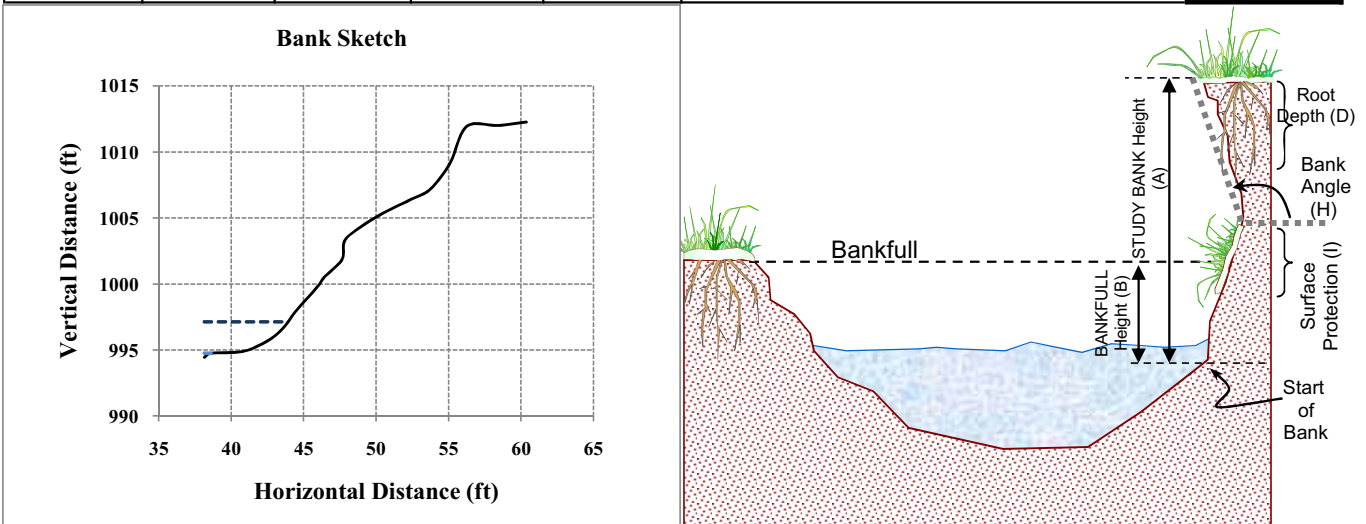
Stream: Banner Creek	Location: Banner Creek Reservoir
Station: Bank Type 2	Observers: GSRC, TWI
Date: 05/28/09	Stream Type: B 5c Valley Type: VIII

Study Bank Height / Bankfull Height (C)				BEHI Score (Fig. 5-19)	
Study Bank Height (ft) =	17.02 (A)	Bankfull Height (ft) =	2.22 (B)	(A) / (B) = 7.66667 (C)	10
Root Depth / Study Bank Height (E)					
Root Depth (ft) =	14 (D)	Study Bank Height (ft) =	17.02 (A)	(D) / (A) = 0.82256 (E)	2.34
Weighted Root Density (G)					
Root Density as % =	20 (F)	(F) x (E) = 16.4512 (G)		7.7	
Bank Angle (H)					
Bank Angle as Degrees =	48 (H)			3.32	
Surface Protection (I)					
Surface Protection as % =	5 (I)			10	
Bank Material Adjustment:					
Bedrock (Overall Very Low BEHI) Boulders (Overall Low BEHI) Cobble (Subtract 10 points if uniform medium to large cobble) Gravel or Composite Matrix (Add 5–10 points depending on percentage of bank material that is composed of sand) Sand (Add 10 points) Silt/Clay (no adjustment)				Bank Material Adjustment	0
				Stratification Adjustment	0
				Add 5–10 points, depending on position of unstable layers in relation to bankfull stage

Very Low	Low	Moderate	High	Very High	Extreme		Adjective Rating and Total Score
5 – 9.5	10 – 19.5	20 – 29.5	30 – 39.5	40 – 45	46 – 50		High
							33.4

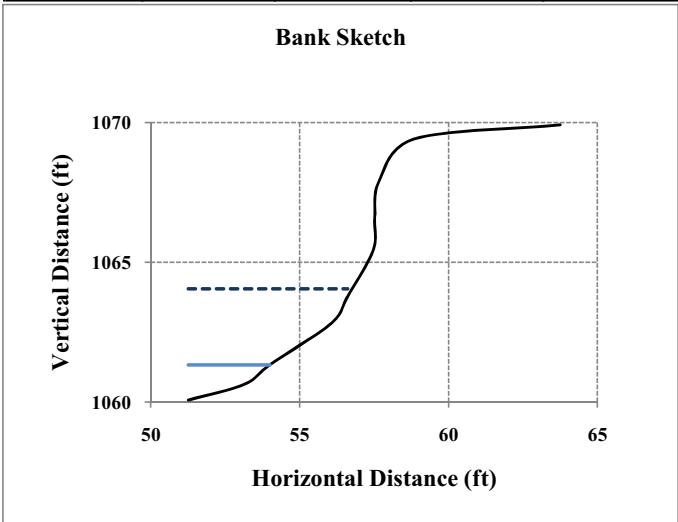
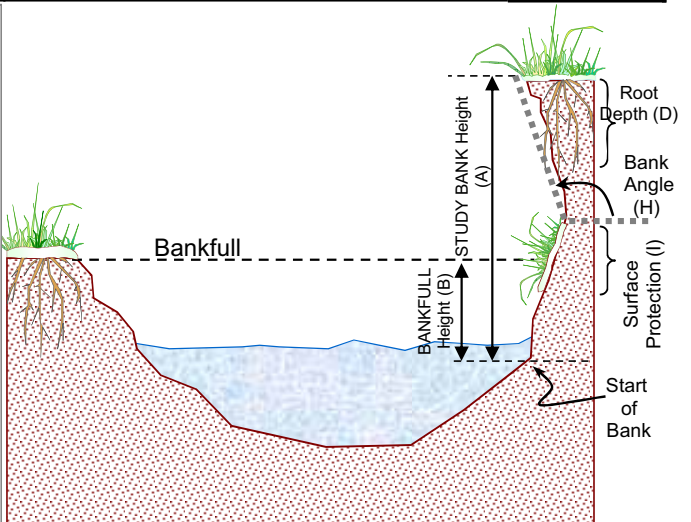
Stream: Clear Creek Tributary	Location: Atchison County Lake
Station: Bank Type 1	Observers: GSRC, TWI
Date: 06/23/09	Stream Type: E 6 Valley Type: VIII

Study Bank Height / Bankfull Height (C)				BEHI Score (Fig. 5-19)	
Study Bank Height (ft) =	6.86 (A)	Bankfull Height (ft) =	3.56 (B)	$(A) / (B) =$ 1.92697 (C)	7.57
Root Depth / Study Bank Height (E)					
Root Depth (ft) =	6.86 (D)	Study Bank Height (ft) =	6.86 (A)	$(D) / (A) =$ 1 (E)	1
Weighted Root Density (G)					
Root Density as % =	40 (F)		$(F) \times (E) =$ 40 (G)	5.11	
Bank Angle (H)					
Bank Angle as Degrees =	58 (H)			3.8	
Surface Protection (I)					
Surface Protection as % =	50 (I)			4.32	
Bank Material Adjustment:					
<ul style="list-style-type: none"> Bedrock (Overall Very Low BEHI) Boulders (Overall Low BEHI) Cobble (Subtract 10 points if uniform medium to large cobble) Gravel or Composite Matrix (Add 5–10 points depending on percentage of bank material that is composed of sand) Sand (Add 10 points) Silt/Clay (no adjustment) 				Bank Material Adjustment 0	
Stratification Adjustment Add 5–10 points, depending on position of unstable layers in relation to bankfull stage				0

Very Low	Low	Moderate	High	Very High	Extreme		Adjective Rating and Total Score
5 – 9.5	10 – 19.5	20 – 29.5	30 – 39.5	40 – 45	46 – 50		Moderate 21.8

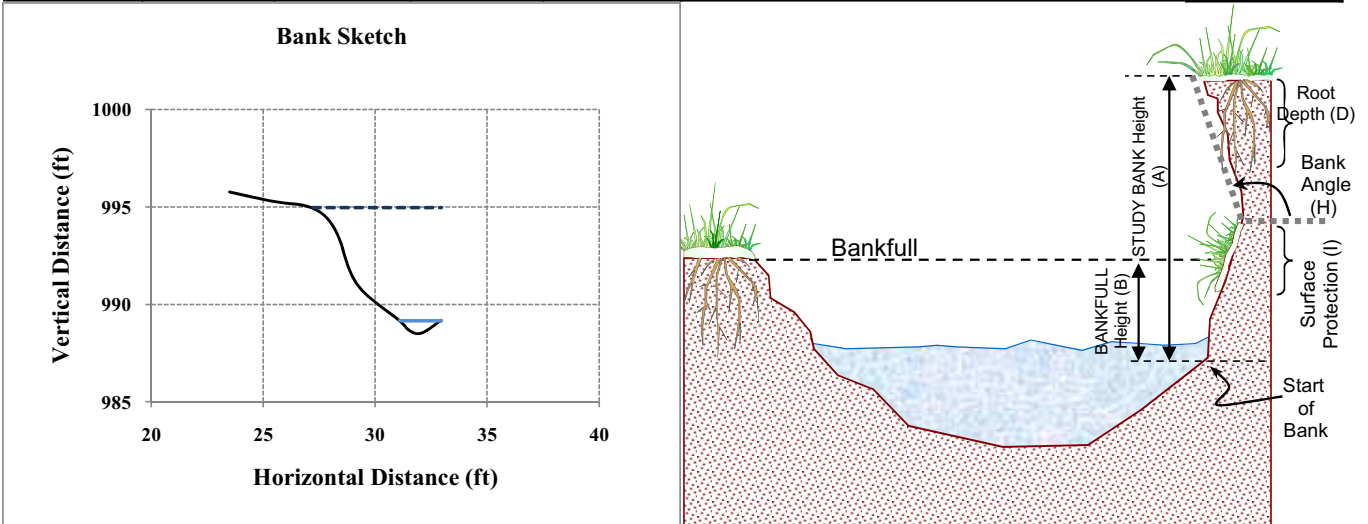
Stream: Centralia Lake Tributary	Location: Centralia Lake
Station: Bank Type 1	Observers: GSRC, TWI
Date: 05/29/09	Stream Type: E 6 Valley Type: VIII

Study Bank Height / Bankfull Height (C)					BEHI Score (Fig. 5-19)
Study Bank Height (ft) =	3.33 (A)	Bankfull Height (ft) =	3.33 (B)	(A) / (B) =	1 (C)
					1
Root Depth / Study Bank Height (E)					
Root Depth (ft) =	3.33 (D)	Study Bank Height (ft) =	3.33 (A)	(D) / (A) =	1 (E)
					1
Weighted Root Density (G)					
Root Density as % =	75 (F)	(F) x (E) =	75 (G)

2.32
Bank Angle (H)					
Bank Angle as Degrees =	63 (H)				
					4.2
Surface Protection (I)					
Surface Protection as % =	30 (I)				
					5.9
Bank Material Adjustment:					
<ul style="list-style-type: none"> Bedrock (Overall Very Low BEHI) Boulders (Overall Low BEHI) Cobble (Subtract 10 points if uniform medium to large cobble) Gravel or Composite Matrix (Add 5–10 points depending on percentage of bank material that is composed of sand) Sand (Add 10 points) Silt/Clay (no adjustment) 				Bank Material Adjustment	0
				Stratification Adjustment	0
				Add 5–10 points, depending on position of unstable layers in relation to bankfull stage

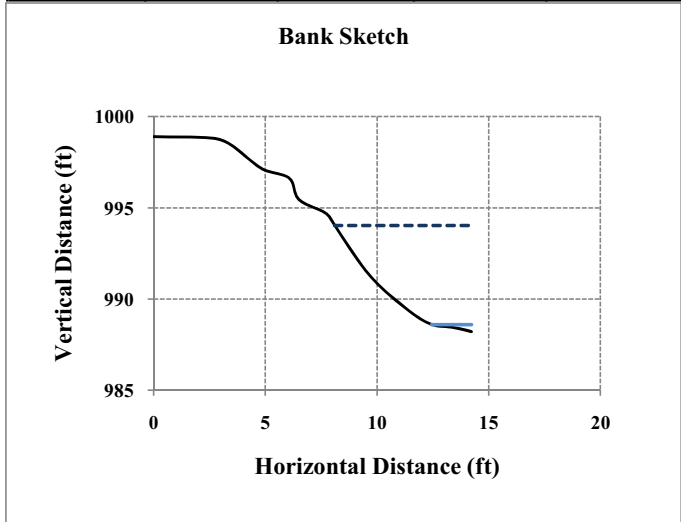
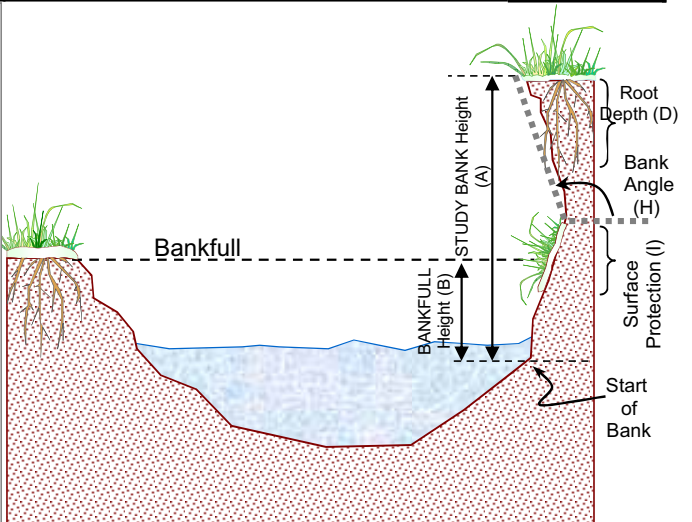
Stream: Centralia Lake Tributary		Location: Centralia Lake	
Station: Bank Type 2		Observers: GSRC, TWI	
Date: 05/29/09	Stream Type: E 6	Valley Type: VIII

Study Bank Height / Bankfull Height (C)				BEHI Score (Fig. 5-19)	
Study Bank Height (ft) =	9.92 (A)	Bankfull Height (ft) =	5.44 (B)	(A) / (B) =	1.82353 (C)
					7.05
Root Depth / Study Bank Height (E)					
Root Depth (ft) =	8.78 (D)	Study Bank Height (ft) =	9.92 (A)	(D) / (A) =	0.88508 (E)
					2
Weighted Root Density (G)					
Root Density as % =	20 (F)	(F) x (E) =			17.7016 (G)
					7.53
Bank Angle (H)					
Bank Angle as Degrees =	48 (H)				
					3.32
Surface Protection (I)					
Surface Protection as % =	10 (I)				
					9

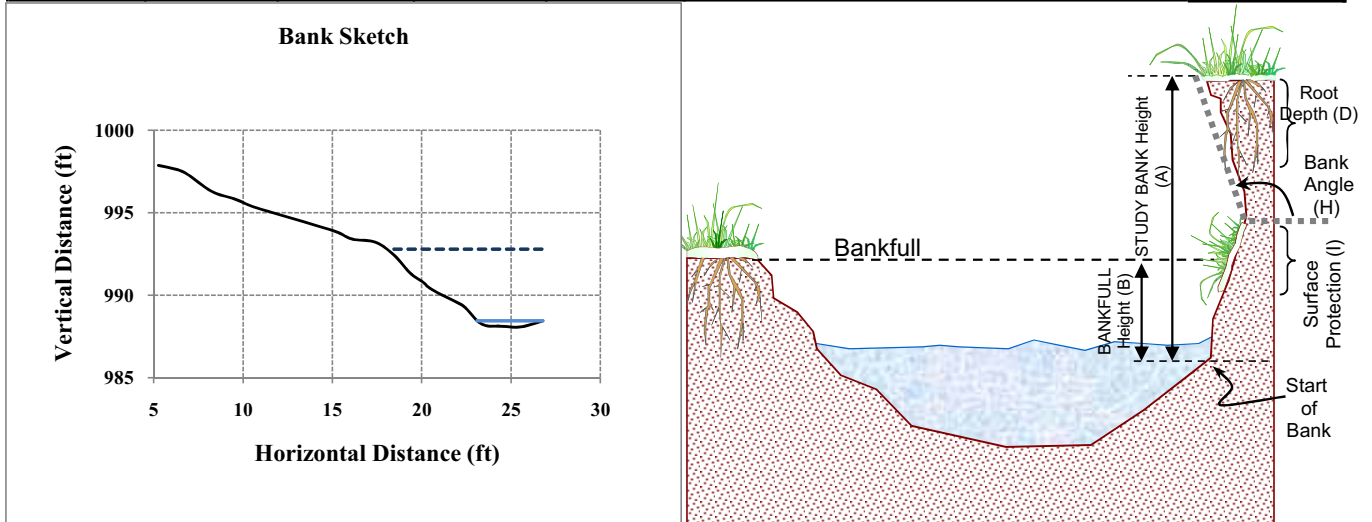
Stream: Centralia Lake Tributary		Location: Centralia Lake	
Station: Bank Type 3		Observers: GSRC, TWI	
Date: 05/29/09	Stream Type: E 6	Valley Type: VIII

Very Low	Low	Moderate	High	Very High	Extreme	Adjective Rating and Total Score	Moderate
5 – 9.5	10 – 19.5	20 – 29.5	30 – 39.5	40 – 45	46 – 50		20.3

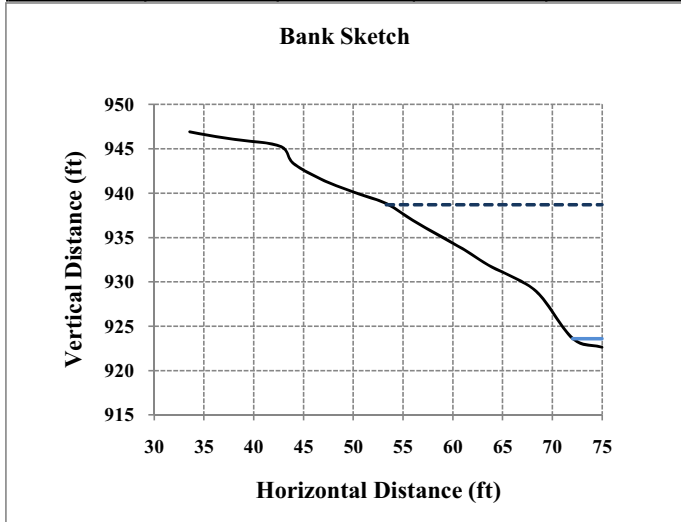
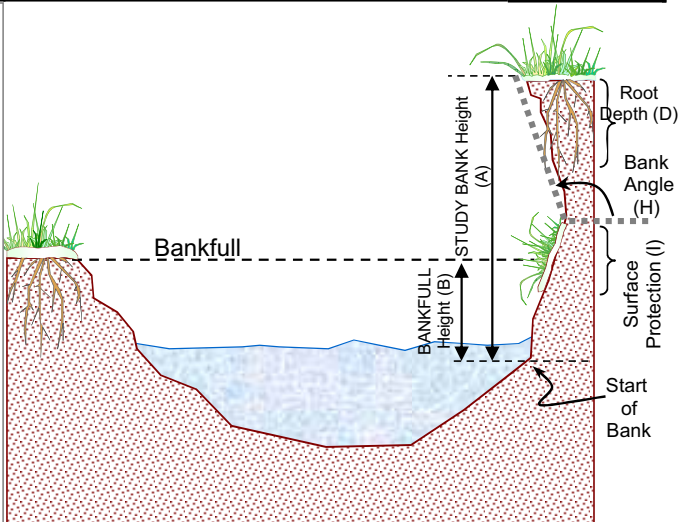
Stream: Delaware River		Location: Muscotah USGS Gage	
Station: Bank Type 1		Observers: GSRC, TWI	
Date: 08/31/09	Stream Type: E 5	Valley Type: VIII

Very Low	Low	Moderate	High	Very High	Extreme	Adjective Rating and Total Score
5 – 9.5	10 – 19.5	20 – 29.5	30 – 39.5	40 – 45	46 – 50	
						Low
						17.1

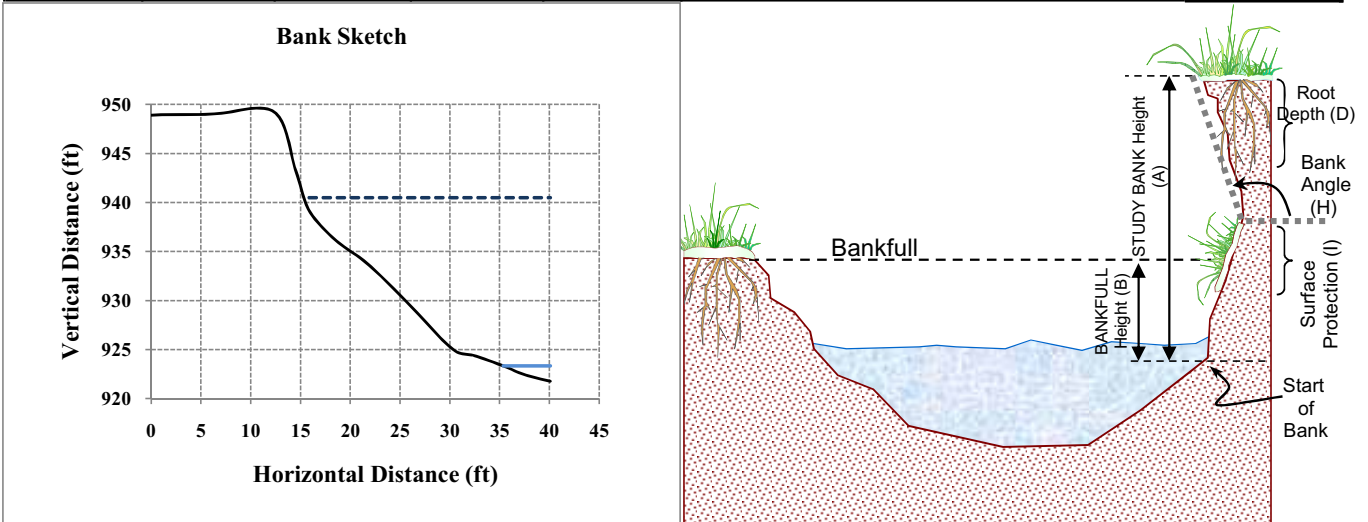
Stream: Delaware River	Location: Muscotah USGS Gage
Station: Bank Type 2	Observers: GSRC, TWI
Date: 08/31/09	Stream Type: E 5 Valley Type: VIII

Very Low	Low	Moderate	High	Very High	Extreme	Adjective Rating and Total Score	High
5 – 9.5	10 – 19.5	20 – 29.5	30 – 39.5	40 – 45	46 – 50		31.8

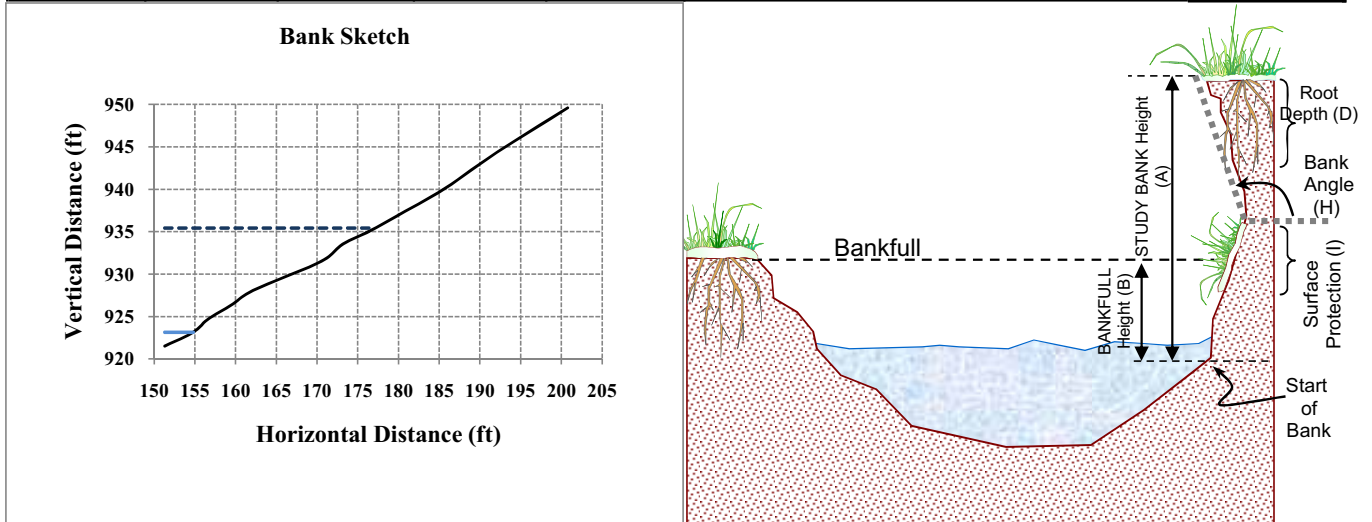
Stream: Delaware River	Location: Muscotah USGS Gage
Station: Bank Type 3	Observers: GSRC, TWI
Date: 08/31/09	Stream Type: E 5 Valley Type: VIII

Very Low	Low	Moderate	High	Very High	Extreme	Adjective Rating and Total Score	Low
5 – 9.5	10 – 19.5	20 – 29.5	30 – 39.5	40 – 45	46 – 50		18.0
