Kansas River Basin Regional Sediment Management Section 204 Stream and River Channel Assessment

March 2010

Final Report

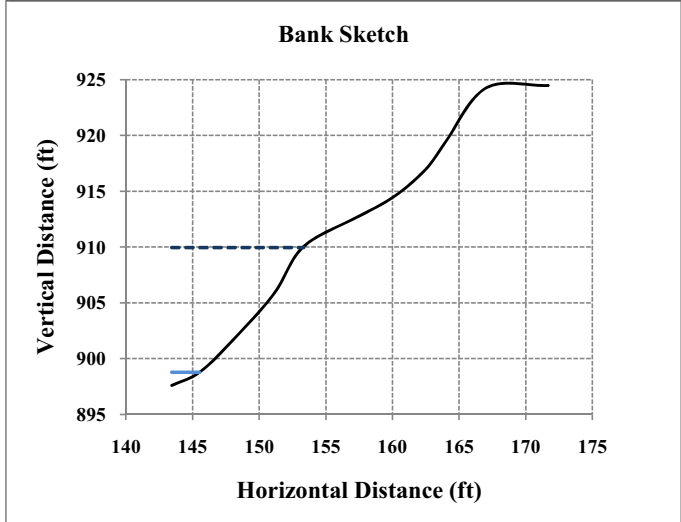
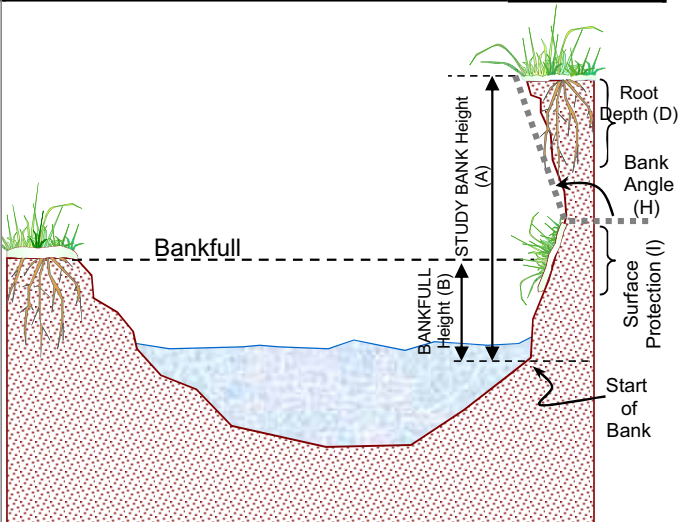
Stream: Delaware River		Location: 254 Road	
Station: Bank Type 1		Observers: GSRC, TWI	
Date: 09/02/09	Stream Type: C 5c-	Valley Type: VIII

Study Bank Height / Bankfull Height (C)				BEHI Score (Fig. 5-19)
Study Bank Height (ft) =	25.48 (A)	Bankfull Height (ft) =	11.18 (B)	(A) / (B) = 2.27907 (C)
				8.26
Root Depth / Study Bank Height (E)				
Root Depth (ft) =	25.48 (D)	Study Bank Height (ft) =	25.48 (A)	(D) / (A) = 1 (E)
				1
Weighted Root Density (G)				
Root Density as % =	30 (F)	(F) x (E) =	30 (G)	5.9
Bank Angle (H)				
Bank Angle as Degrees =	50 (H)	3.41		
Surface Protection (I)				
Surface Protection as % =	10 (I)	9

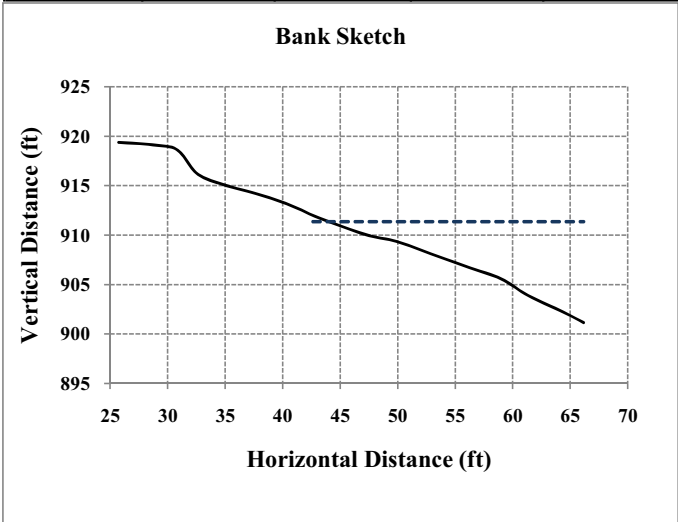
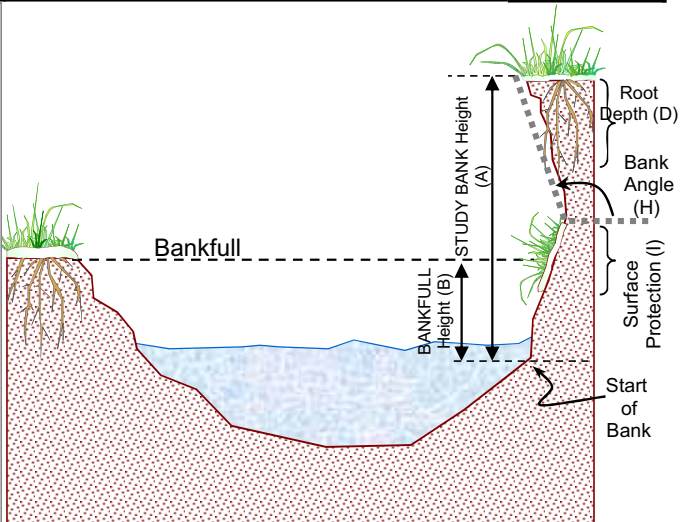
Stream: Delaware River	Location: 254 Road
Station: Bank Type 2	Observers: GSRC, TWI
Date: 09/02/09	Stream Type: C 5c- Valley Type: VIII

2.32
Bank Angle (H)					
Bank Angle as Degrees =	21 (H)				
					2
Surface Protection (I)					
Surface Protection as % =	50 (I)				
					4.32
Bank Material Adjustment:					
<ul style="list-style-type: none"> Bedrock (Overall Very Low BEHI) Boulders (Overall Low BEHI) Cobble (Subtract 10 points if uniform medium to large cobble) Gravel or Composite Matrix (Add 5–10 points depending on percentage of bank material that is composed of sand) Sand (Add 10 points) Silt/Clay (no adjustment) 			➔	Bank Material Adjustment	
					0
			Stratification Adjustment		0
			Add 5–10 points, depending on position of unstable layers in relation to bankfull stage

Very Low	Low	Moderate	High	Very High	Extreme		Adjective Rating and Total Score
5 – 9.5	10 – 19.5	20 – 29.5	30 – 39.5	40 – 45	46 – 50	➔	Low
							17.6

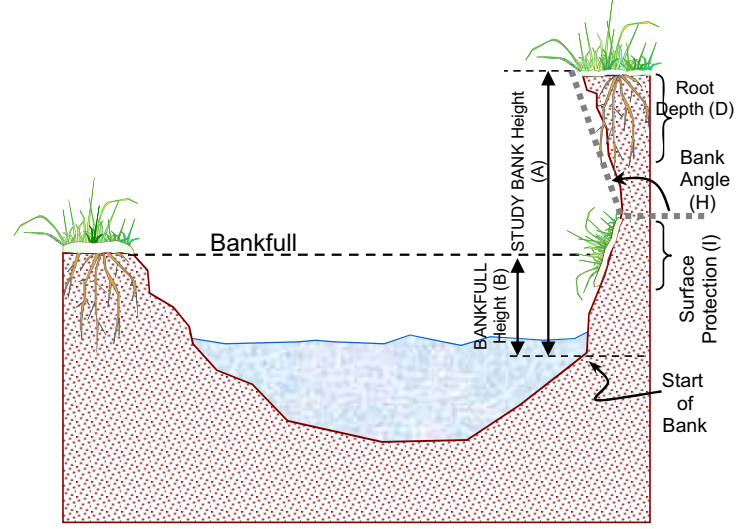
Stream: Delaware River	Location: 254 Road
Station: Bank Type 3	Observers: GSRC, TWI
Date: 09/02/09	Stream Type: C 5c- Valley Type: VIII

Very Low	Low	Moderate	High	Very High	Extreme	Adjective Rating and Total Score	Moderate
5 – 9.5	10 – 19.5	20 – 29.5	30 – 39.5	40 – 45	46 – 50		27.8

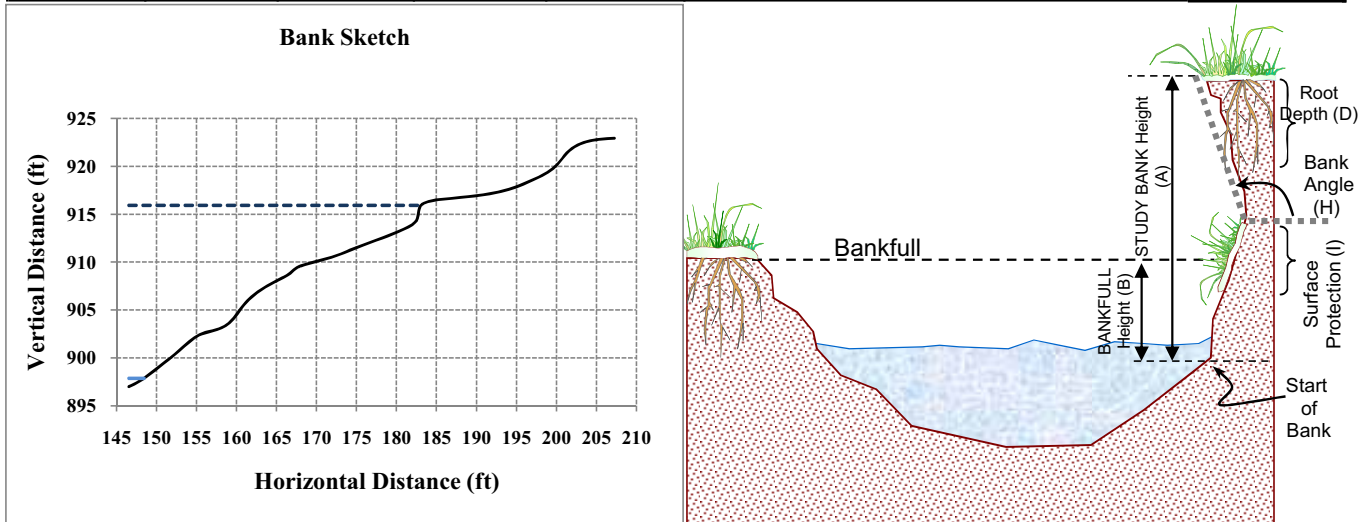
Very Low	Low	Moderate	High	Very High	Extreme	Adjective Rating and Total Score	Low
5 – 9.5	10 – 19.5	20 – 29.5	30 – 39.5	40 – 45	46 – 50		18.9

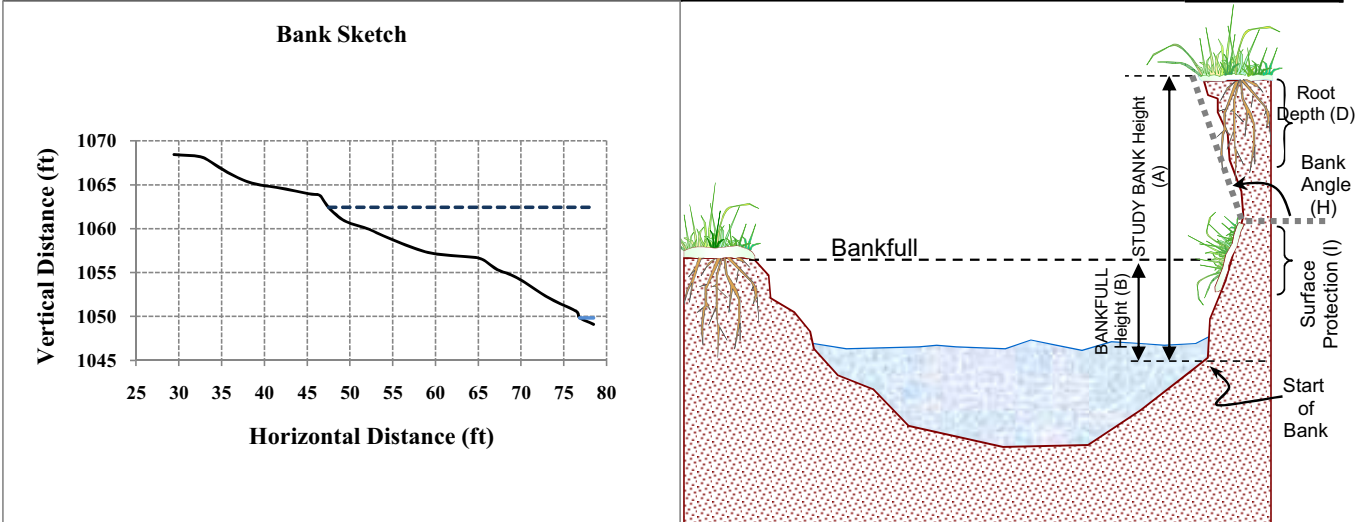
Stream: Delaware River	Location: Muddy Creek Confluence
Station: Bank Type 1	Observers: GSRC, TWI
Date: 09/11/09	Stream Type: E 5 Valley Type: VIII

2.32
Bank Angle (H)					
Bank Angle as Degrees =	23 (H)				
					2.1
Surface Protection (I)					
Surface Protection as % =	60 (I)				
					3.5
Bank Material Adjustment:					
Bedrock (Overall Very Low BEHI) Boulders (Overall Low BEHI) Cobble (Subtract 10 points if uniform medium to large cobble) Gravel or Composite Matrix (Add 5–10 points depending on percentage of bank material that is composed of sand) Sand (Add 10 points) Silt/Clay (no adjustment)				Bank Material Adjustment	0
				Stratification Adjustment	0
				<small>Add 5–10 points, depending on position of unstable layers in relation to bankfull stage</small>

Very Low	Low	Moderate	High	Very High	Extreme		Adjective Rating and Total Score
5 – 9.5	10 – 19.5	20 – 29.5	30 – 39.5	40 – 45	46 – 50		Low
							14.4

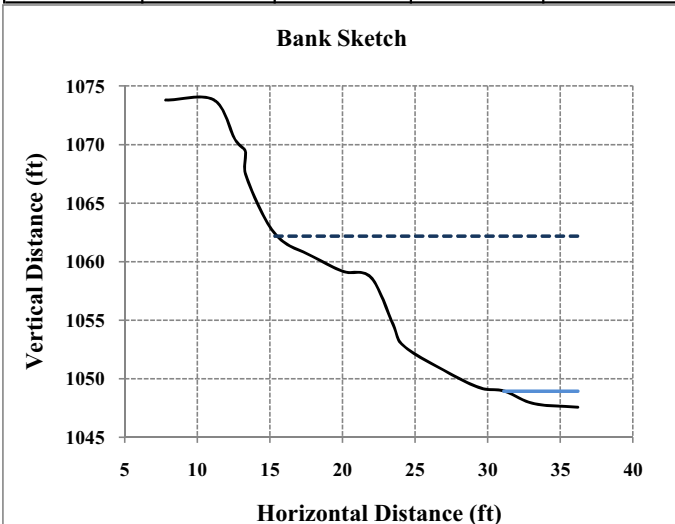
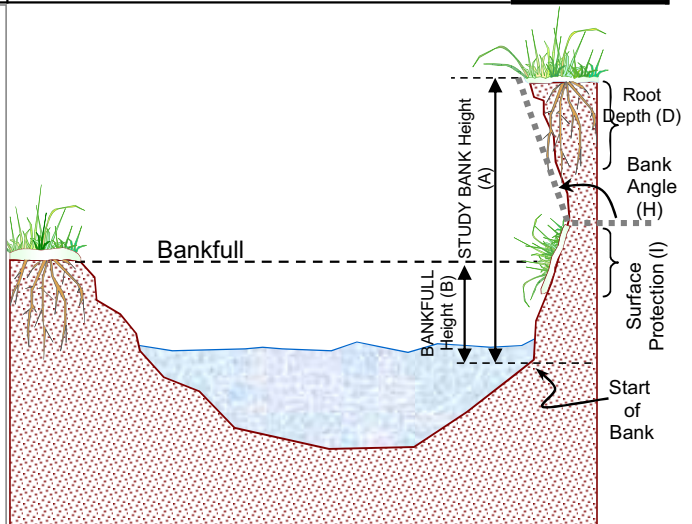
Stream: Delaware River	Location: Muddy Creek Confluence
Station: Bank Type 2	Observers: GSRC, TWI
Date: 09/11/09	Stream Type: E 5 Valley Type: VIII

Study Bank Height / Bankfull Height (C)				BEHI Score (Fig. 5-19)	
Study Bank Height (ft) =	25.95 (A)	Bankfull Height (ft) =	14.31 (B)	(A) / (B) = 1.81342 (C)	7
Root Depth / Study Bank Height (E)					
Root Depth (ft) =	0 (D)	Study Bank Height (ft) =	25.95 (A)	(D) / (A) = 0 (E)	10
Weighted Root Density (G)					
Root Density as % =	0 (F)	(F) x (E) = 0 (G)		10	
Bank Angle (H)					
Bank Angle as Degrees =	50 (H)			3.41	
Surface Protection (I)					
Surface Protection as % =	10 (I)			9	
Bank Material Adjustment:					
<ul style="list-style-type: none"> Bedrock (Overall Very Low BEHI) Boulders (Overall Low BEHI) Cobble (Subtract 10 points if uniform medium to large cobble) Gravel or Composite Matrix (Add 5–10 points depending on percentage of bank material that is composed of sand) Sand (Add 10 points) Silt/Clay (no adjustment) 				Bank Material Adjustment	0
				Stratification Adjustment	0
				Add 5–10 points, depending on position of unstable layers in relation to bankfull stage

Very Low	Low	Moderate	High	Very High	Extreme		Adjective Rating and Total Score
5 – 9.5	10 – 19.5	20 – 29.5	30 – 39.5	40 – 45	46 – 50		High
							39.4

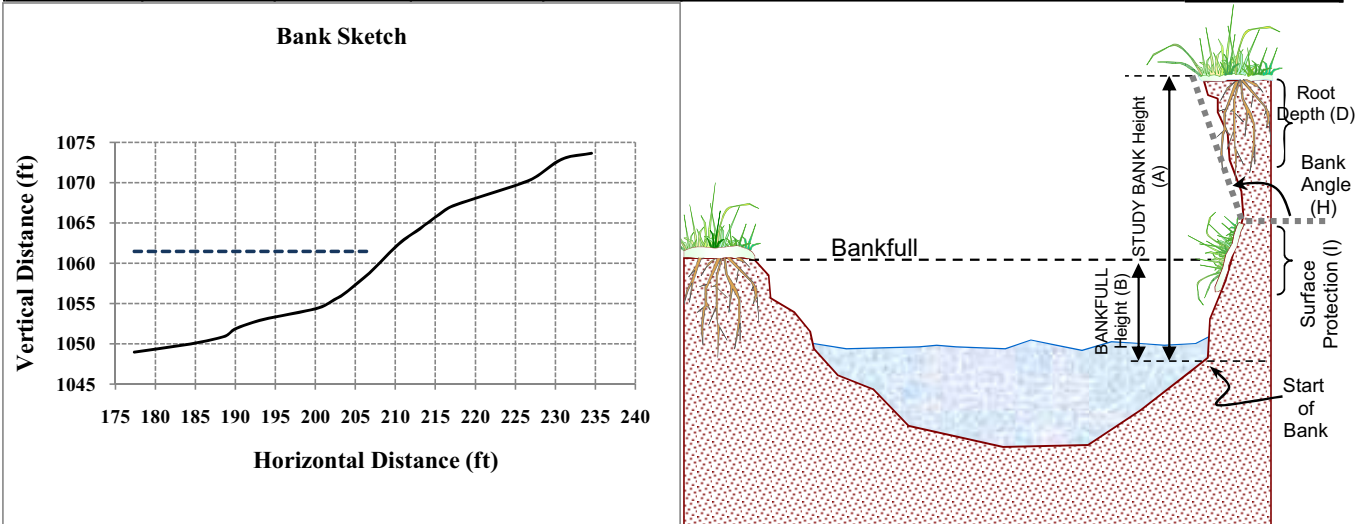
Stream: Delaware River	Location: Muddy Creek Confluence
Station: Bank Type 3	Observers: GSRC, TWI
Date: 09/11/09	Stream Type: E 5 Valley Type: VIII

2.1
Weighted Root Density (G)					
Root Density as % =	50 (F)	(F) x (E) =			43.2841 (G)
					4.85
Bank Angle (H)					
Bank Angle as Degrees =	33 (H)				2.58
Surface Protection (I)					
Surface Protection as % =	50 (I)				4.32
Bank Material Adjustment:					
<ul style="list-style-type: none"> Bedrock (Overall Very Low BEHI) Boulders (Overall Low BEHI) Cobble (Subtract 10 points if uniform medium to large cobble) Gravel or Composite Matrix (Add 5–10 points depending on percentage of bank material that is composed of sand) Sand (Add 10 points) Silt/Clay (no adjustment) 				Bank Material Adjustment	0
				Stratification Adjustment	0
				Add 5–10 points, depending on position of unstable layers in relation to bankfull stage

Very Low	Low	Moderate	High	Very High	Extreme	Adjective Rating and Total Score	Low
5 – 9.5	10 – 19.5	20 – 29.5	30 – 39.5	40 – 45	46 – 50	14.9	14.9

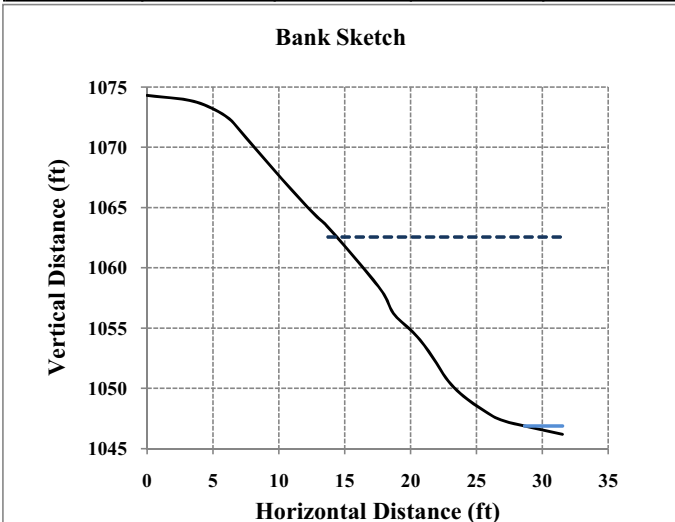
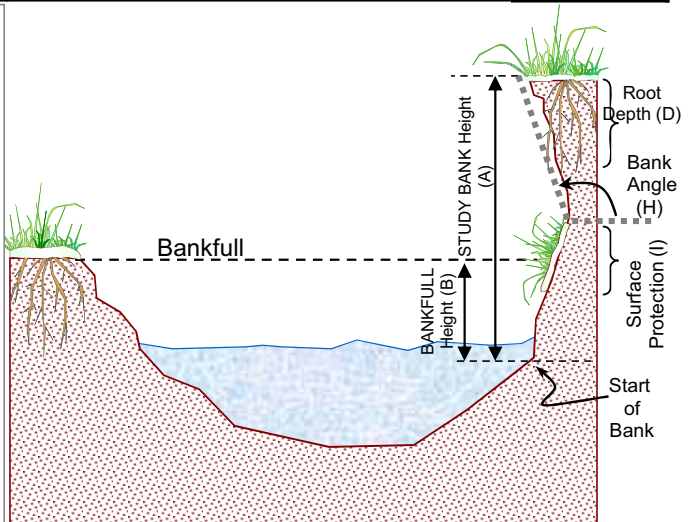
Stream: Delaware River	Location: Muddy Creek Confluence
Station: Bank Type 4	Observers: GSRC, TWI
Date: 09/14/09	Stream Type: E 5 Valley Type: VIII

Study Bank Height / Bankfull Height (C)				BEHI Score (Fig. 5-19)	
Study Bank Height (ft) =	26.9 (A)	Bankfull Height (ft) =	15.66 (B)	(A) / (B) = 1.71775 (C)	6.57
Root Depth / Study Bank Height (E)					
Root Depth (ft) =	26.9 (D)	Study Bank Height (ft) =	26.9 (A)	(D) / (A) = 1 (E)	1
Weighted Root Density (G)					
Root Density as % =	10 (F)	(F) x (E) = 10 (G)		8.44	
Bank Angle (H)					
Bank Angle as Degrees =	47 (H)			3.27	
Surface Protection (I)					
Surface Protection as % =	10 (I)			9	
Bank Material Adjustment:					
Bedrock (Overall Very Low BEHI) Boulders (Overall Low BEHI) Cobble (Subtract 10 points if uniform medium to large cobble) Gravel or Composite Matrix (Add 5–10 points depending on percentage of bank material that is composed of sand) Sand (Add 10 points) Silt/Clay (no adjustment)				Bank Material Adjustment	0
				Stratification Adjustment	0
				Add 5–10 points, depending on position of unstable layers in relation to bankfull stage

Very Low	Low	Moderate	High	Very High	Extreme		Adjective Rating and Total Score	Moderate
5 – 9.5	10 – 19.5	20 – 29.5	30 – 39.5	40 – 45	46 – 50	→	28.3	28.3

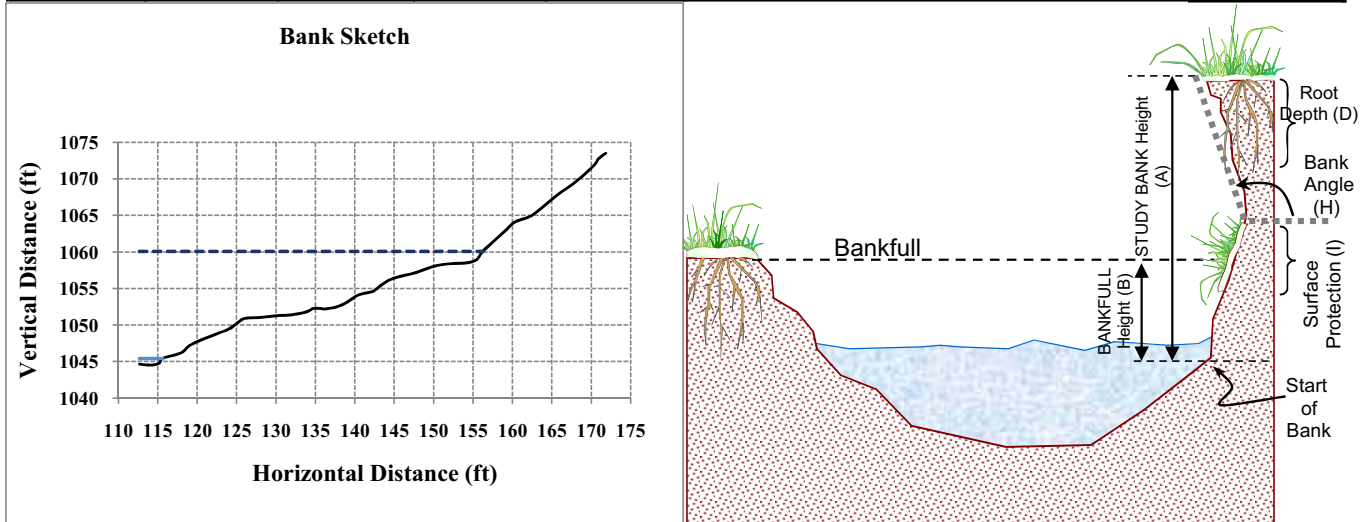
Stream: Delaware River		Location: Muddy Creek Confluence	
Station: Bank Type 5		Observers: GSRC, TWI	
Date: 09/14/09	Stream Type: E 5	Valley Type: VIII

Bank Material Adjustment:	Bank Material Adjustment
<ul style="list-style-type: none"> Bedrock (Overall Very Low BEHI) Boulders (Overall Low BEHI) Cobble (Subtract 10 points if uniform medium to large cobble) Gravel or Composite Matrix (Add 5–10 points depending on percentage of bank material that is composed of sand) Sand (Add 10 points) Silt/Clay (no adjustment) 	0
	Stratification Adjustment
	Add 5–10 points, depending on position of unstable layers in relation to bankfull stage
	0

Very Low	Low	Moderate	High	Very High	Extreme	Adjective Rating and Total Score	High
5 – 9.5	10 – 19.5	20 – 29.5	30 – 39.5	40 – 45	46 – 50		33.8

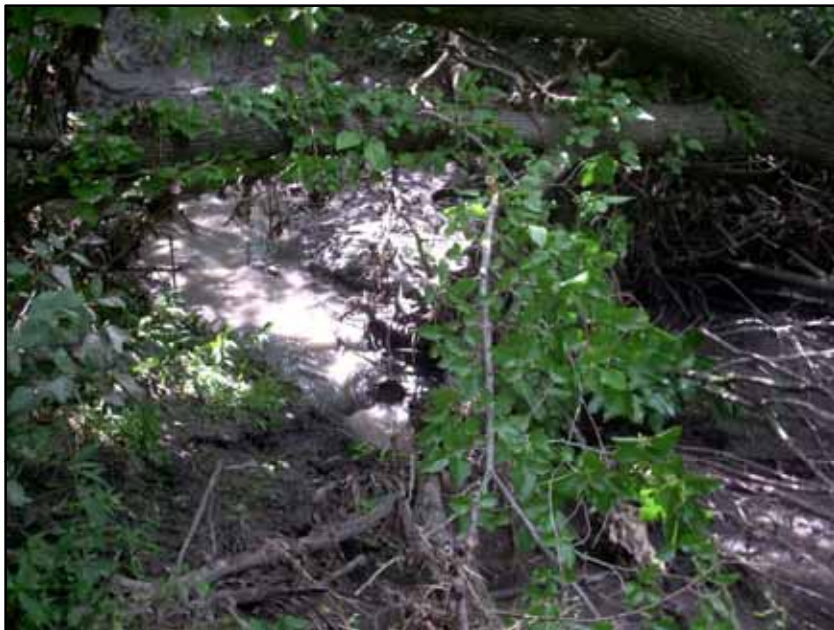
Kansas River Basin Stream and River Channel Assessment Direction: Southwest	DESCRIPTION	Small knickpoint	6
	LOCATION	Clear Creek Tributary	Date
	PHOTOGRAPHER	Brock Emmert	June 19, 2009

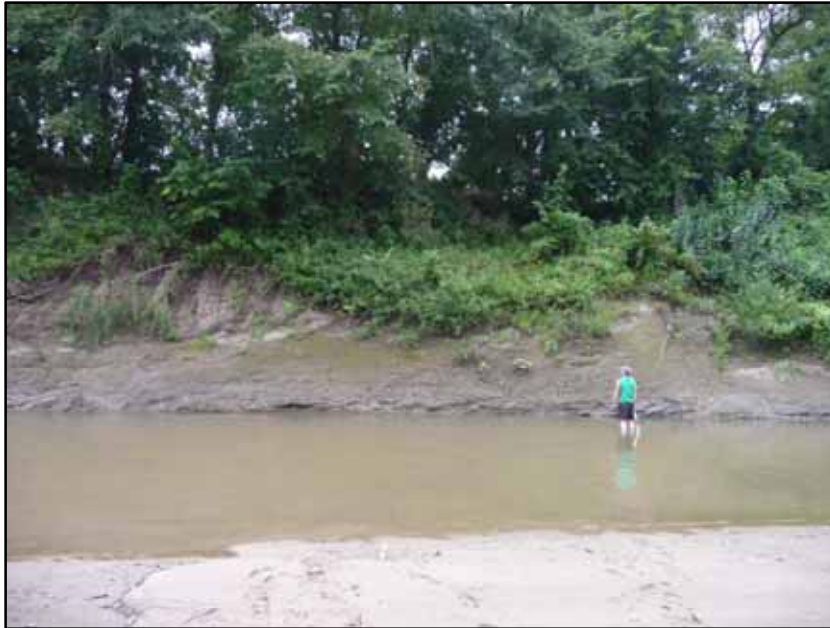
Kansas River Basin Stream and River Channel Assessment Direction: West	DESCRIPTION	Bank type 1	15
	LOCATION	Delaware River near 254 Road	Date
	PHOTOGRAPHER	Brock Emmert	Sept. 2, 2009

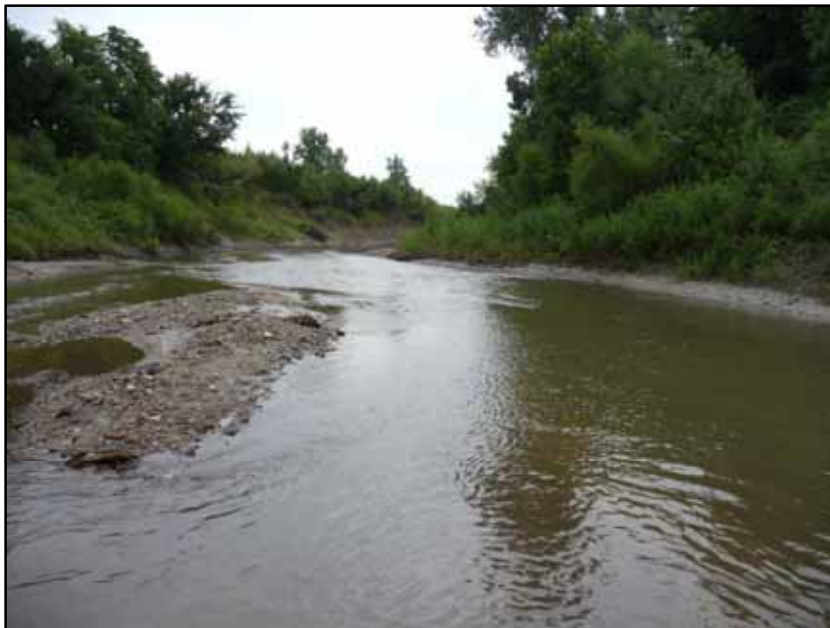
Kansas River Basin Stream and River Channel Assessment Direction: South	DESCRIPTION	Bank Type 2	16
	LOCATION	Delaware River near 254 Road	Date
	PHOTOGRAPHER	Brock Emmert	Sept. 2, 2009

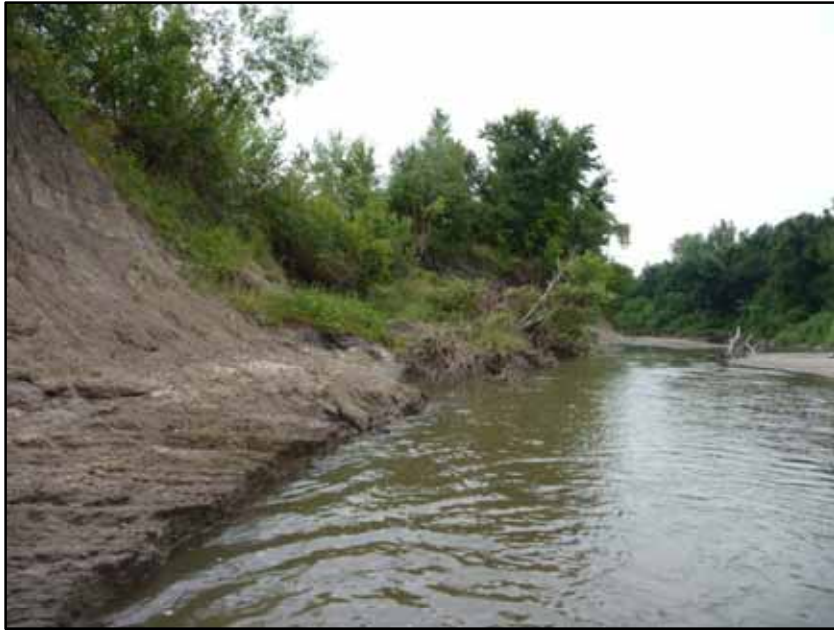
Kansas River Basin Stream and River Channel Assessment Direction: West	DESCRIPTION	Bank Type 3 with bank slump in background	17
	LOCATION	Delaware River near 254 Road	Date
	PHOTOGRAPHER	Brock Emmert	Sept. 2, 2009

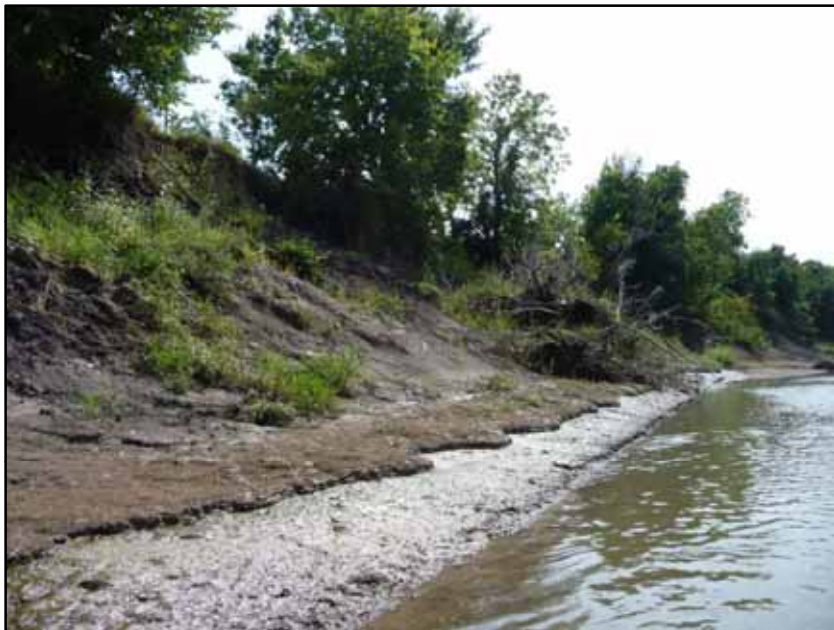
Kansas River Basin Stream and River Channel Assessment Direction: Southwest	DESCRIPTION	Groundwater seeps at lower bank type 3	18
	LOCATION	Delaware River near 254 Road	Date
	PHOTOGRAPHER	Brock Emmert	Sept. 2, 2009

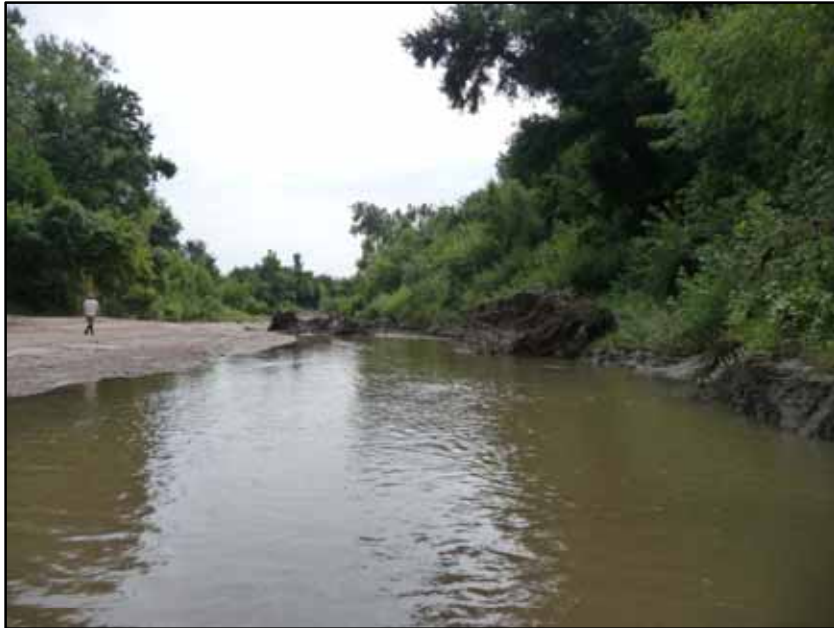
Kansas River Basin Stream and River Channel Assessment	DESCRIPTION	Bank type 4	19
	LOCATION	Delaware River near 254 Road	Date
	PHOTOGRAPHER	Brock Emmert	Sept. 2, 2009
Direction: West

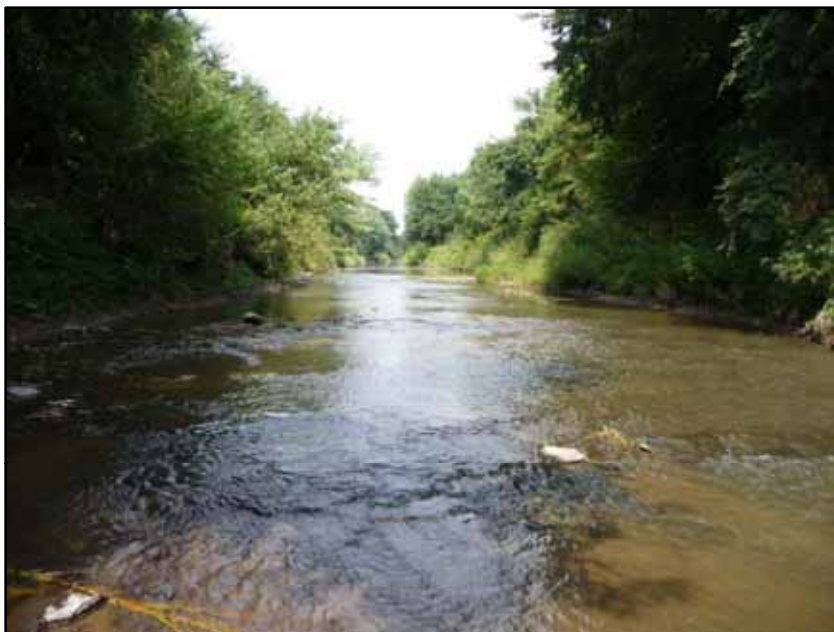
Kansas River Basin Stream and River Channel Assessment	DESCRIPTION	Bank Type 1	20
	LOCATION	Delaware River near Muddy Creek Confluence	Date
	PHOTOGRAPHER	Brock Emmert	Sept. 11, 2009
Direction: North

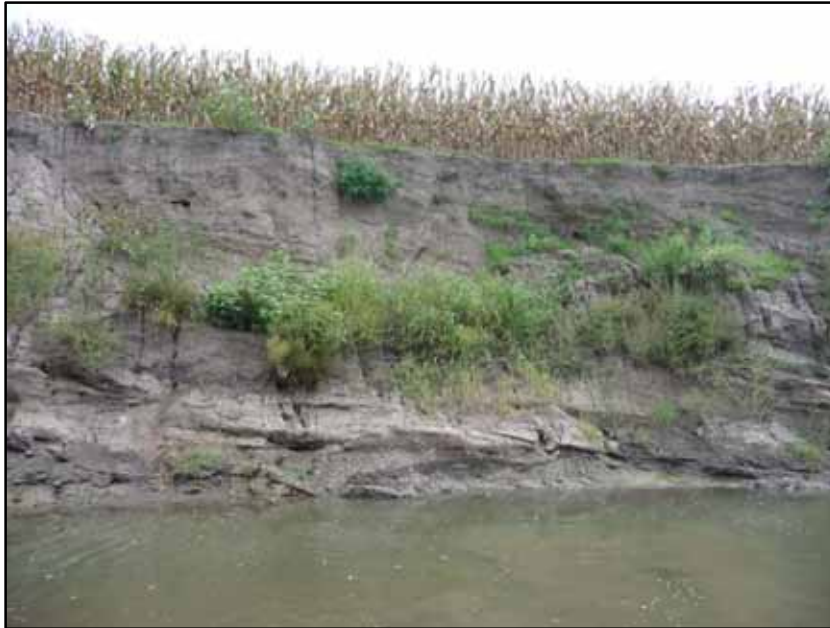
Kansas River Basin Stream and River Channel Assessment Direction: Southeast	DESCRIPTION	Bank Type 2	21
	LOCATION	Delaware River near Muddy Creek Confluence	Date
	PHOTOGRAPHER	Brock Emmert	Sept. 11, 2009

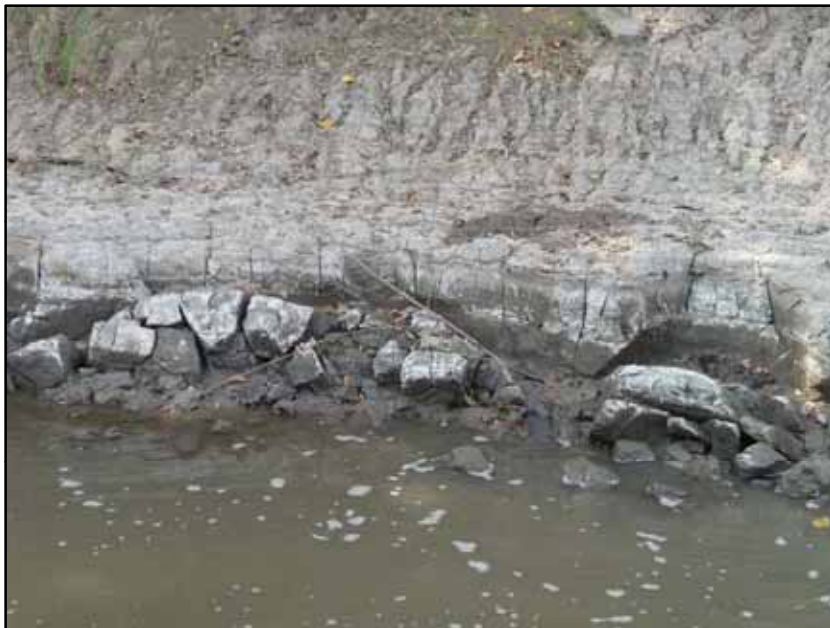
Kansas River Basin Stream and River Channel Assessment Direction: East	DESCRIPTION	Active bank type 2 erosion	22
	LOCATION	Delaware River near Muddy Creek Confluence	Date
	PHOTOGRAPHER	Brock Emmert	Sept. 11, 2009

Bank shaping by excavating steep banks to a 3 to 1 horizontal to vertical slope will be required to rehabilitate unstable banks on the river bends. Constructing a bankfull bench will help increase stream stability by dissipating energy during high flow events. The bench does not have to be wide, as any bankfull features will be an improvement to the stream stability. Excavating stream banks to suitable conditions will cost \$30 to \$40 per linear foot. Planting a riparian buffer consisting of live cuttings, bare root seedlings, and a native grass strip will cost approximately \$5.00 per linear foot.

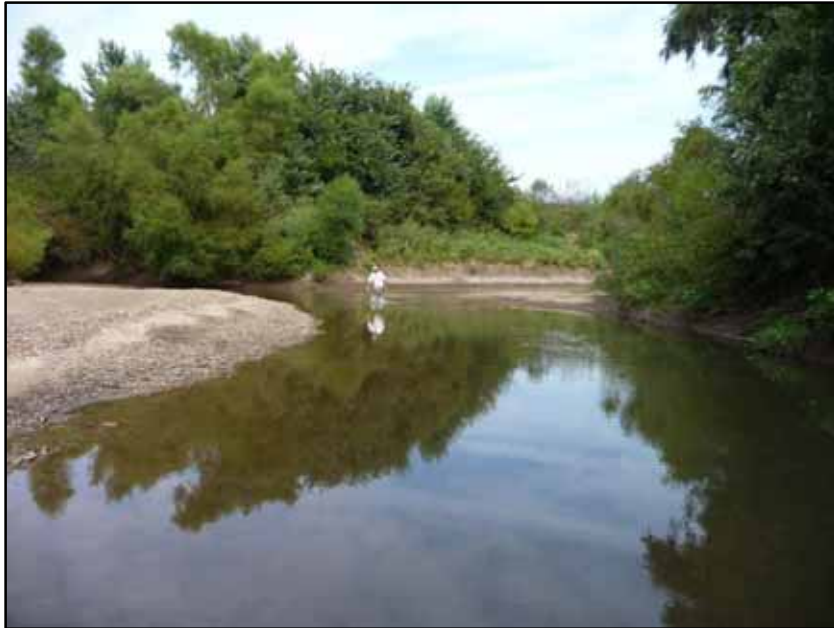
Kansas River Basin Stream and River Channel Assessment Direction: Northwest	DESCRIPTION	Bank Type 3	23
	LOCATION	Delaware River near Muddy Creek Confluence	Date
	PHOTOGRAPHER	Brock Emmert	Sept. 11, 2009

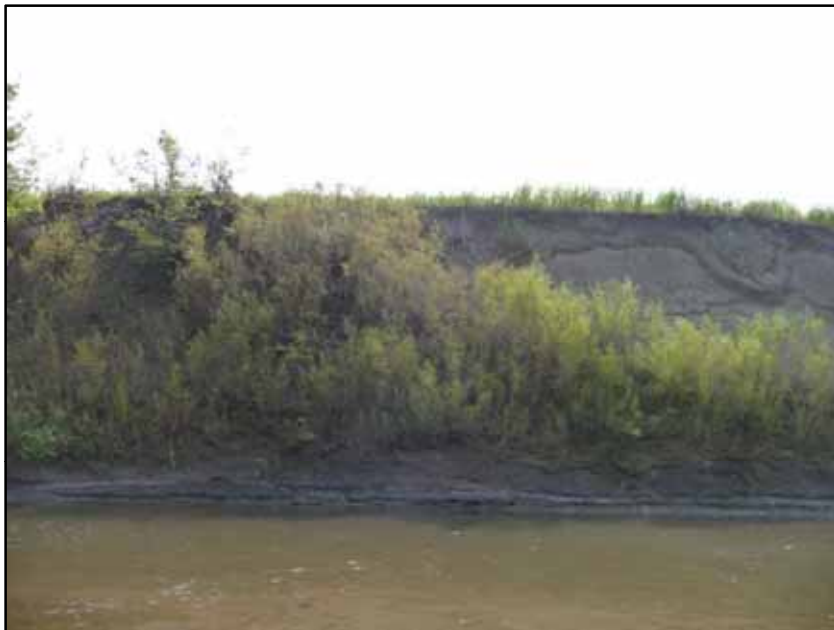
Kansas River Basin Stream and River Channel Assessment Direction: East	DESCRIPTION	Bank Type 4	24
	LOCATION	Delaware River near Muddy Creek Confluence	Date
	PHOTOGRAPHER	Brock Emmert	Sept. 14, 2009

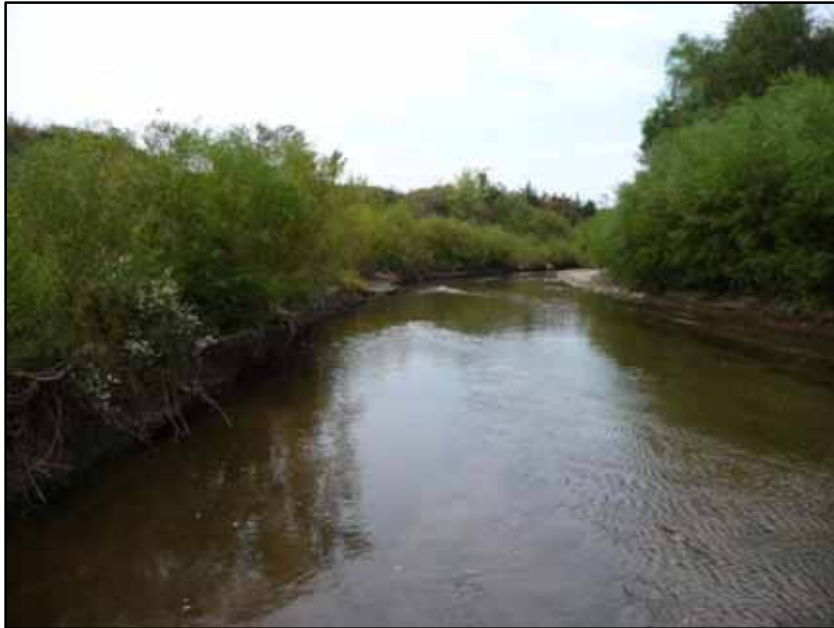
Kansas River Basin Stream and River Channel Assessment Direction: West	DESCRIPTION	Willow along bank type 5	25
	LOCATION	Delaware River near Muddy Creek Confluence	Date
	PHOTOGRAPHER	Brock Emmert	Sept. 14, 2009

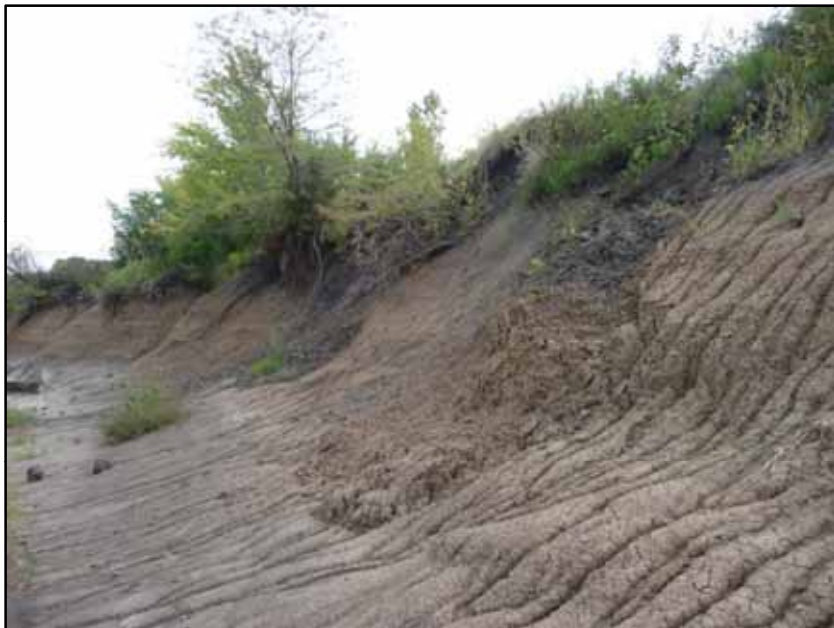
Kansas River Basin Stream and River Channel Assessment Direction: East	DESCRIPTION	Bank type 5	26
	LOCATION	Delaware River near Muddy Creek Confluence	Date
	PHOTOGRAPHER	Brock Emmert	Sept. 14, 2009

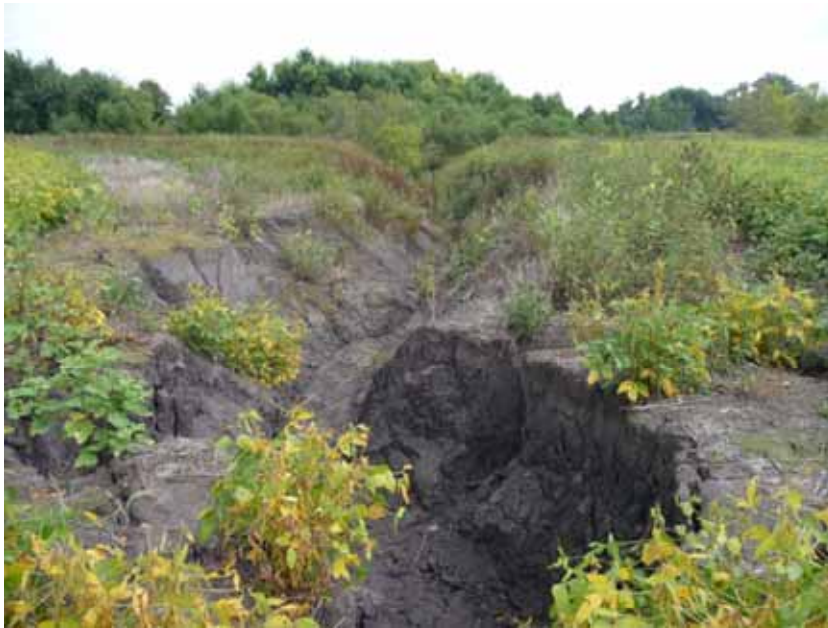
Kansas River Basin Stream and River Channel Assessment Direction: Northeast	DESCRIPTION	Active gully erosion at bank type 5	27
	LOCATION	Delaware River near Muddy Creek Confluence	Date
	PHOTOGRAPHER	Brock Emmert	Sept. 14, 2009

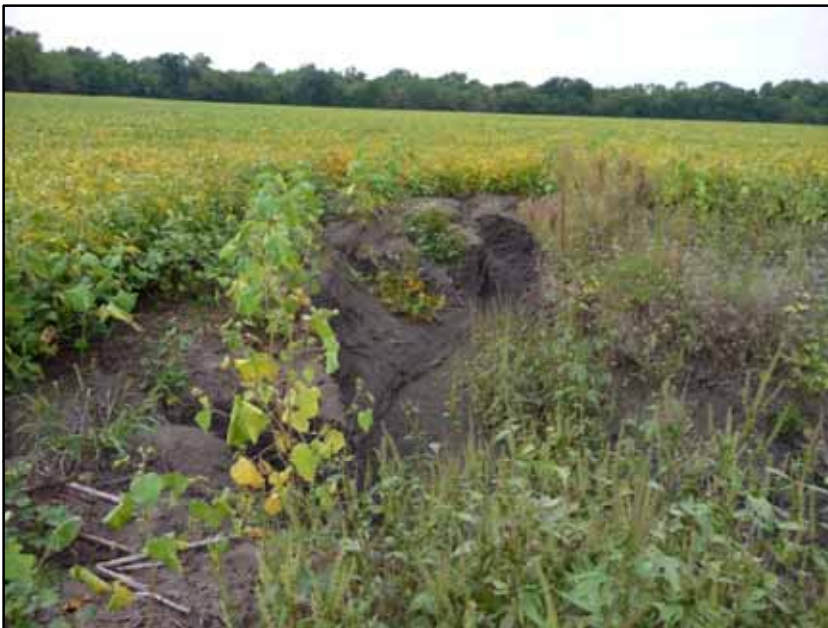
Kansas River Basin Stream and River Channel Assessment Direction: Southwest	DESCRIPTION	Active gully erosion at bank type 5	28
	LOCATION	Delaware River near Muddy Creek Confluence	Date
	PHOTOGRAPHER	Brock Emmert	Sept. 14, 2009
